Pre-purchase Condominium *Inspection Report*

Sample of a 18 year old 2,400 square foot Condo

Steve Garcia Inspections

FILE/DATE/TIME This is a preliminary report before the recommended specialist evaluation /reports.
 File # 180910
 Date of inspection: September 18, 2010
 Time of inspection: 1:00 PM - 7:00 PM.

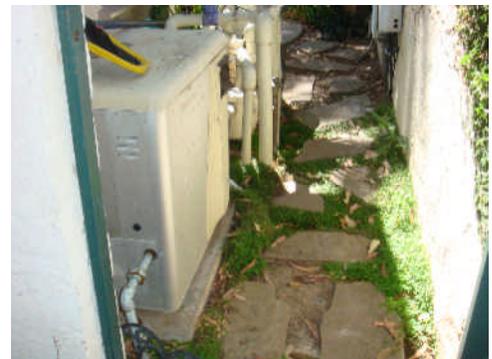
[FE] The two right side building exit doors landings do not appear to have proper slope for proper water runoff.

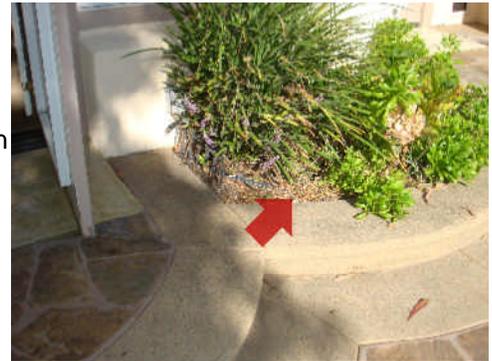
[RU] There is no visible surface /underground drains at the spa equipment and right side planter between the exit door landings. Based on the evidence noted above I recommend drains be added.

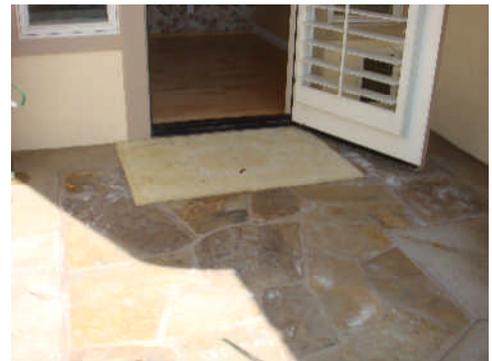
[FE] The landing outside of the kitchen has efflorescence on the surface. This is salt / mineral deposits left when moisture in the concrete evaporates. It indicates that the hardscape is experiencing wet and dry cycles.

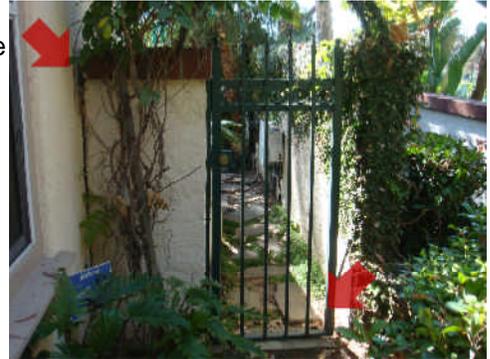
[CR] The original iron gate is attached to the settled block wall. The gate is rusted /damaged and drags on the grade.

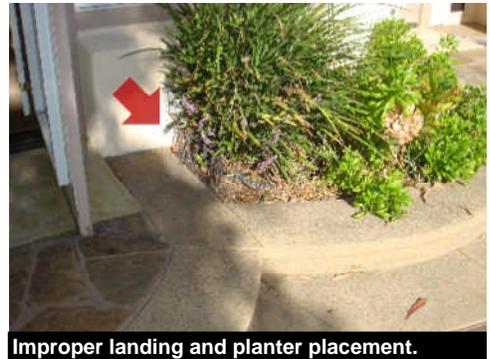
[CR] The added raised planter enclosure up onto the right stucco wall is above the stucco screed improperly. This condition could be conducive to moisture intrusion, and cause damage to the wall materials.

Improper landing and planter placement.

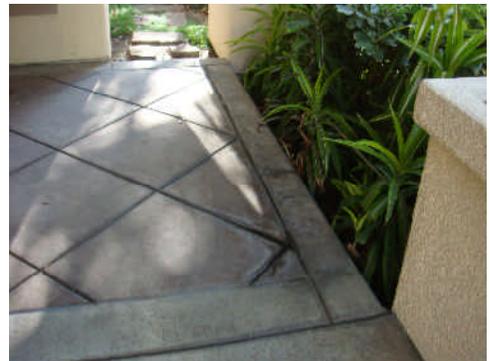
[CR] The front association sprinkler is spraying water onto the entry landing improperly.

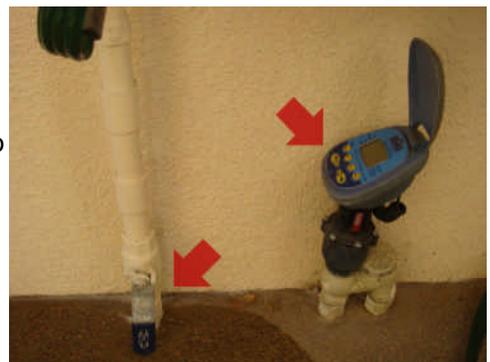
[FE] Outside of the kitchen is a ball valve that appears to supply the added side yard sprinklers.

[FE] The automatic control is not operating /no power and its function is unknown.

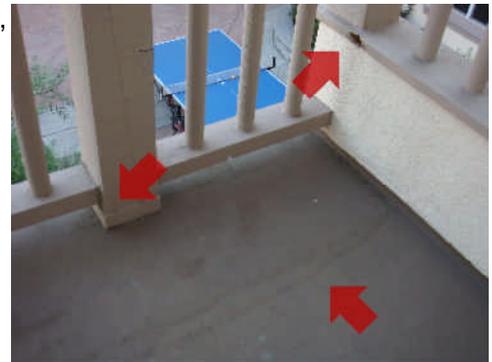
[FE] signs of puddling is evident at the end of the deck around the railing posts. This condition could be conducive to moisture intrusion and deterioration.

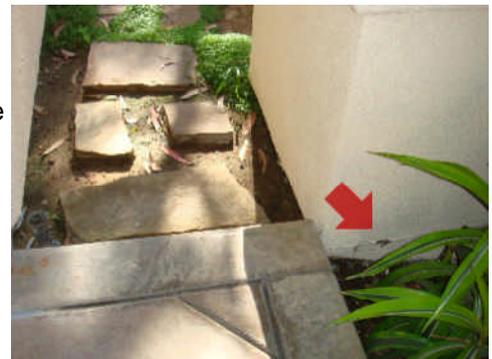
[CR] The stucco screed has moisture damage and is rusted at the front entry column. The landscape sprinkler water appears to have caused the damage.

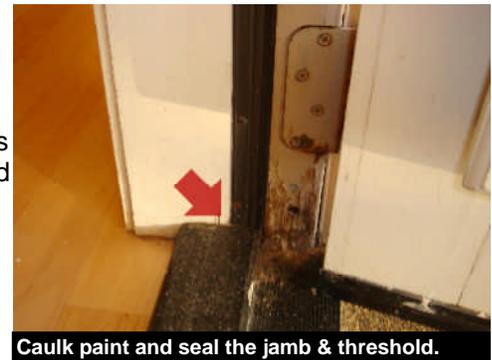
[CR] The paint is weathered and chipping off the kitchen door jamb. The exterior door jambs and thresholds intersections should be caulked and maintained.

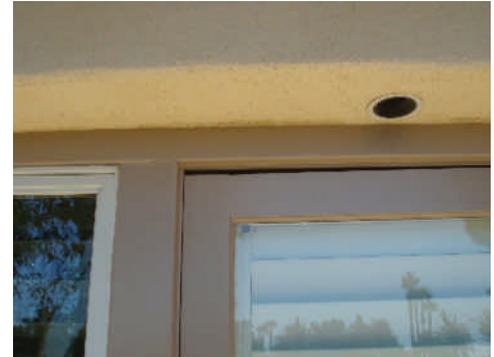
[CR] The family door rubs the threshold. The door bottom metal weather strip holder is loose. The top of the door is cut irregular.

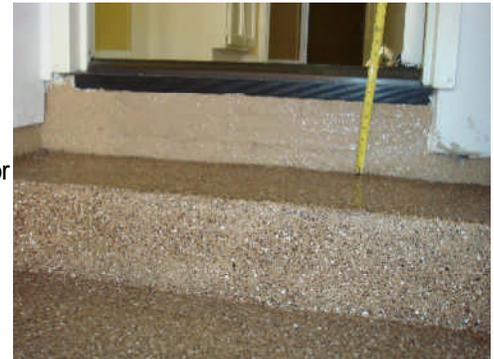
[SC] The steps from the garage into the interior have improper and uneven rise due to the threshold height. This condition is a trip and fall hazard.

The step down into the garage from the interior of the house exceeds allowed building standards height for safety with the threshold.

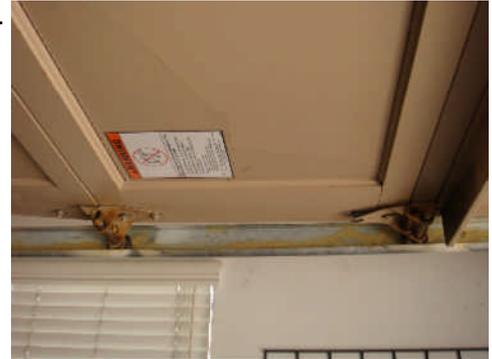
[CR] The garage door hardware /hinges are loose and missing securing nuts.

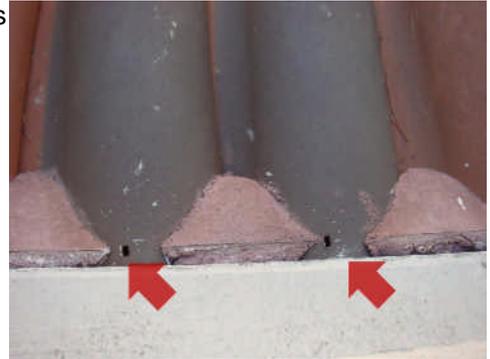
[CR] Loose mortar plugs and overexposed tiles at the left side of the wall flashing intersection.

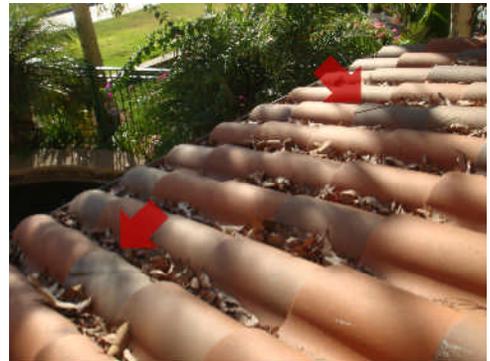
510 CLAY TILES [CR] There are a number of cracked and broken tiles on the lower right roof area visible from the bedroom window.

The debris should be removed from the roof tiles at the right side lower roof area.

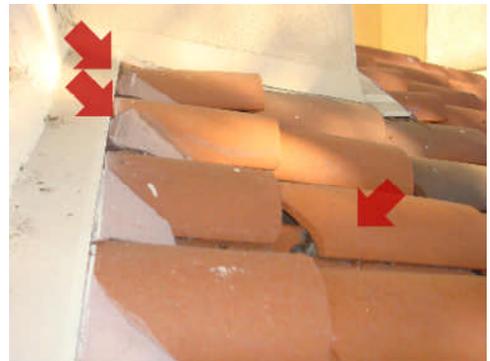
516 COMMENTS [CR] The lower roof tiles and mortar plugs are loose at the wall flashing intersection.

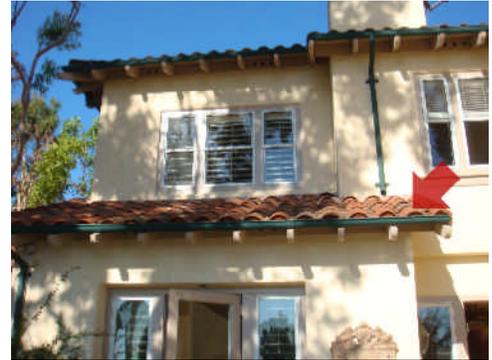
[FE] The right side upper roof downspout terminated onto the lower roof. The lower roof gutter is lacking a splash block.

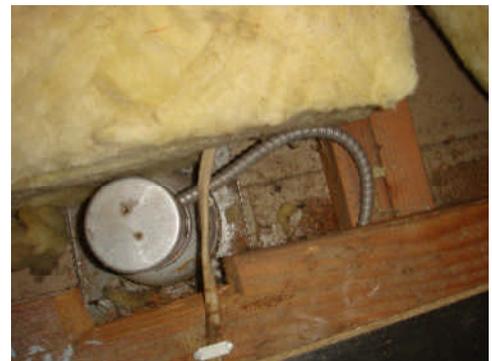
602 COMMENTS [FE] Some rodent droppings are evident over the master bathroom.

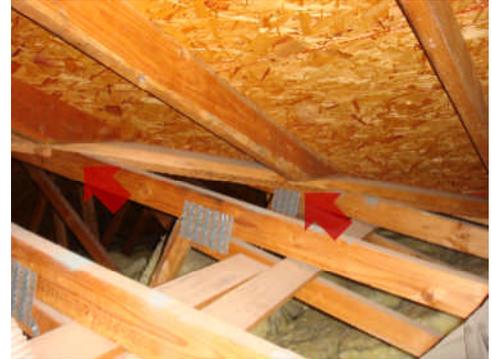
[CR] The conventional framing jack rafters are lacking bearing point framing members for proper support and connection.

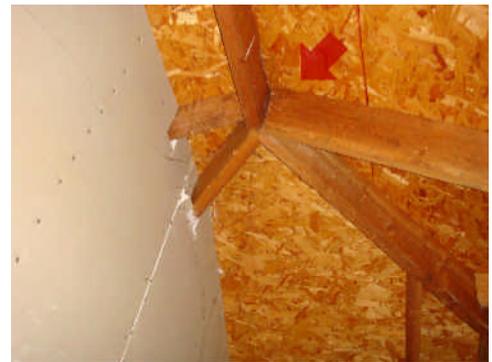
[CR] The conventional framing connections have gaps, and lacking hardware /fasteners.

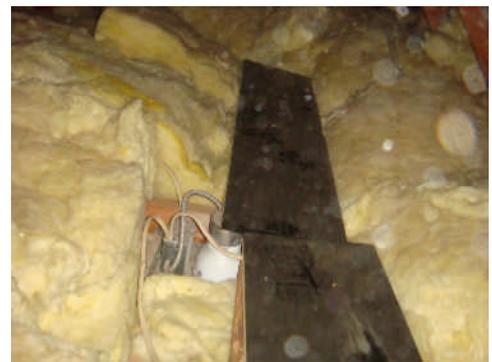
Shelving boards have been placed on the joists, insulation and light fixture improperly. Remove.

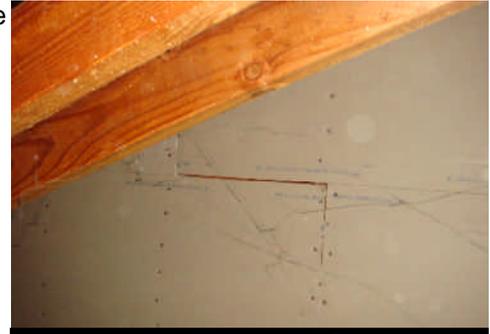
Fire separation walls not taped & sealed.

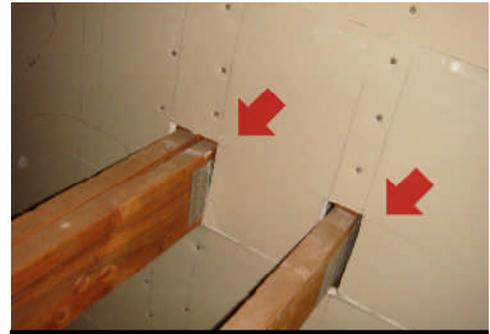
- 612 COMMENTS** [SC] There are gaps and unsealed joints in the fire-resistive walls between the joining / neighboring spaces. This condition is a fire safety concern.

Gaps & voids in the fire separation walls.

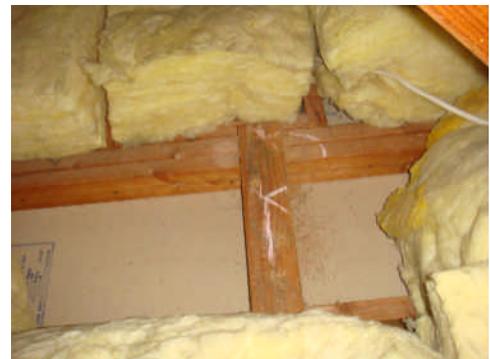
[CR] The insulation is out of place and missing at areas exposing the ceiling.

[CR] The insulation is on top of framing and wiring improperly. The insulation should be in contact with the ceilings to be effective.

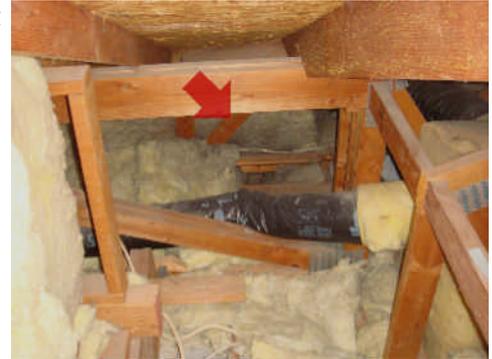
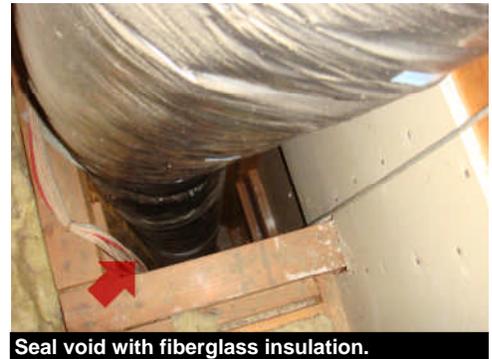
619 COMMENTS I recommend the void at the air supply duct over the master closet be sealed with fiberglass batt insulation.

Seal void with fiberglass insulation.

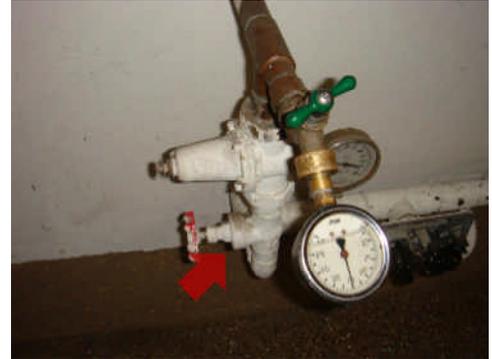
[CR] The main water shutoff valve is corroded. I recommend the valve be replaced with a 1/4 turn ball valve.

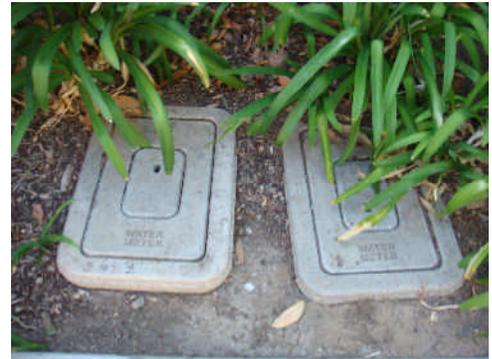
[FE] The water meters are not labeled at the front sidewalk area. I recommend the meters be labeled for shutting off the water when replacing the garage shutoff valve.

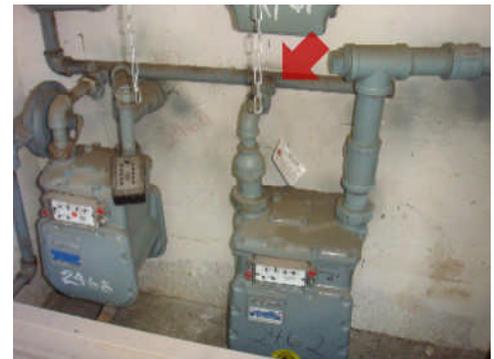
[RU] The main gas supply shutoff was not operated. There is no emergency shutoff wrench present. I recommend providing a wrench or installing a seismic automatic shut off valve for emergencies.

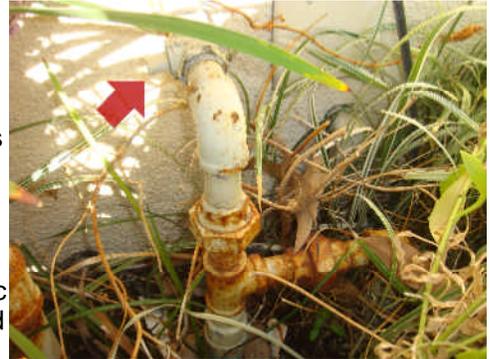
The pipes have union connectors with the shutoff valve before the unions. During seismic movement the unions could become loose and leak gas. A wrench should be placed adjacent to the valve to shutoff if a gas leak is evident.

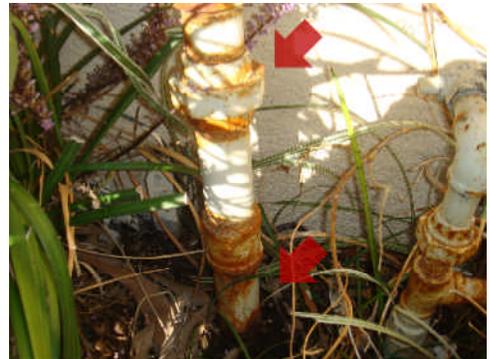
[SC] The spa gas supply pipe has a union connector with out a shut-off valve. A valve should be installed before the union pipe connector.

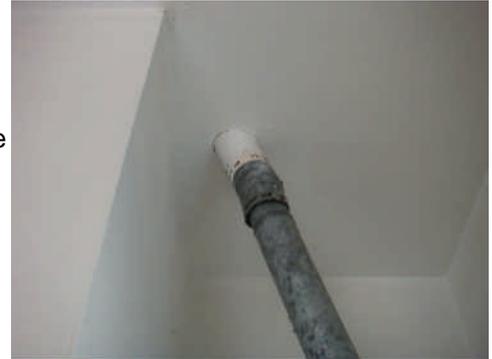
[FE] The gas vent flue is not visible past the sheetrock /drywall in the attic.

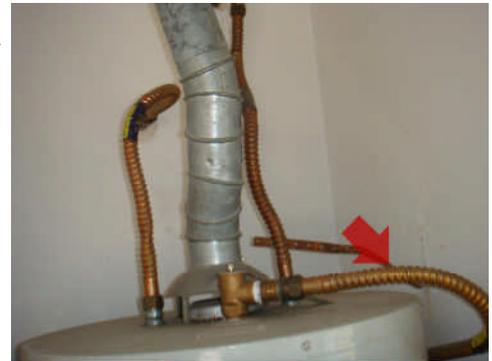
[CR] The temperature /pressure relief valve discharge line is a material that is not rated for this application, [flex copper]. I recommend installing an approved discharge line material.

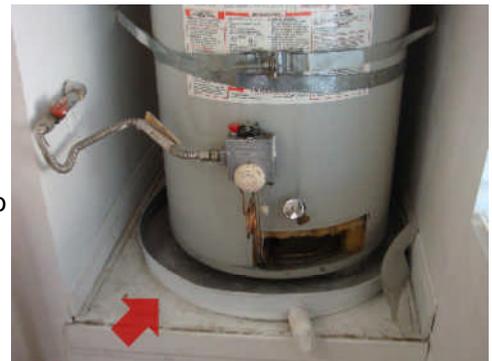
[FE] The water heater support platform is sagging. When replacing the tank place a 3/4" thick plywood over the sagging platform wall to wall, than install the pan and tank.

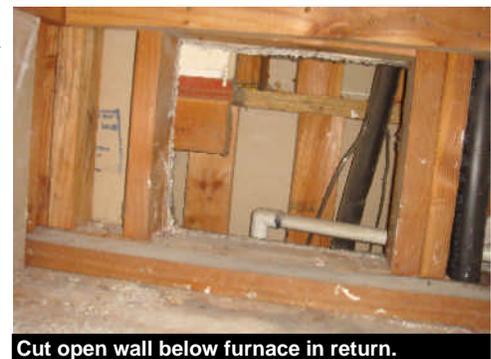
[FE] The attic insulation is soiled above this area. The soiled insulation may be from the open wall adjacent to the furnace closet. The open wall may have gaps into the attic.

Cut open wall below furnace in return.

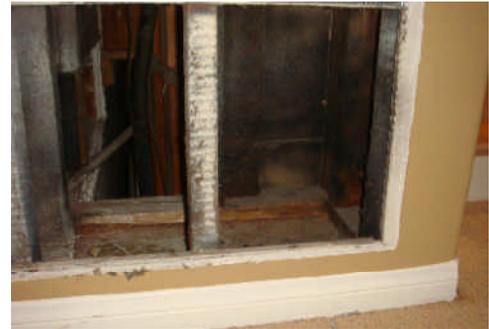
[CR] The open wall cavity is very irregular. It appears the wall below the furnace was cut open for return air from the first floor with the irregular duct below the stairs.

Wall return adjacent to the furnace closet

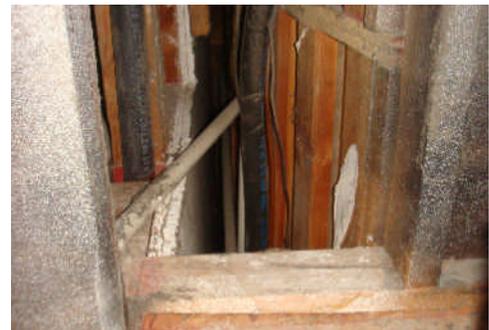
[CR] The duct is not visible at the furnace return plenum. This installation is improper.

No return air duct from below stairs.

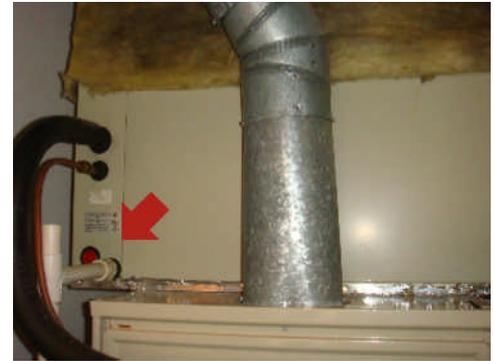
[CR] The second floor cooling coil installation has no secondary condensation drain line to the exterior as required.

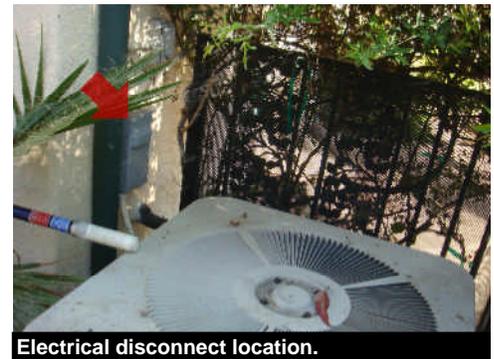
[SC] The electrical disconnect is located behind the unit improperly, inadequate clearance /access to the disconnect.

Electrical disconnect location.

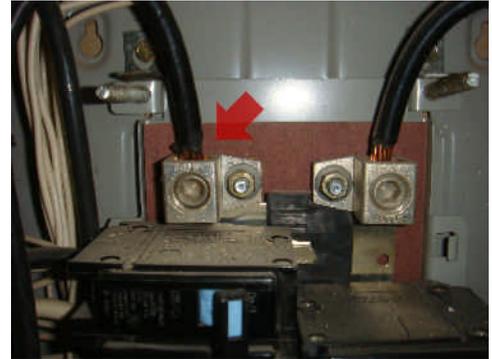
[SC] Scorched feeder conductor on the bus connection. The conductor and fastening should be evaluated.

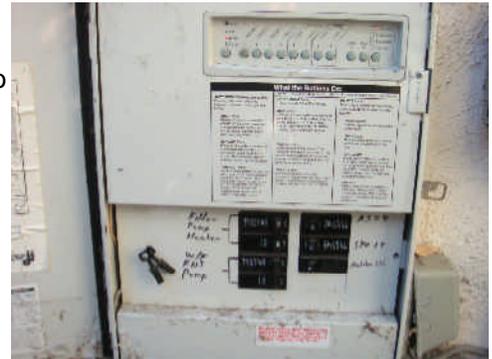
[CR] Screws are missing from the front panel cover.

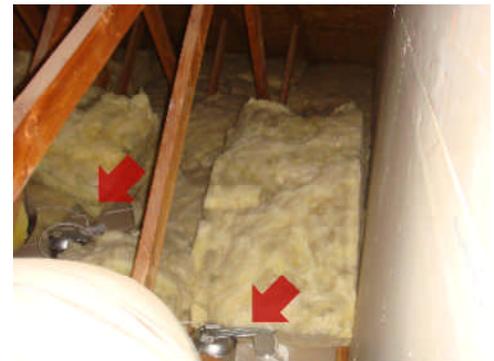
[FE] The attic insulation is in contact and covering the recessed luminaries [lighting fixtures]. It is unknown if the ceiling recessed light fixtures are "IC-rated for insulation contact. I recommend the trims and bulb be removed to expose the manufactures label to determine the rating.

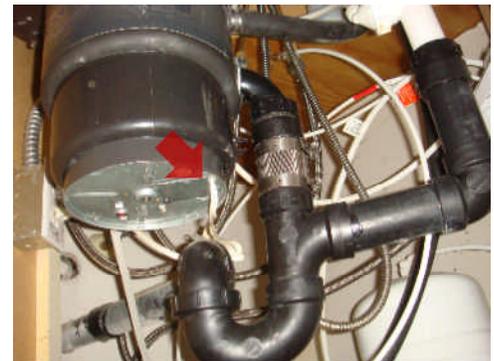
[CR] The splash guard is damaged/deteriorated/missing.

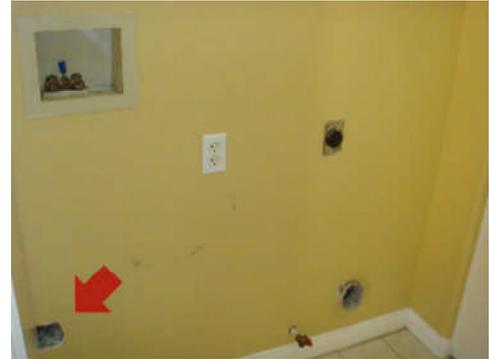
[CR] The room walls are missing covers on the cable wiring box and electric bond wire inspection access. Install the covers.

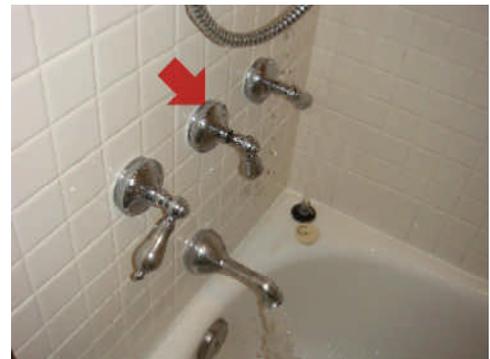
[CR] The Jack and jill tub shower diverter leaked when operating, and the stem is loose.

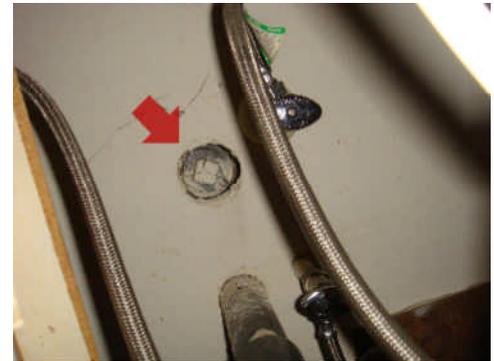
[CR] The drain cleanout is improperly recessed in the wall below the kitchen sink.
