Pre-purchase Home Inspection Report

Sample of a 21 year old 2,000 square foot house

Steve Garcia Inspections

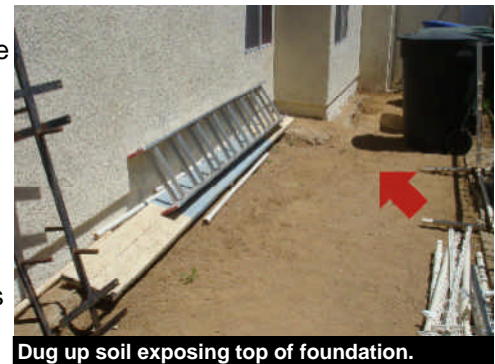
[CR] The left and right sides of the house grade has been dug up from the home owners dog. The grade is uneven and should be corrected /backfilled to provide proper surface water runoff to the street.

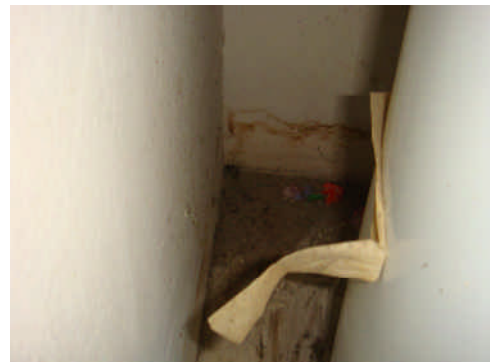
[FE] There is moisture stains on the wall and platform at the back side of the water heater.

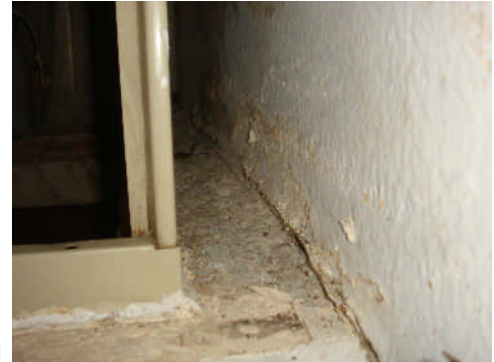
[CR] At the furnace platform the wall is moisture stained and damaged. The damaged wall board should be repaired.

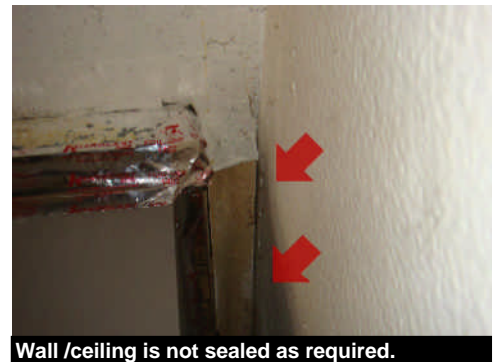
[SC] There is damaged/missing sections of fire separation wall /ceiling between the garage and joining living space at the furnace supply air plenum, water heater pipes and the wall taping is not sealed properly at areas.

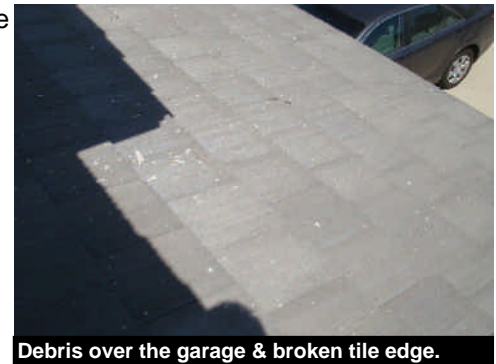
Debris over the garage & broken tile edge.

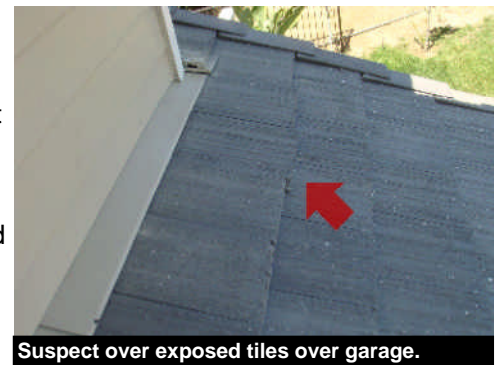
[FE] The garage tiles may have been installed without proper lap.

Suspect over exposed tiles over garage.

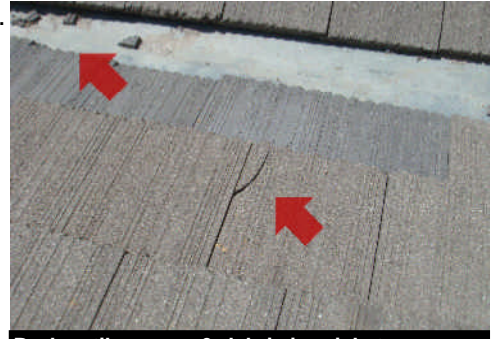
Broken tile corner & debris in cricket.

Remove all the debris from the roofing system.

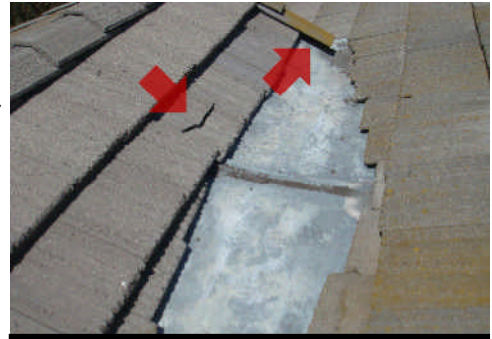
[CR] There is small cut tiles tiles in the closed valleys. This improper tile installation could cause the valley water runoff to be diverted laterally.

Rake tile blocking valley water runoff.

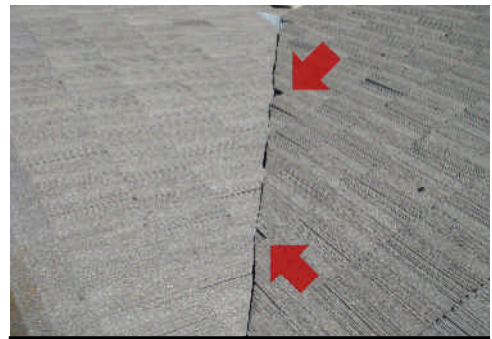
Closed valleys with small cut tiles.

I recommend the valleys small cut tiles be removed and the tiles be opened cut back.

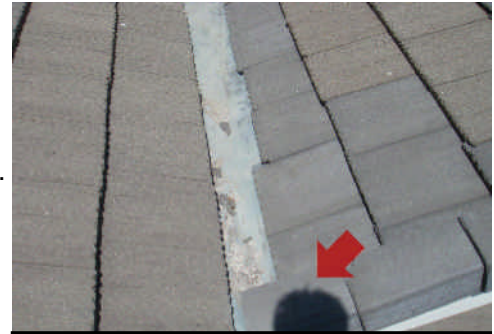
Tile blocking water runoff.

[CR] The debris in the two cricket valley flashings should be removed, and the tiles in the valleys should be cut back for water runoff.

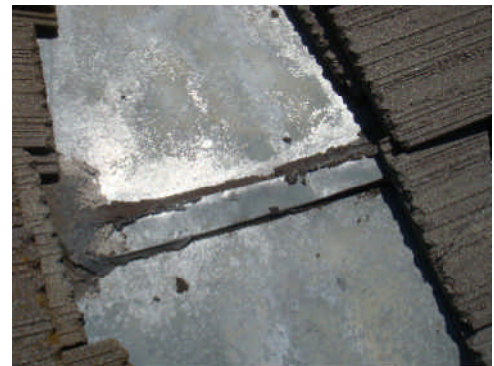
[CR] The upper cricket valley flashing seam sealant is dried and deteriorated.

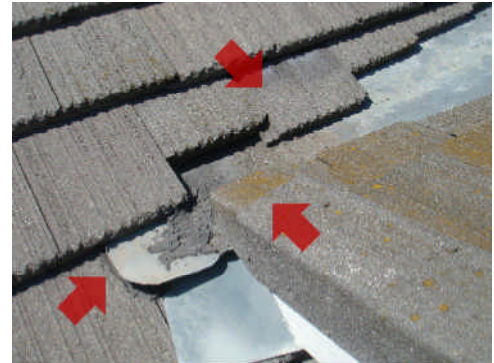
[CR] The front left valley cricket tiles are improperly in the valley, the valley has built-up mastic /tar holding back debris, and the end of the flashing is lifted a bit.

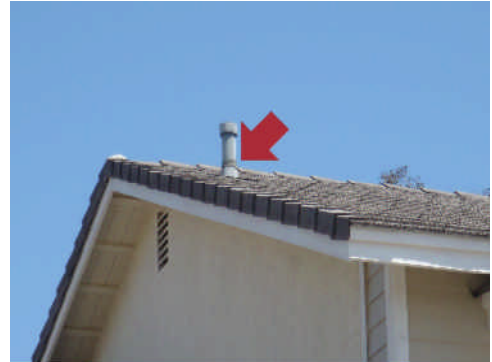
[CR] The furnace flue is missing a collar.

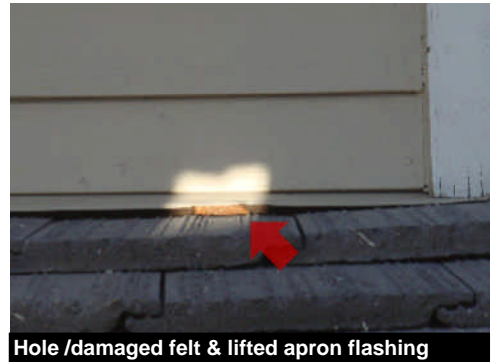
[CR] The roof to wall felt undrelayment has a hole below the apron flashing above the garage.

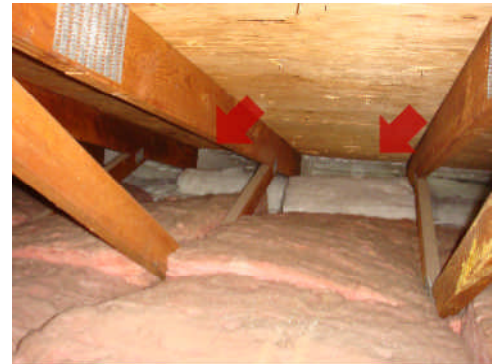
602 COMMENTS Over the master bedroom is evidence of painting on the underside of the roof deck sheathing. This is the area the home owner stated water damaged was repaired.

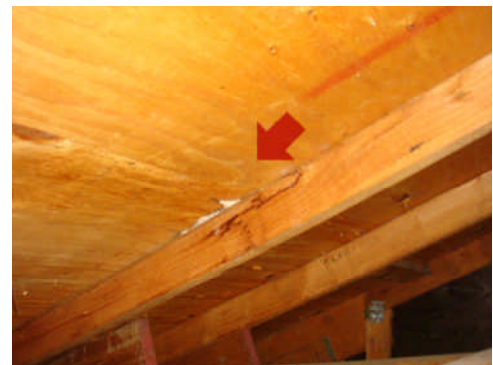
[FE] Moisture stains are evident on the underside of the visible plywood sheathing above the master closet.

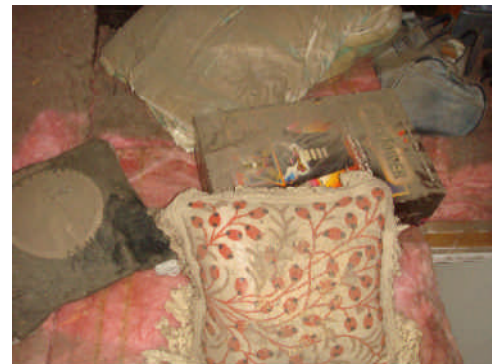
612 COMMENTS The personal items should be removed from the attic space adjacent to the front attic access.

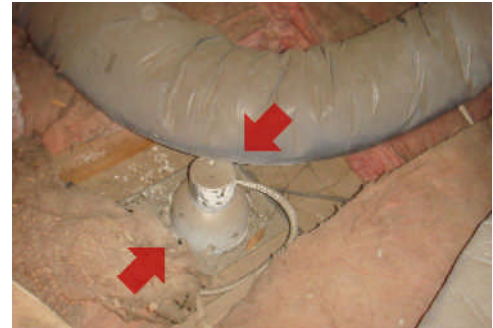
619 COMMENTS [CR] The insulation and duct is not properly separated from the recessed luminaries [lighting fixtures].

[FE] It appears the that the ceiling recessed light fixtures are not "IC-rated for insulation contact. I recommend the trims and bulb be removed to expose the manufactures label to determine the rating.

3" of seperation is required if Non IC.

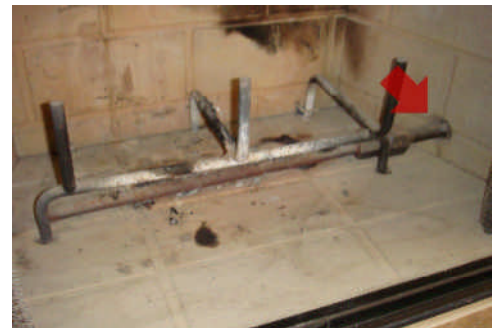
[SC] The gas pipe is not sealed at the wall where it entered the firebox. The pipe should be sealed around with the proper material.

Seal around the gas pipe.

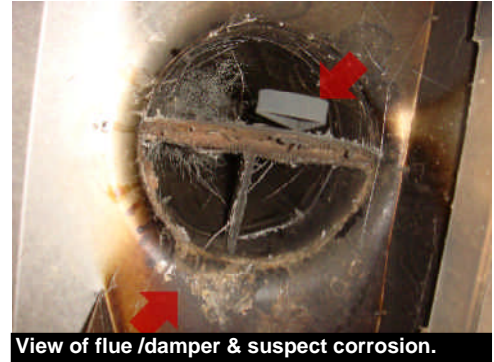
[FE] The flue is soiled, has staining and suspect corrosion.

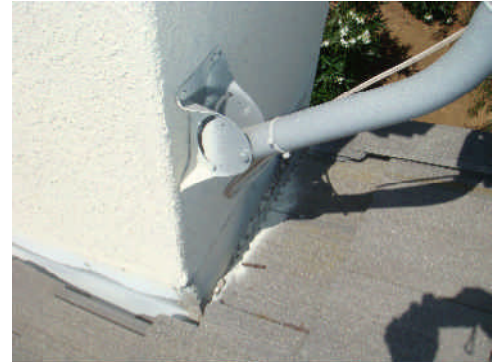
[FE] The dish fasteners are not sealed to the stucco wall.

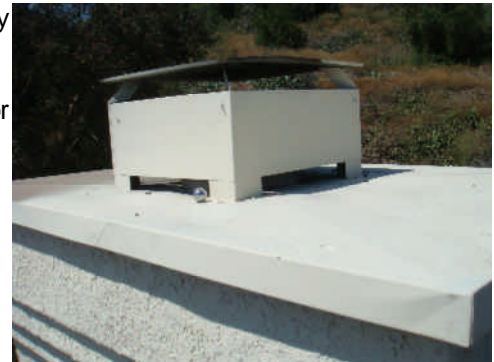
[FE] The chase cap does not slope properly for water runoff. No visible damage at this time.

I recommend painting the metal cap completely.

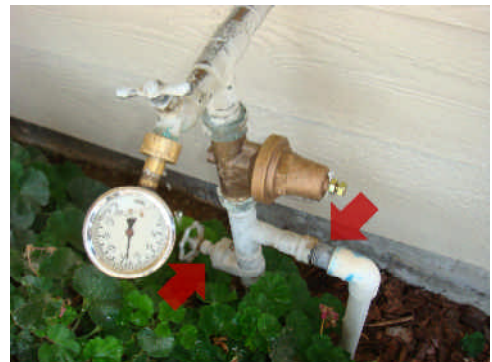
[CR] The sprinkler water supply adjacent to the main water valve is lacking a shutoff valve as required.

[RU] I recommend replacing the main water supply valve with a 1/4 turn ball valve.

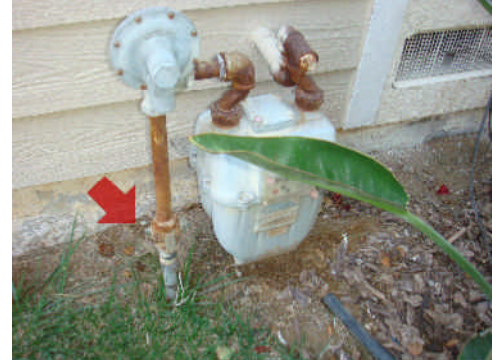
[RU] The main gas supply shutoff was not operated. There is no emergency shutoff wrench present. I recommend providing a wrench or installing a seismic automatic shut off valve for emergencies.

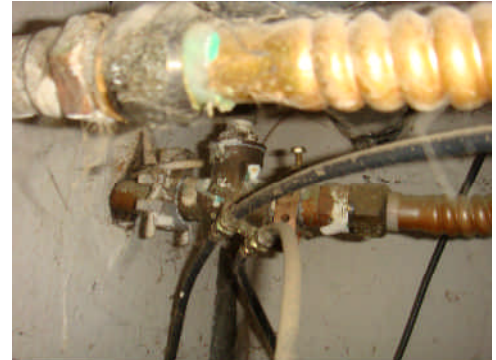
[CR] Low voltage cable wiring is improperly connected to the tank pipes, and too close to the vent connector.

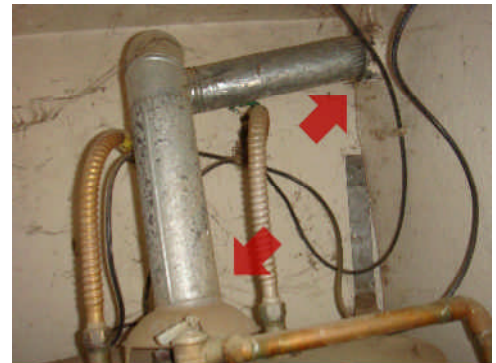
[CR] The flue vent pipe connector is not properly secured at the connections.

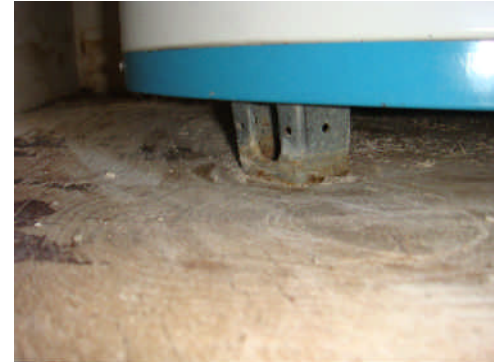
[FE] Past moisture is evident on the platform, adjacent walls and tank legs.

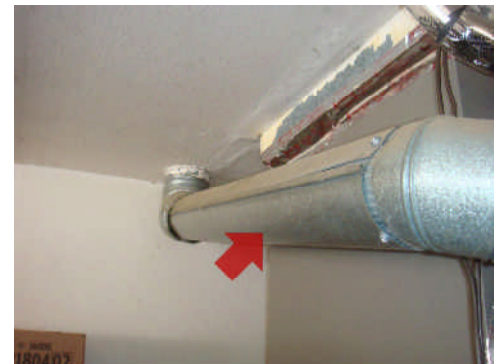
[FE] The furnace and water heater vent flues are in contact with the sheetrock /drywall.

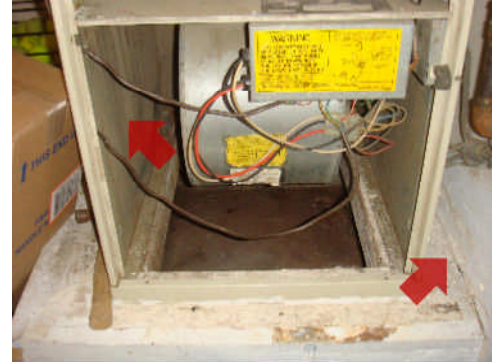
The low voltage wiring is lacking bushings. Tape and seal all gaps and the fan cover.

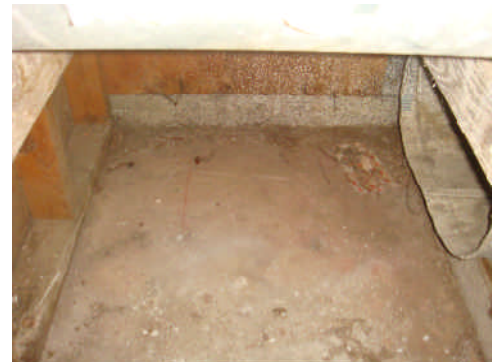
[CR] The return air plenum and duct is soiled. I recommend cleaning the area below the furnace and duct of all dirt and debris.

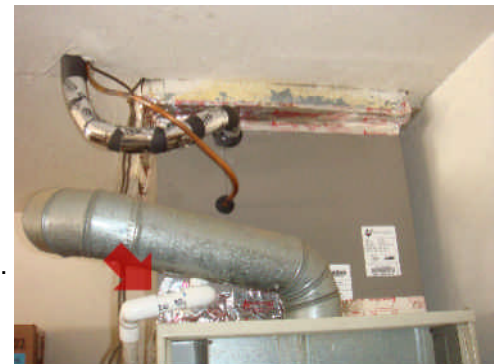
[RU] The cooling coil is lacking a secondary condensation drain line.

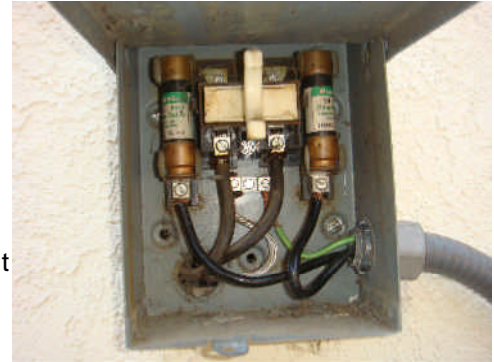
[SC] The protective "dead front" cover is missing from the panel. This is a contact hazard.

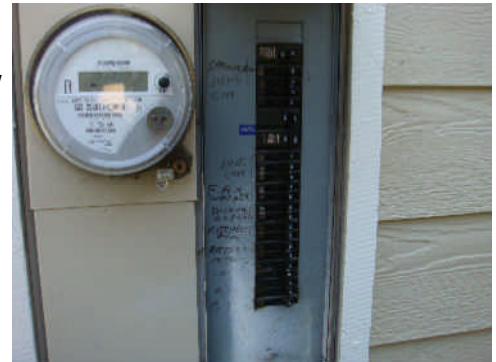
[CR] A number of the circuit breakers are not labeled or labeled properly. The circuit breakers should be accurately labeled to allow individual circuits to be shut off for maintenance or emergency needs.

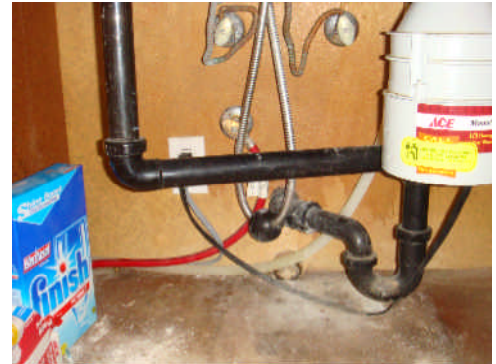
[FE] The cabinet below the sink is worn.

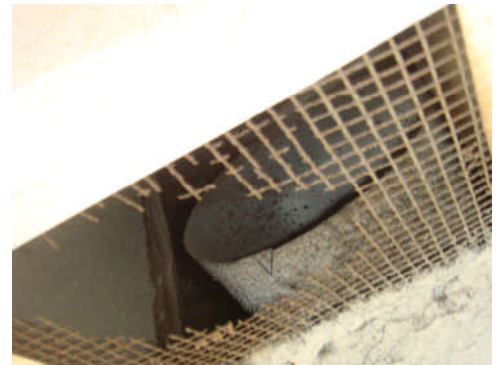
[CR] The exhaust vent screen is damaged and opened improperly.

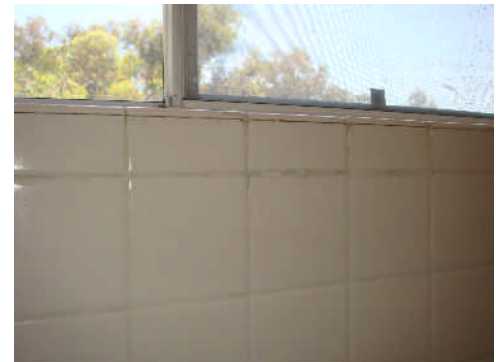
[CR] The hall bath shower window ledge tiles are loose and separating.

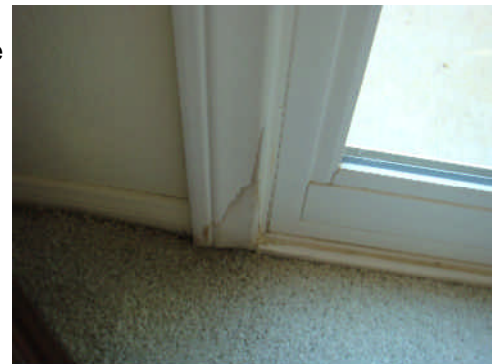
**1504
CONDITIONS** The walls did not have visible defects other than, some slight cracks evident, and moisture stain at the dining exterior door casing.
