Pre-purchase Town Home Inspection Report

Exclusively for: John Smith

Long Beach, CA. 90803

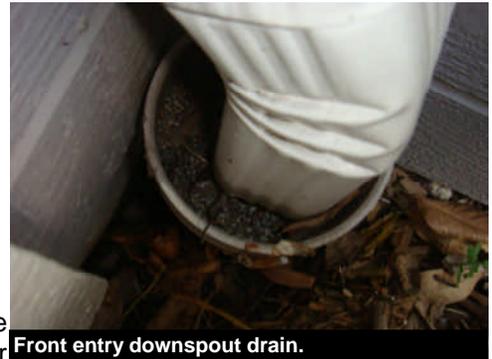
[CR] The gutter downspouts are lacking proper underground drain connectors. The front entry and rear right drains are dirty or clogged with debris.

Front entry downspout drain.

I recommend all debris be removed rather than flushed through the piping if possible and all drains should be cleaned on a regular basis.

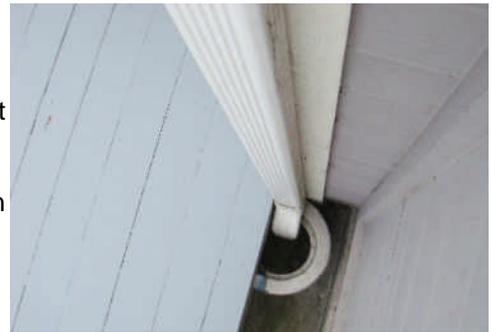
[CR] The front right curb drain termination has debris inside. I recommend cleaning the drain pipe.

Rear right drain adjacent to the fence.

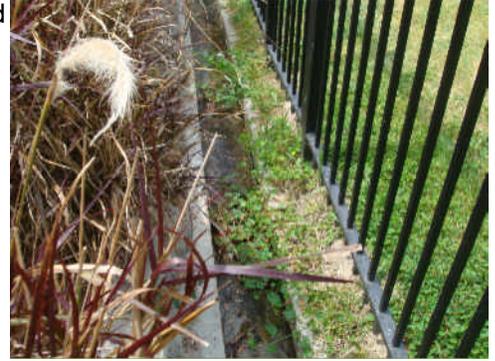
At the rear of the yard is a concrete drainage system that should be free of debris.

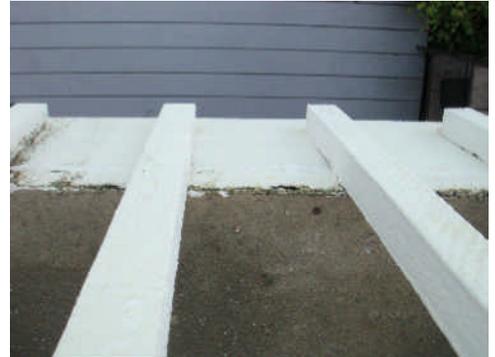
[CR] The balcony deck surface and edge flashing is deteriorated, and there is no visible flashing between the balcony deck and the building wall. These conditions are conducive to moisture intrusion and deterioration.

Evidence of leaks on the underside of the deck.

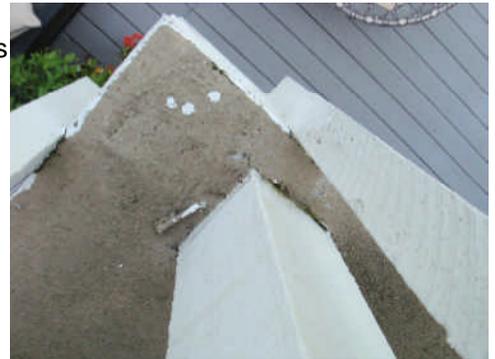
[SC] The guardrails installed have wide spaces. I recommend additional measures be taken for child safety.

[CR] The railing posts into the deck are lacking flashing to prevent moisture intrusion /damage.

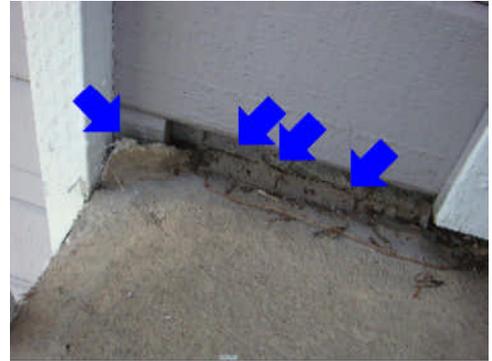
[CR] The decking surface material should have been installed below the wall flashing to prevent moisture intrusion / damage.

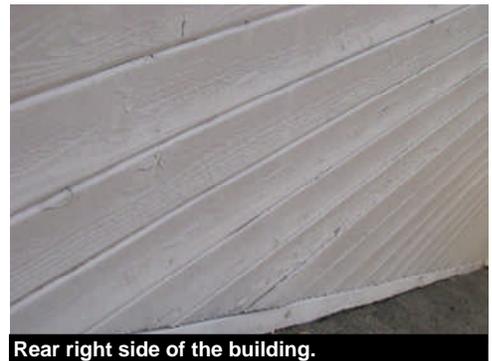
Rear right side of the building.

[CR] The wood siding is damaged, deteriorated and wrapped at the rear left and right sides of the building. These conditions are conducive to moisture intrusion/deterioration.

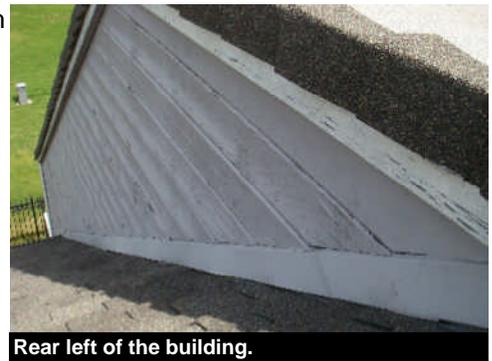
Rear left of the building.

[FE] There are cracks/holes/separations in the wood siding. These conditions are conducive to moisture intrusion/deterioration.

[FE] There is evidence of conditions that require further evaluation by a pest control operator. Small holes noted.

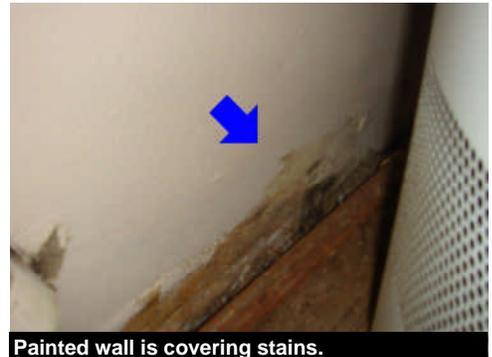
[CR] Moisture/stains and damage is evident on the wall behind the water heater. Black staining is evident.

[FE] Evidence of past repairs /painting was noted on the walls and ceiling. I recommend inquiring about the condition noted with the owner /seller.

Painted wall is covering stains.

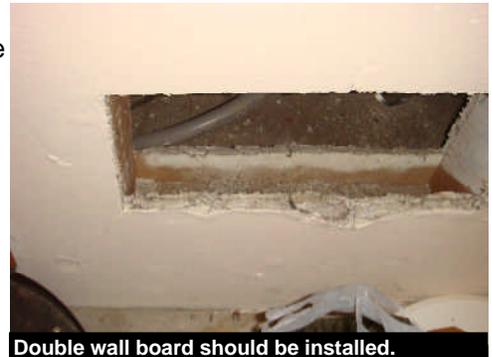
[CR] There are holes and openings in the fire-resistive walls and ceiling between the garage and living space.

[SC] This is a fire safety hazard, and carbon moxide health concern.

Double wall board should be installed.

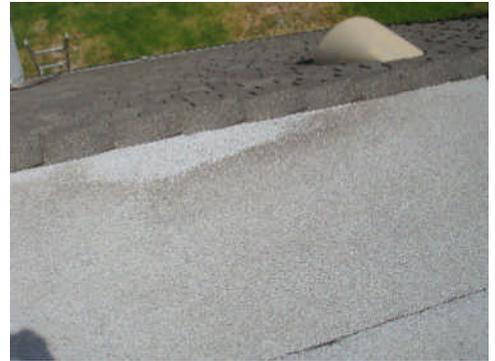
[FE] The shingled roofing ridge cap at the edge of the low slope roof appears to prevent proper water run-off.

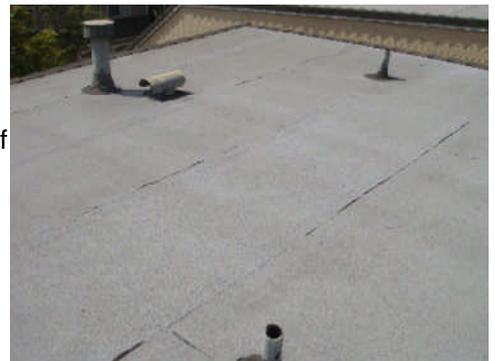
[FE] Evidence of puddling is noted at the shingle ridge cap. Regular maintenance of the area is vital to prevent the build-up of debris and possible damage to the roof.

[CR] The mastic at the vent pipes require maintenance.

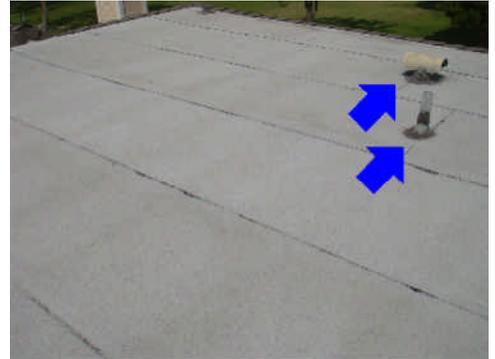
[CR] The mastic used to seal the roof penetrations is cracked.

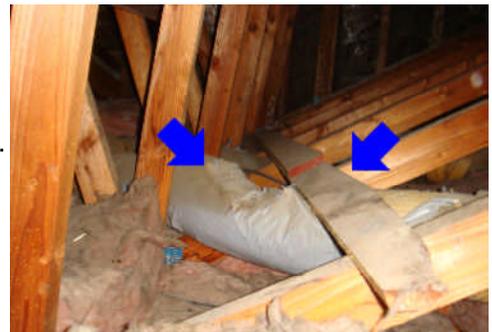
[CR] Unsecured and lacking truss bracing.

Un-secured truss bracing damaged duct.

Recommend seismic upgrade /truss bracing.

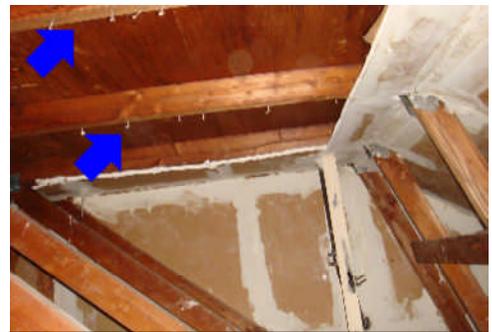
[SC] The fire separation wall is moisture damaged and missing at areas.

Fire separation board is missing & damaged

[CR] The right and left walls should be repaired for fire separation.

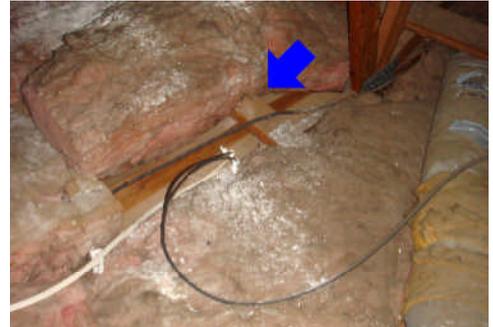
Insulation on framing, voids and gaps.

[CR] Some of the fiberglass insulation is installed upside down, with the vapor barrier facing the unconditioned space. The vapor barrier should be in contact with the ceilings.

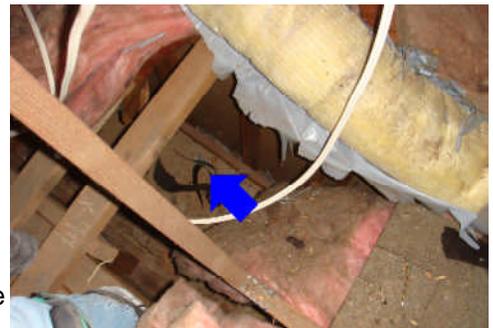
[CR] Voids down into the vaulted walls are lacking insulation.

Void ceiling & walls lacking insulation.

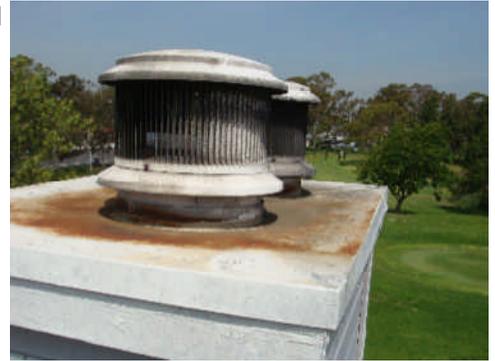
[CR] The chase /chimney cap is bent down and damaged. This condition caused puddling water and rust on the cap. These condition(s) are conducive to moisture intrusion and deterioration of the flue and firebox below.

I recommend an inspection by a qualified fireplace professional prior to the close of this transaction. My inspection of the fireplaces and chimneys is limited to the readily visible portions only. The inner reaches of the flues are relatively inaccessible from the bottom and is not adequate to discover possible deficiencies or damage. A qualified fireplace specialist will use specialized tools /video camera as needed to evaluate the flue systems.

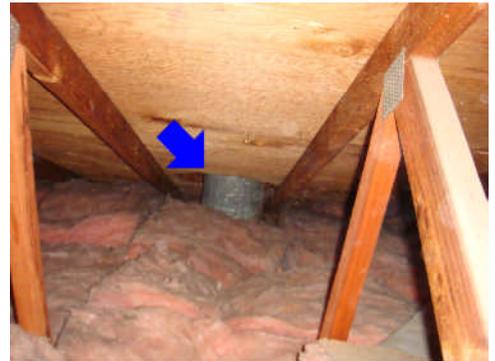
[FE] The visible flue in the attic could not be accessed to determine proper clearances from the framing system and insulation.

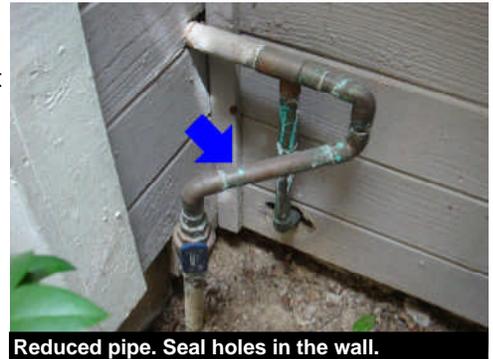
[FE] The pipe has been reduced to 3/4" at the main supply pipe.

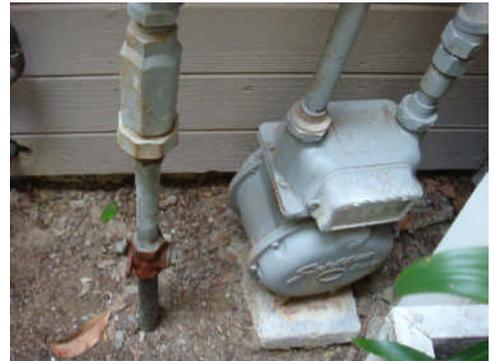
[RU] The supply shutoff appeared functional, I do not operate these devices. There is no emergency shutoff wrench present. I recommend providing a wrench or installing a seismic automatic shut off valve for emergencies.

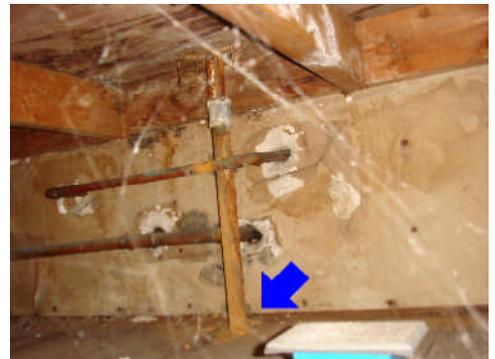
[SC] Below the water heater platform a suspected gas supply pipe is fed from under the slab without a visible sleeve. This installation could cause the metal pipe to rust and leak gas.

[FE] There is no sediment trap/drip leg in the gas line before the furnace and water heater.

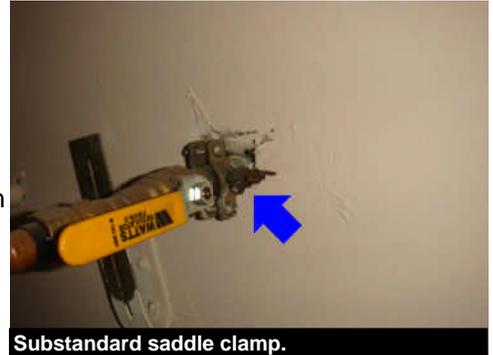
[FE] A saddle clamp water valve has been added onto the cold water supply pipe. This type of valve is substandard.

Substandard saddle clamp.

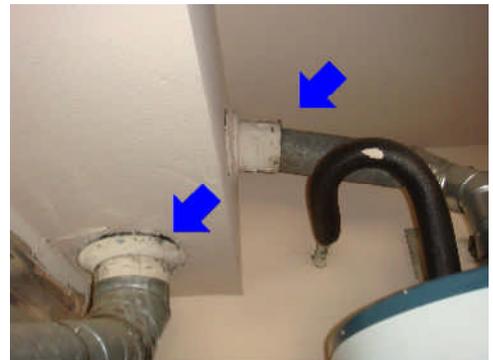
[FE] The flue in the wall is not visible and should be connected to the furnace flue. The furnace flue is the only visible flue in the attic.

[SC] The two flues collars at the garage fire separation are an irregular type, and are not installed to prevent fire and gases from entering the wall.

I recommend full evaluation of the flues connection, and replacing the collars with proper fire separation collars.

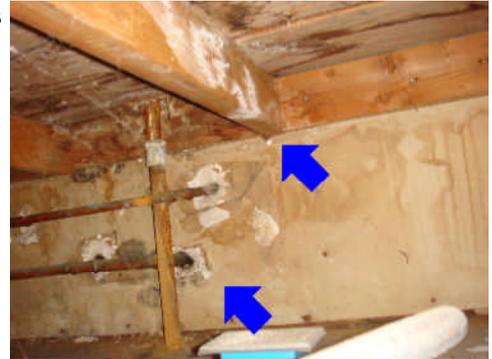
[CR] The wall board is moisture damaged and has holes. Black staining is noted.

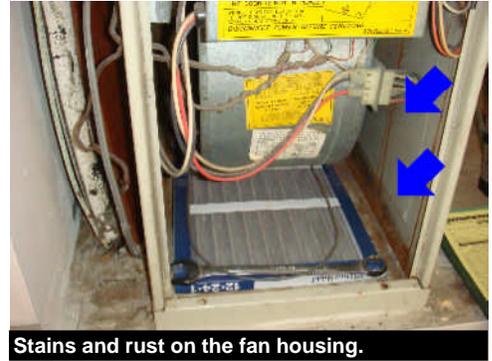
[CR] A wrench is used to hold the filter down.

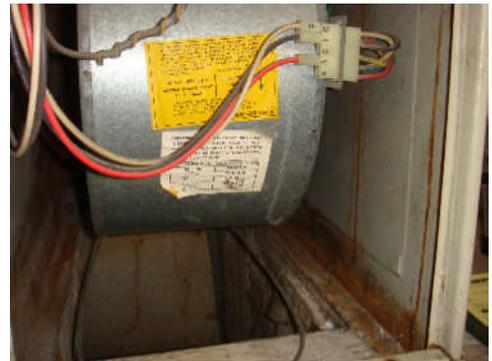
[CR] There are moisture stains down the front of the furnace, into the fan housing, on the platform and into the return air plenum. The A/C cooling coil appears to have leaked.

[RU] Due to age of unit and conditions noted the furnace is at the end of or beyond its useful service life.

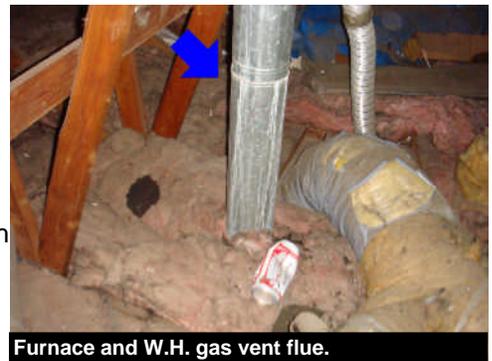
[SC] The flue vent piping is in contact with combustible materials /insulation paper backing in the attic. This condition is a potential fire hazard.

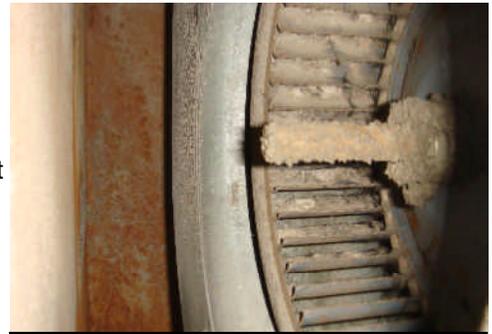
Soiled fan blades reduce the supply air flow.

Excessively soiled blower blades.

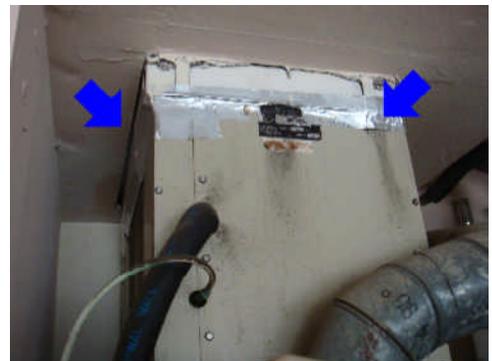
[SC] The plenum is not sealed /dry wall taped at the fire separation ceiling.

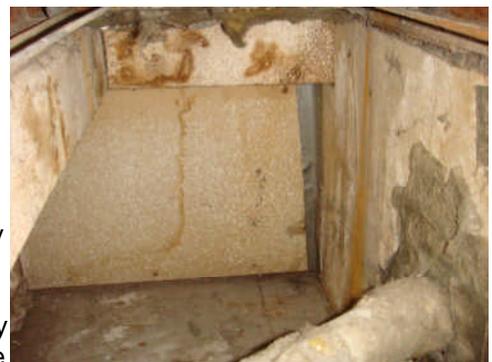
[SC] There are air leaks in the return air plenum and at the base of the furnace. This condition can allow contaminated air to be drawn into the system and distributed throughout the house.

The location of the return air in the laundry room is very irregular and impractical. The gas dryer gases and the moisture from the washing machine may enter the return air.

[RU] I recommend relocating the return air to the entry wall below the stairs. A solid duct or ducts should be installed for fire separation below the stairs.

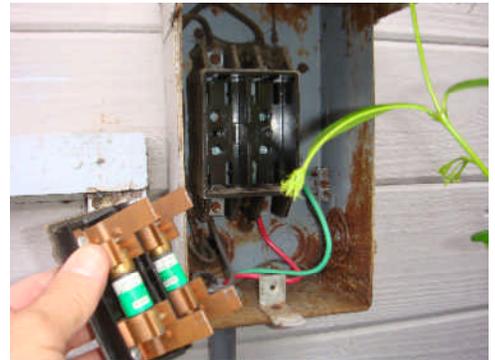
[SC] The disconnect fuses and sub panel circuit breakers have a higher amperage rating than specified for on the condensing unit ID tag.

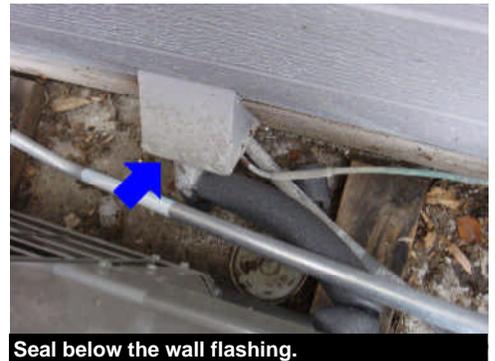
The refrigerant lines appear to be fed below the building slab.

Seal below the wall flashing.

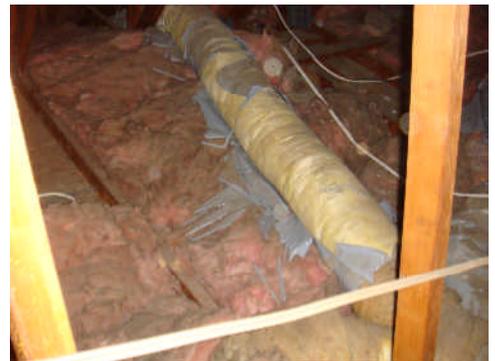
The duct system is at the end of or beyond its useful service life.

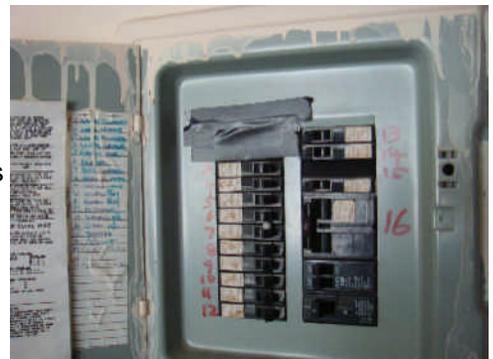
[SC] There are missing twist-outs in the breaker /panel cover. Install plastic covers in the openings.

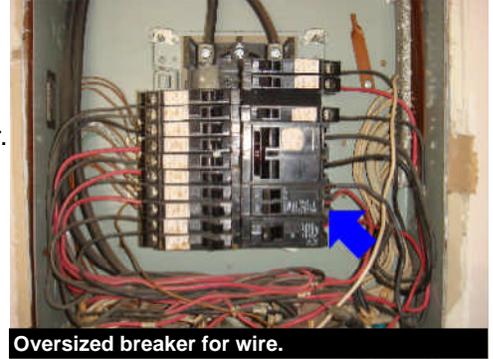
[SC] Breaker amperage exceeds wire capacity at the bottom right circuit breaker.

Oversized breaker for wire.

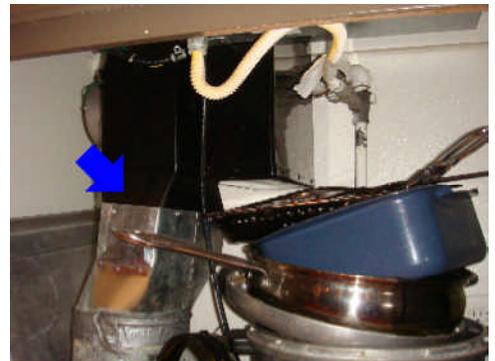
[CR] Duct tape is lacking at the exhaust vent connection. Air leaks noted.

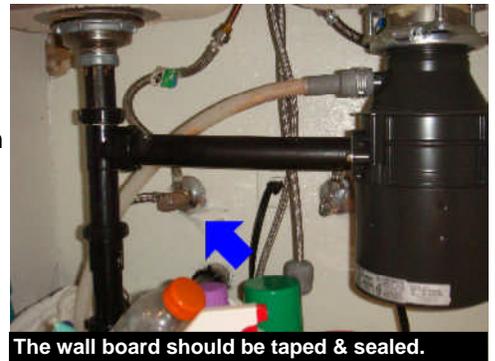
[CR] The dishwasher is connected directly to the garbage disposal. The drain hose is not connected to the air gap device before the disposal.
