# *Pre-purchase Home Inspection Report*

Exclusively for: Good Client

Sample of a 33 year old 3,400 square foot house with pool & spa

***Steve Garcia Inspections***

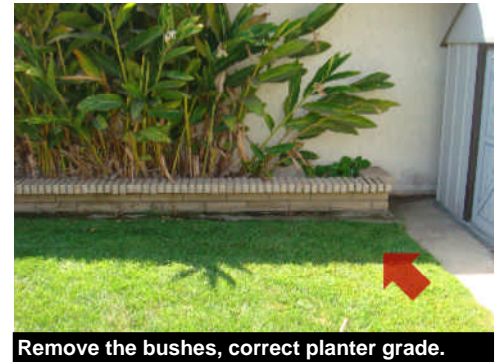
[FE] The rear site water runoff appears to drain towards the rear block wall. The site rain water runoff should not be directed or drain into the neighbors site.

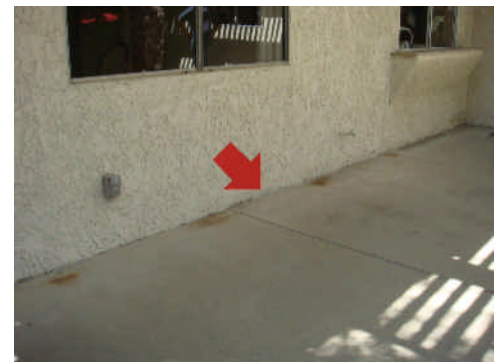
[FE] The patio surface is above the weep screed at the bottom edge of the stucco wall. This condition could be conducive to moisture intrusion and deterioration of the wall.

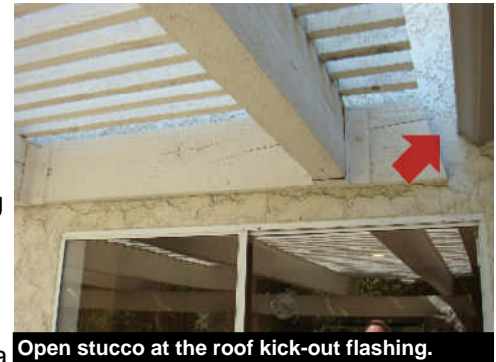
[CR] The wood lattice is moisture damaged and excessively weathered.

I recommend the lattice be removed the framing be painted, and plastic /PVC lattice be installed.

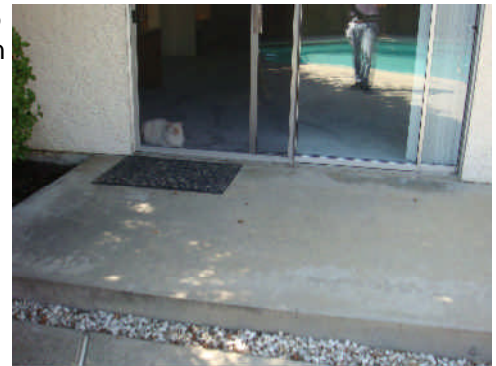
[FE] The rear exit landing has been placed up to the stucco screed improperly. This condition does not appear to have caused moisture damage.

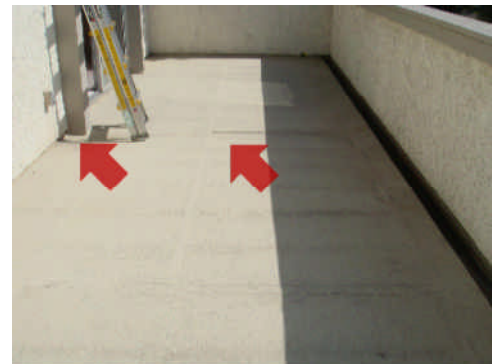
[CR] The deck metal drain gutter is holding water and a seam is corroded.

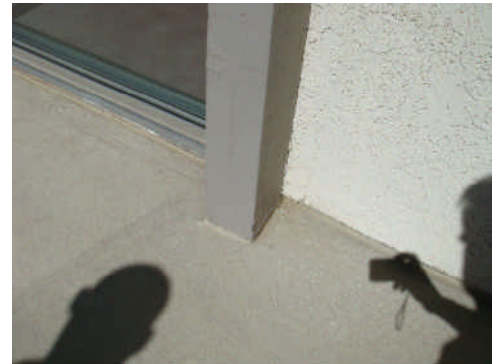
[CR] The building 6X6 cosmetic columns are in contact with the deck waterproof coating improperly.

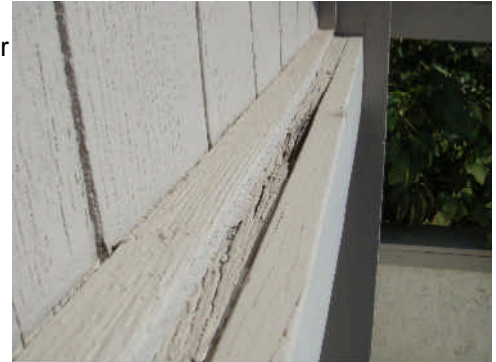
[CR] There are no visible metal flashings installed at the top of the master bedroom door and living room window trims. This condition has caused moisture intrusion/deterioration of the siding above the door and window.

A board has been nailed to the damaged materials masking the damaged materials from below.

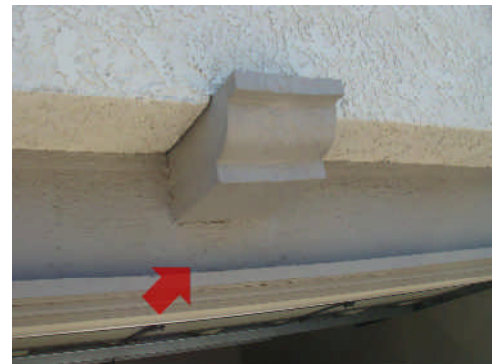
[CR] The garage beams and siding intersection are lacking flashing. The siding is damaged.

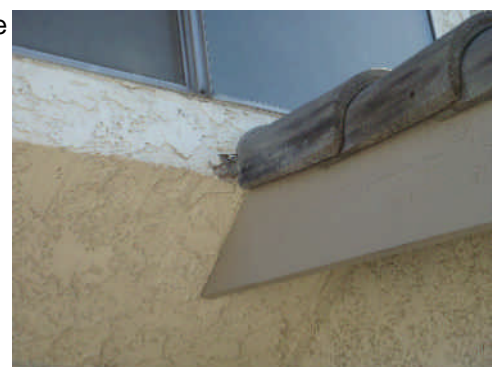
[FE] The roof tiles and wood fascia boards are butted up-onto the stucco walls. The stucco is broken at the left side.

The wood boards could become moisture damaged.

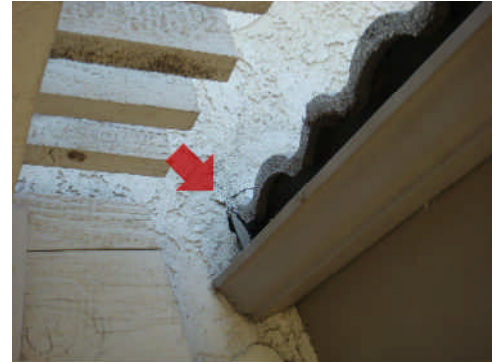
[CR] The stucco wall is open at the rear lower roof termination kick-out flashing adjacent to the kitchen window.

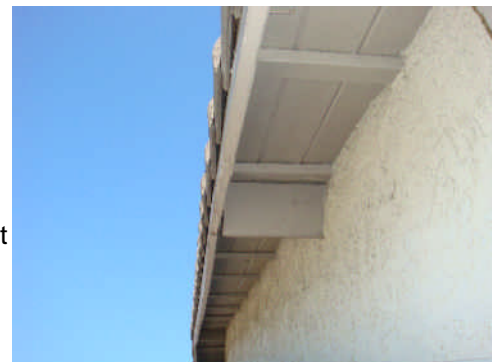
[CR] The fascias are weathered, and the paint is chipping off.

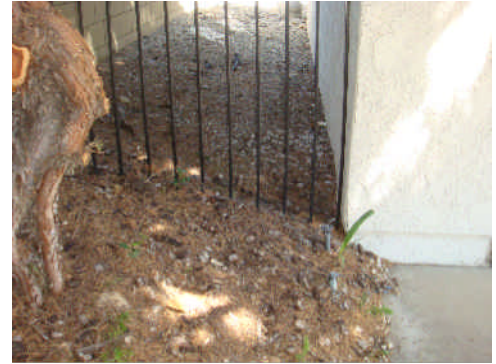
The foundation adjacent to the left grade has efflorescence from moisture.

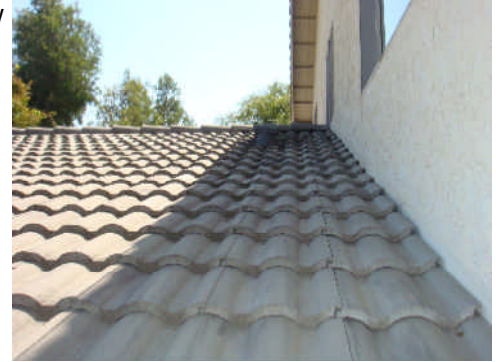
[FE] Areas of the roof slope appears to be low for a tile roofing system.

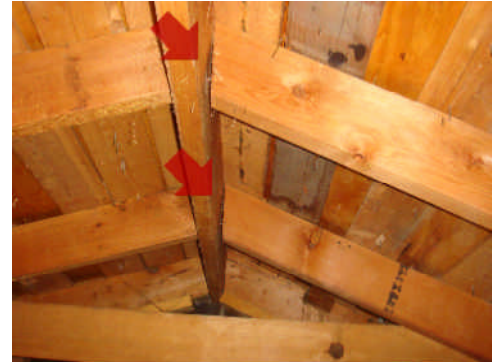
[CR] The upper ends of the rafters in the original attic have a 1/2" separation from the ridge board. I recommend installing hangers for proper connection.

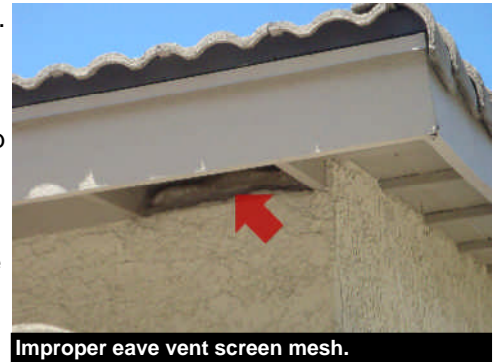
[CR] The upper right side eave vent screen is improper and should be replaced with 1/4" screen mesh.

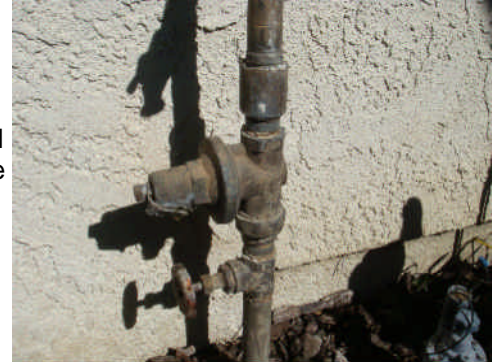
[CR] The main water shutoff valve is corroded and not operational. I recommend the valve be replaced with a 1/4 turn ball valve.

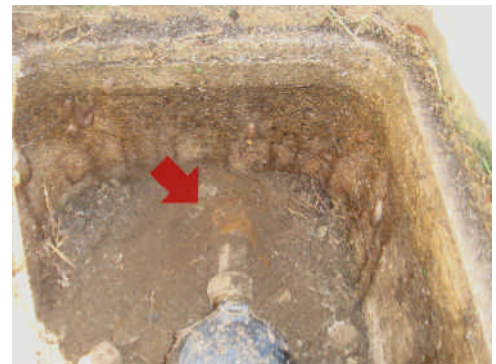
[RU] The galvanized pipe is corroded and rusted at the water meter. No leakage evident at this time. I recommend monitoring the condition before replacing.

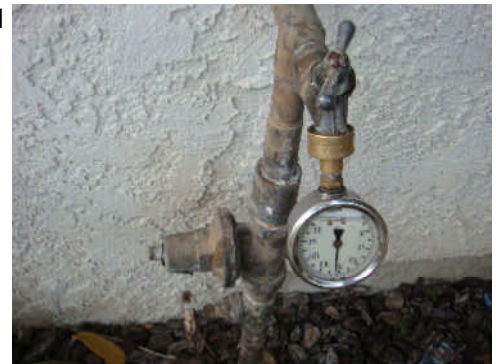
[CR] The pressure regulator is corroded and evidently leaks. The regulator should be replaced as required to limit the water pressure to or below 60 PSI, or appliance design limits.

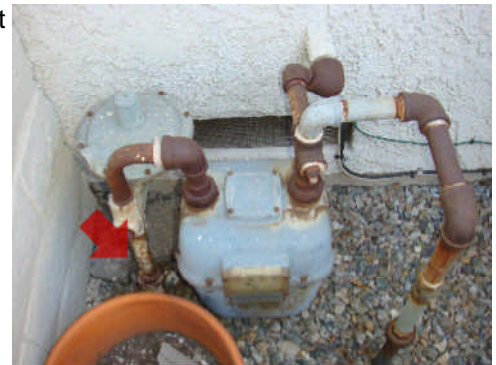
[RU] The main gas supply shutoff was not operated. There is no emergency shutoff wrench present. I recommend providing a wrench or installing a seismic automatic shut off valve for emergencies.

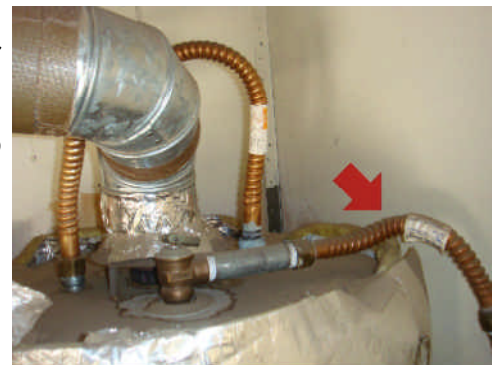
[CR] The temperature /pressure relief valve discharge line is a material that is not rated for this application, [flex copper]. I recommend installing an approved discharge line that extends to the exterior and terminates close to the ground facing downward.

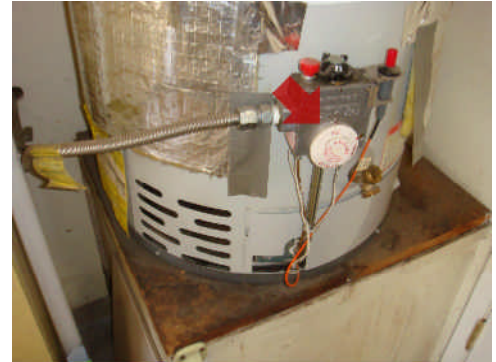
[SC] The temperature control is set to the "high/very hot position". Excessively high water temperatures can be dangerous and inefficient. I recommend the temperature setting be lowered to the manufacturers recommended setting.

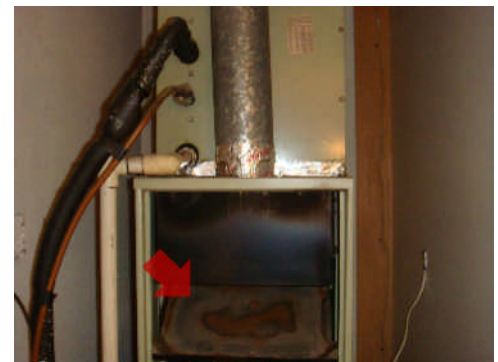
[SC] The connector is damaged at the flue vent connection visible from the interior. Products of combustion are spilling out the draft diverter.

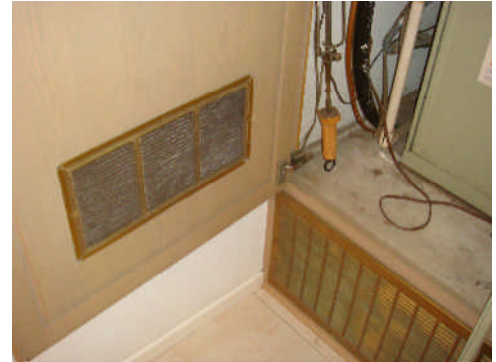
[SC] With the openings in the door combustion and return air sources for the furnace are too close to each other. This condition will allow for mixing between the two air sources and the distribution of potentially contaminated air supply.

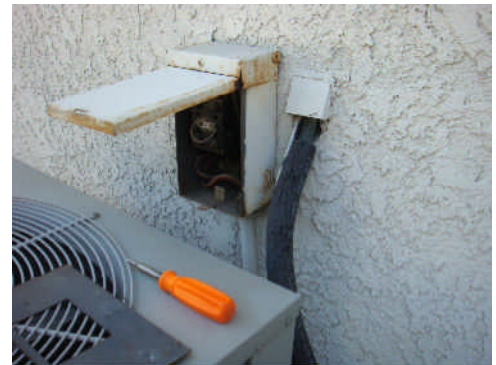
[CR] The insulation on the coolant line insulation is deteriorated and missing section at the exterior.

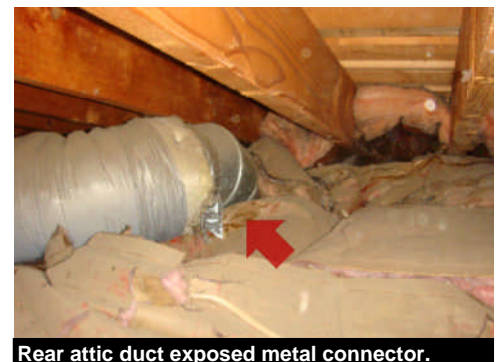
Rear attic duct exposed metal connector.

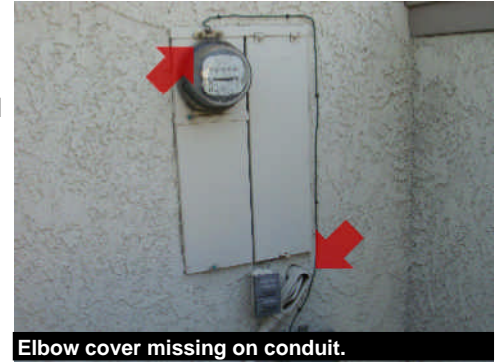
[SC] There is an improper clamp on the panel exterior.

Elbow cover missing on conduit.

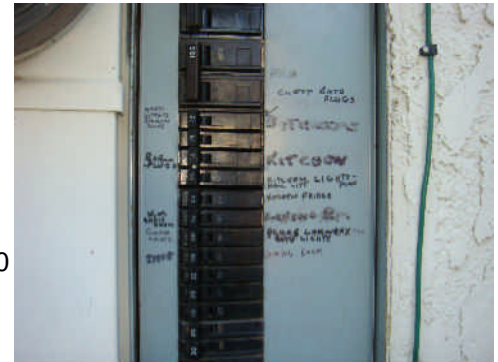
[CR] The panel cover circuit breakers labeled kitchen are labeled at the 15 amp. circuit breakers. Kitchens are required to have two 20 amp. counter top circuits.

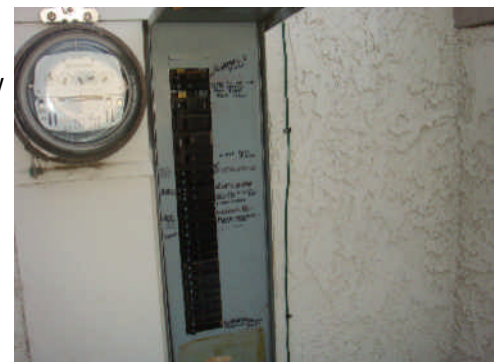
[SC] The panel breaker cover securing screw is an improper pointed type.

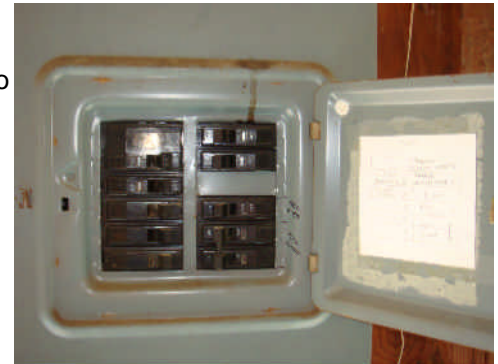
[CR] A number of breakers are not properly labeled. The circuit breakers should be accurately labeled to allow individual circuits to be shut off for maintenance or emergency needs.

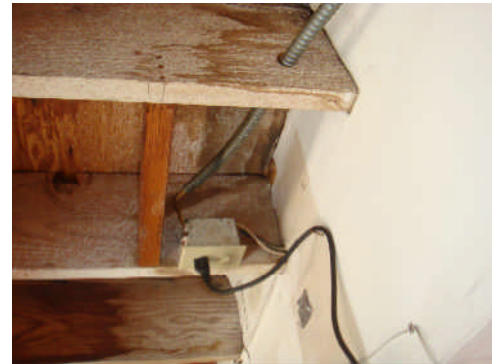
[SC] At the left side of the house is metal conduit with improper interior connectors.

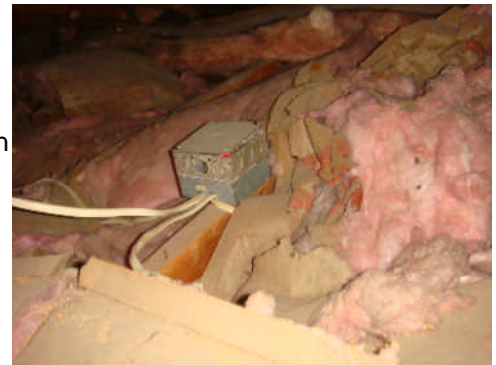
[SC] The wiring and junction box installation in the rear attic is un-workman.

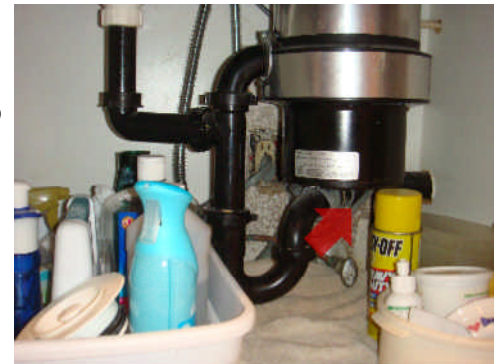
[CR] The island disposal failed to function. The unit could not be freed with the wrench provided.

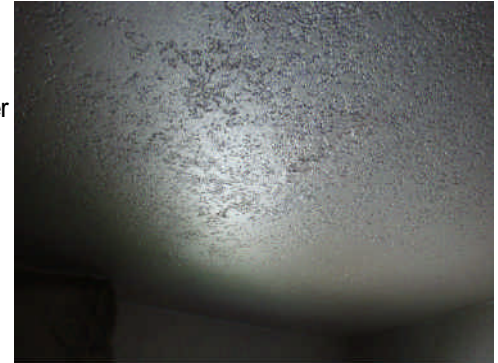
[CR] Damage /blistering at the family room ceiling.

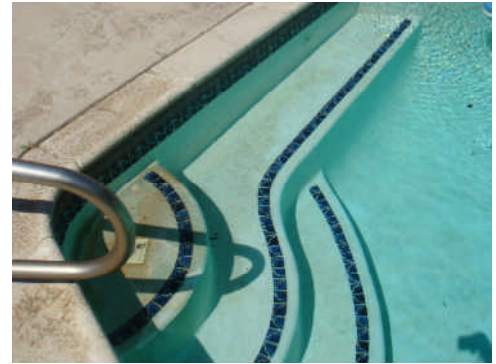
**1619 VESSEL** [FE] The vessel surface is damaged/deteriorated in areas with slight cracking. Discolored areas are evident.

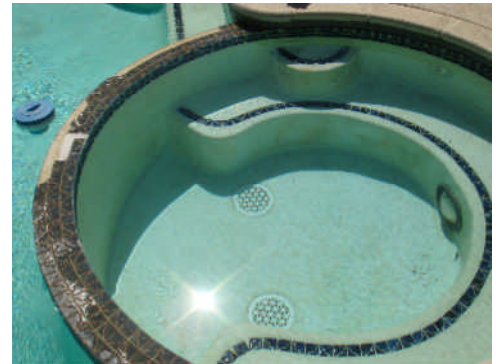
[CR] There were loose/damaged/missing water line /dam tiles at the spa.

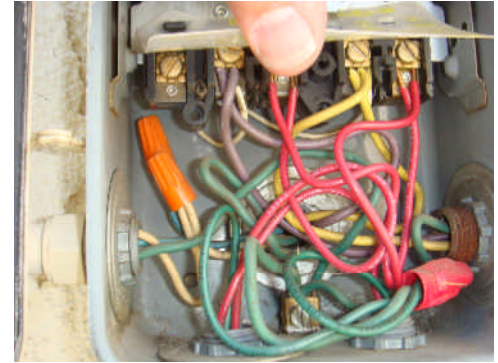
[SC] Separated metal conduit below the junction box.

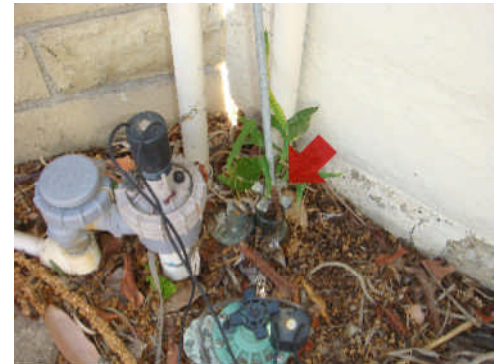
[CR] The pool water supply valve leaks when operating.
