Pre-purchase Home Inspection Report

Sample of a 78 year old 2,000 square foot house

Steve Garcia Inspections

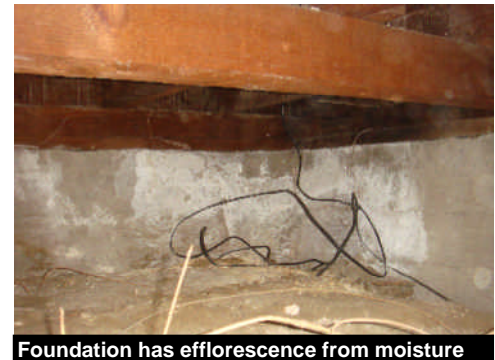
[FE] Sections of the foundation /mud sill wall frame is marginally above the exterior grade. I recommend modifications in these areas to maintain a minimum of 4 inches clearance between the earth and any wood portions of the structure.

[CR] The yard grading at the left and rear of the house are not adequately sloped away from the perimeter foundation. It is important that surface grade be sloped away from the perimeter foundation to prevent moisture accumulation next to the foundation, which may infiltrate below the building effecting the structural integrity of the building/s support systems.

The foundation does not have evidence of damage from the improper grading or drainage, although the foundation has efflorescence at areas from moisture due to poor drainage and grading.

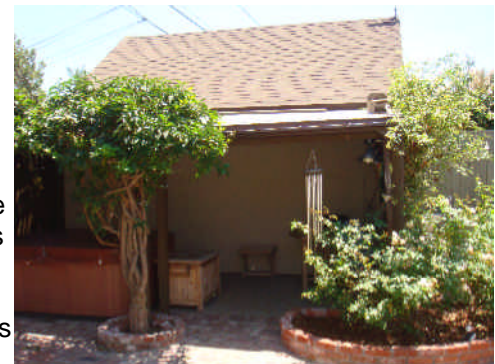
[CR] The framing posts are imbedded into the ground and brick improperly. Insect damage is evident.

[RU] I recommend adding hardware /fasteners to the structure connections.

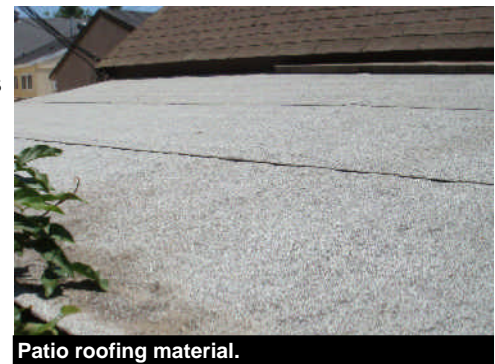
[CR] The rolled roofing material has been installed improperly, unsecured, blisters and has a low point at the edge. The edge metal is an improper type, evidence of puddling water.

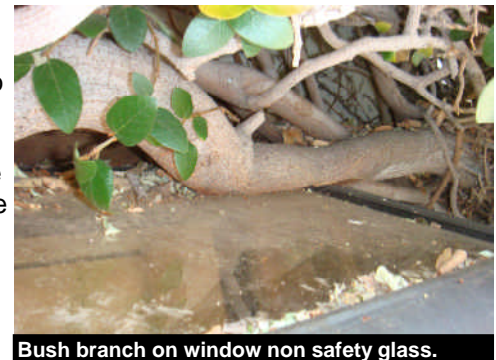
[SC] The bush branch is bearing on top of the kitchen window. This condition could break the window.

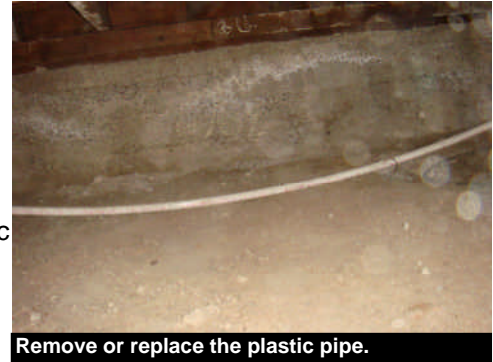
[CR] Plastic PVC sprinkler pipe is in the craw space below the living room improperly. Plastic water pipe should not be in craw spaces.

Remove or replace the plastic pipe.

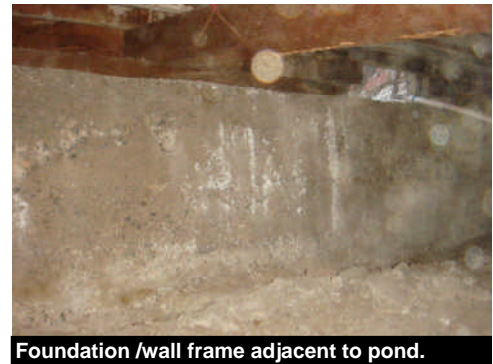
Foundation /wall frame adjacent to pond.

[FE] The entry brick bench and water feature has been built up onto the stucco wall, and is over the building wall mud sill /framing improperly.

From the craw space the wall frame does not have visible moisture damage.

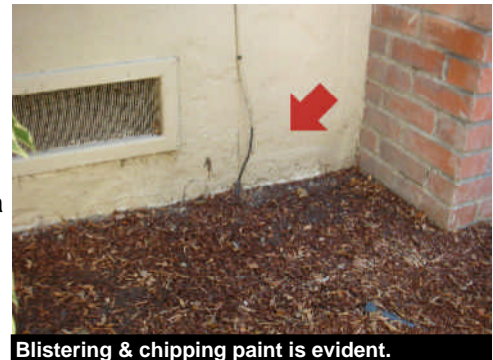
Blistering & chipping paint is evident.

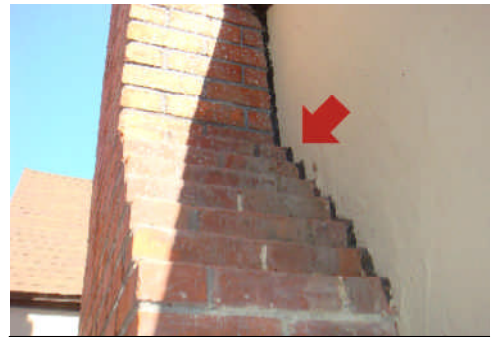
Mastic /tar appears to have been added.

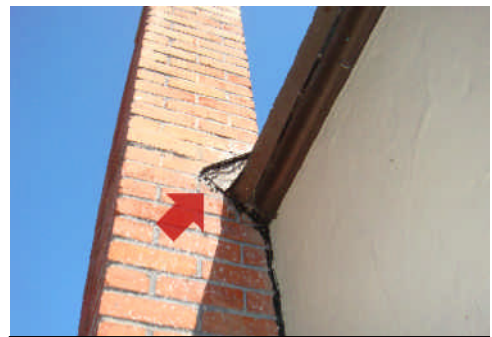
[RU] I recommend kick-out flashings and gutters at the termination point of the roof flashing and chimney to divert water away from the chimney shoulder bricks.

Install kick-out flashings & gutters.

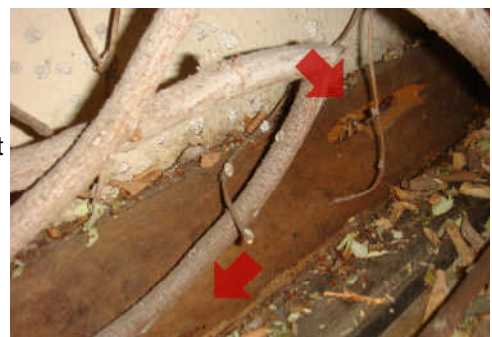
[CR] The kitchen window trim /casing is insect damaged.

Insect damaged wood trim above window.

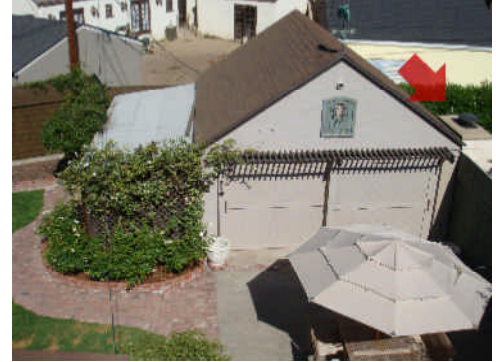
[FE] The neighbor has a fireplace adjacent to the garage. The fireplace chimney termination is less than 10' from the garage.

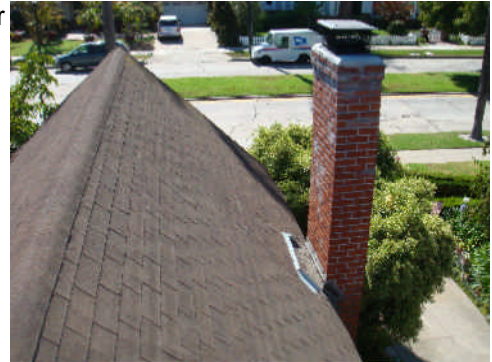
[FE] Due to the height of the chimney above the building wall I recommend evaluation of the required bracing for this chimney.

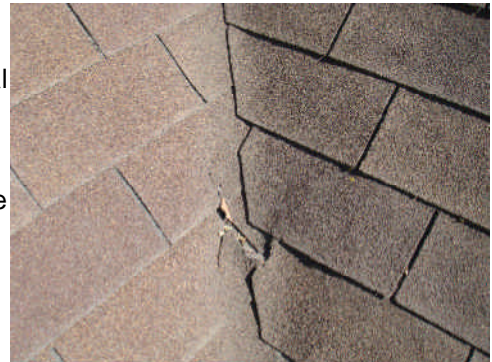
[FE] The roofing material appeared functional at this time with the exception of the valley shingles. I recommend a licensed professional roofing contractor evaluate the material for the estimated remaining life.

[CR] The valley shingles do not appear to have been cut back properly for proper water runoff. Debris and moisture could become trapped below the valleys. Damaged shingles are evident.

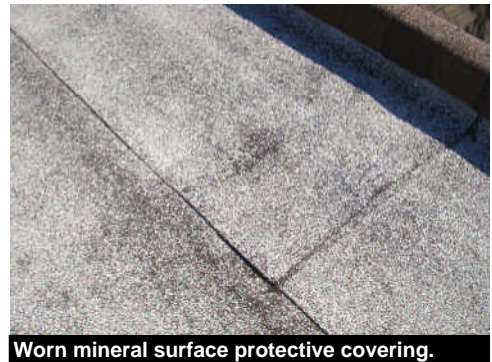
[FE] The upper low sloped roofing material mineral surface is weathered where the protective minerals are worn off.

[CR] The front entry overhang low slope roofing material is blistered and has improper drainage to the building without a gutter and downspout to control water runoff. See picture # 527 below.

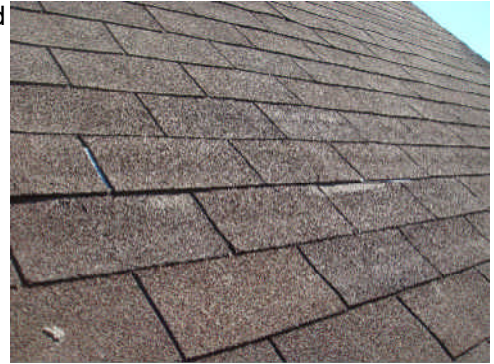
516 COMMENTS [FE] View of the shingles where the suspected chimney brace was installed. The patch is irregular.

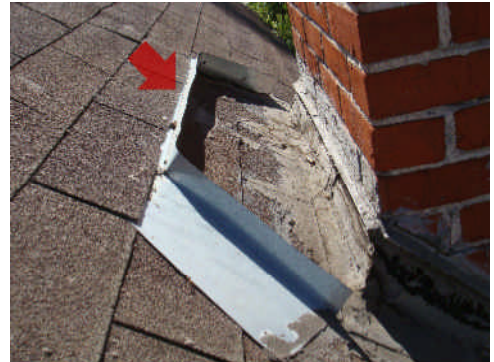
[FE] The chimney has an irregular added cricket flashing installed. This flashing / installation is sub-standard.

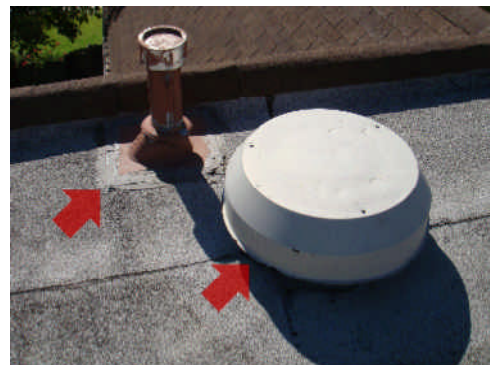
[FE] The furnace jack flashing is only sealed with mastic /tar, and the attic vent sealant was not visible.

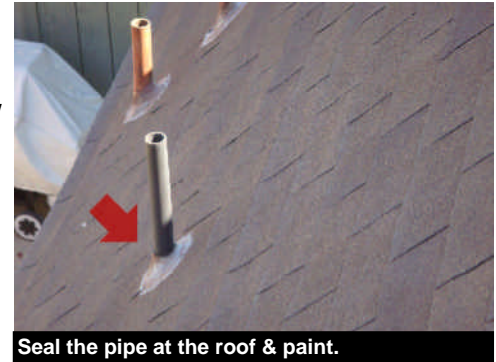
[CR] The rear added ABS plastic drain vent pipe is not painted to protect from the sun UV rays.

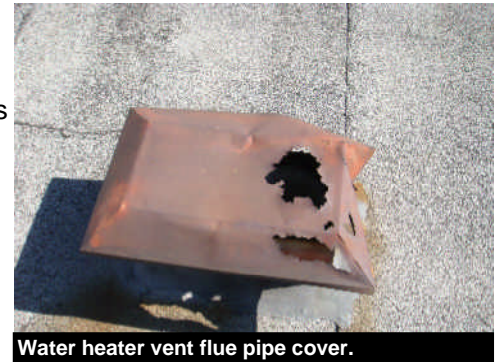
[CR] The water heater vent flue metal cover is rusted out and open.

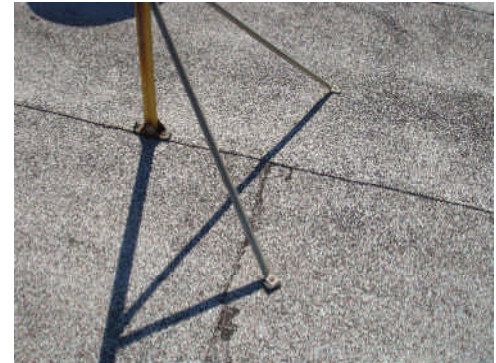
522 COMMENTS [CR] The antenna should be removed and the fastener holes sealed.

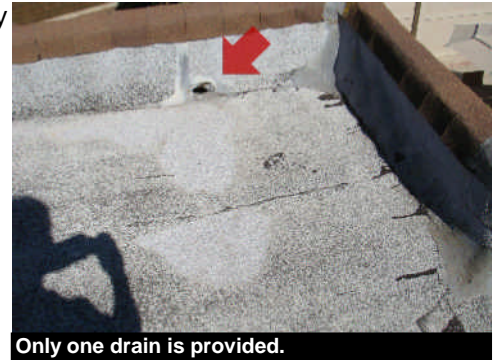
525 GUTTERS [FE] A secondary roof drain above the primary drain is not provided to remove possible blocked water accumulation should the primary drain become clogged.

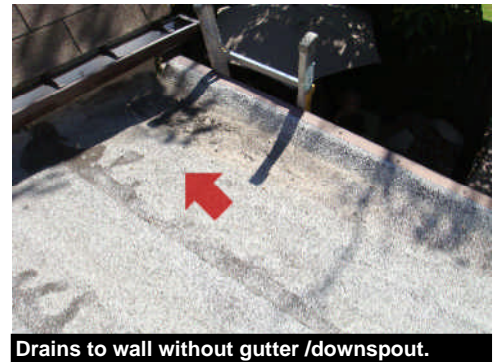
527 COMMENTS [CR] The front entry overhang low slope roof surface edge is raised, and drainage is improper.

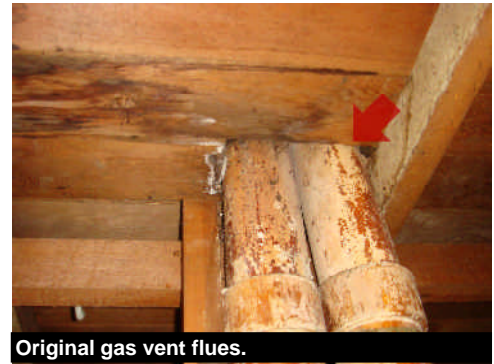
[FE] The plank sheathing is moisture stained at the original gas vent flues.

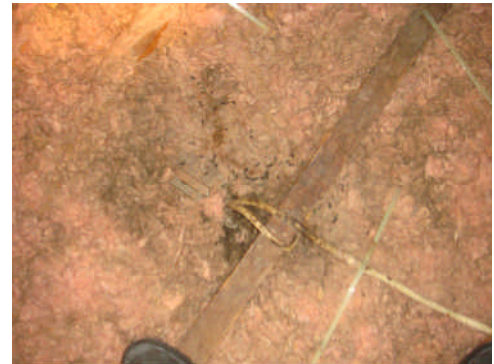
[FE] Rodent droppings are evident on the ceilings in the insulation.

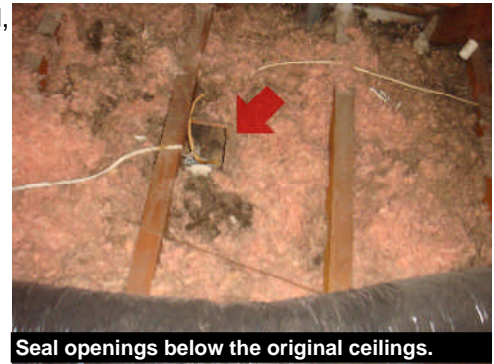
[CR] The insulation is out of place/missing in areas. This condition minimizes the overall value of the insulation.

Voids /openings into the lower ceilings should be sealed with fiberglass batt insulation.

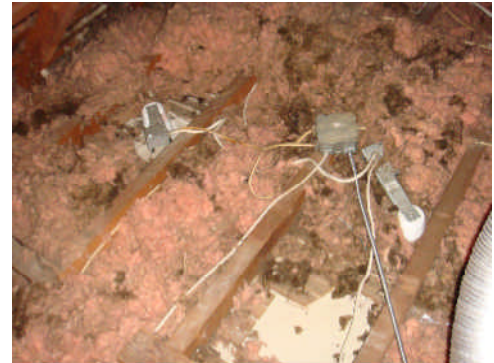
[SC] The insulation is in contact and covering the recessed luminaries [lighting fixtures]. It is unknown if the ceiling recessed light fixtures are "IC-rated for insulation contact. I recommend the trims and bulb be removed to expose the manufactures label to determine the rating.

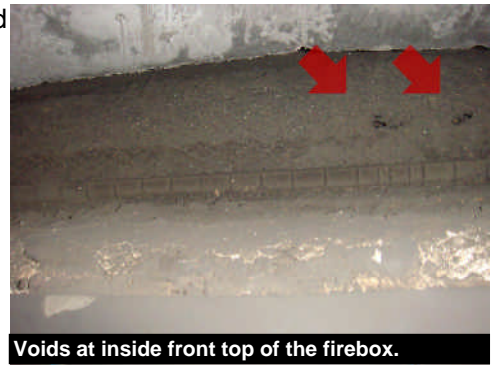
[CR] Voids and exposed rebar is evident above the fireplace opening.

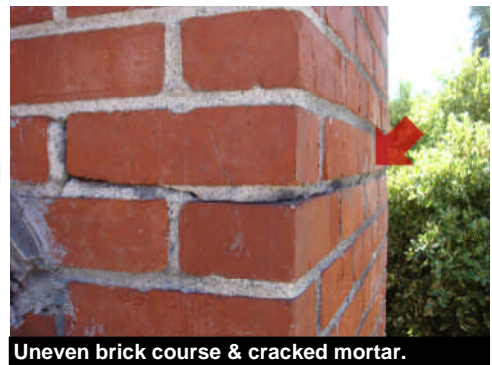
[FE] The chimney appears to have broke at the roof line. This condition could have been before the chimney was lined, although should be evaluated.

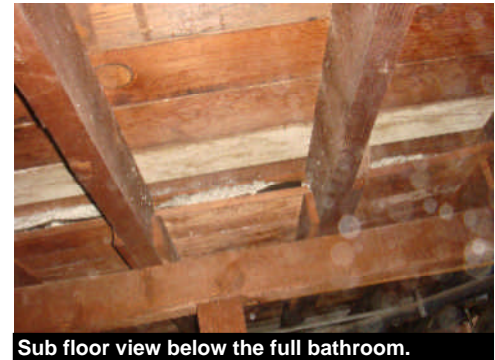
Sub floor view below the full bathroom.

The full bathroom tiled flooring is cracked at the floor joists. It appears the mortar bed was placed between the floor joists, causing the tiles on the joists to crack.

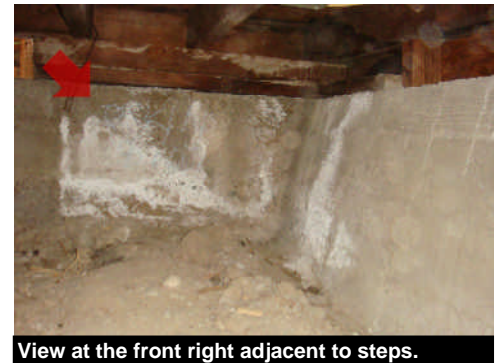
View at the front right adjacent to steps.

[FE] There is a condition known as efflorescence on portions of the foundation walls. This is a salt deposit left when moisture in the foundation evaporates. It indicates that the foundation is experiencing wet and dry cycles. I recommend the exterior grading and drainage be improved to divert moisture away from the foundation.

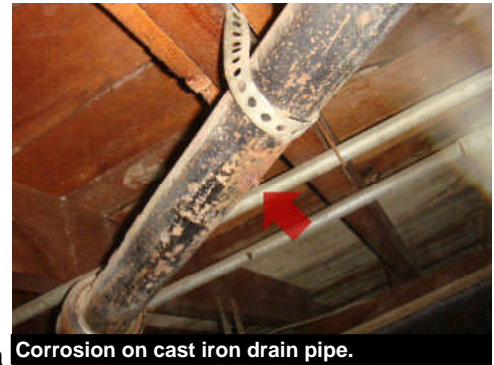
Corrosion on cast iron drain pipe.

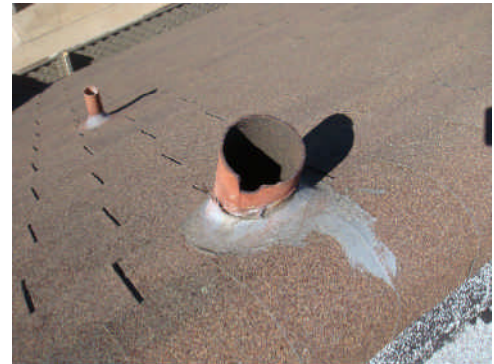
[FE] The cast iron vent pipe above the roof is broken at the top edge. This condition is typically caused from a plumbers snake.

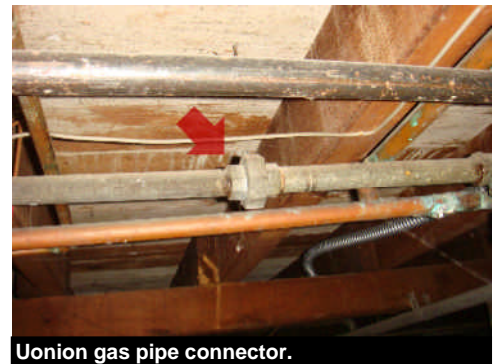
[FE] A fuel /gas sediment trap is not installed on end of the gas supply pipes before the equipment shut-off valves, at the water heater and furnace. The trap catches any debris that may be in the gas supply pipe before the regulators.

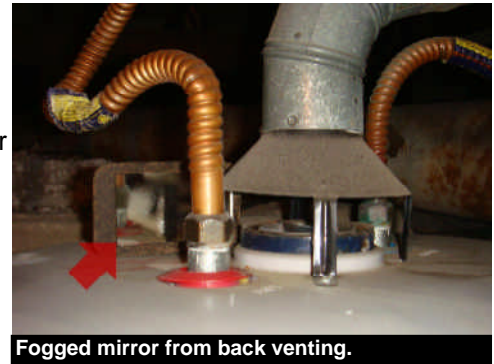
[FE] The tank single wall metal vent connector in the basement is irregular, and the vent flue is a cementitious material, and may have asbestos.

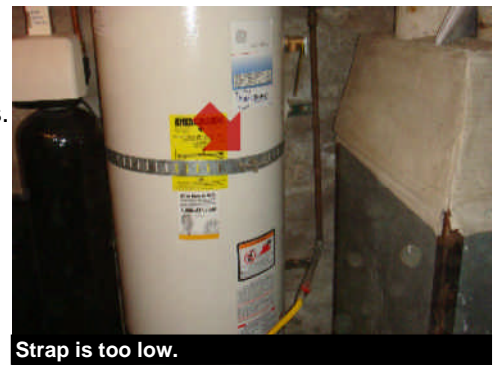
[SC] The water heater seismic strapping is installed in a manner that does not meet the State Architect's requirements or the water heater strapping kit manufacturers instructions. The top strap is too low, should be one third down from the top.

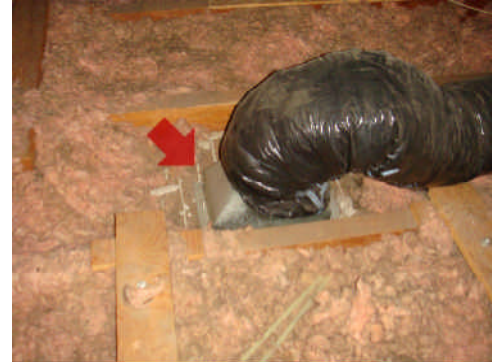
[CR] The metal duct boots should be insulated.

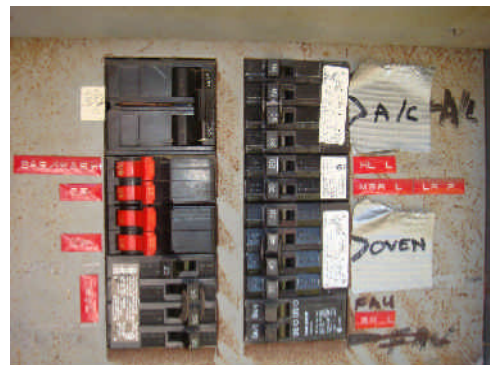
[CR] A number of the circuit breakers are not labeled or labeled properly. The circuit breakers should be accurately labeled to allow individual circuits to be shut off for maintenance or emergency needs.

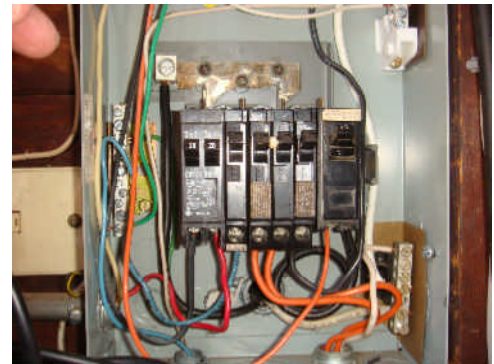
[SC] The panel is lacking grounding and conductor.

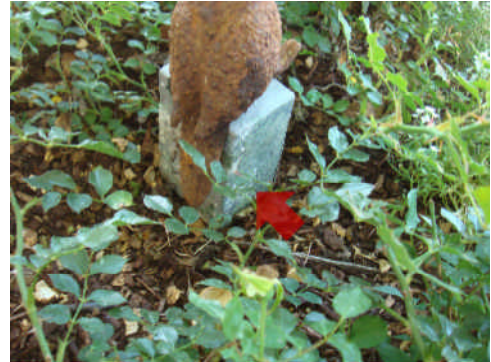
[CR] Unknown function of the electrical box in the front tree planter.

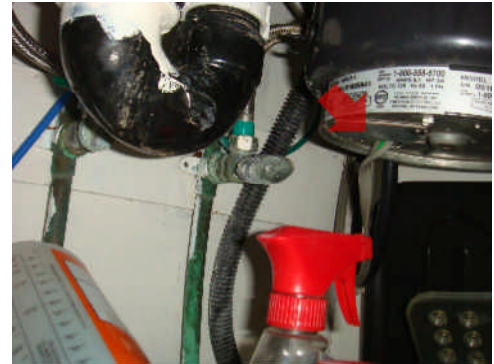
[SC] The power cord/wiring is not clamped to the disposal.

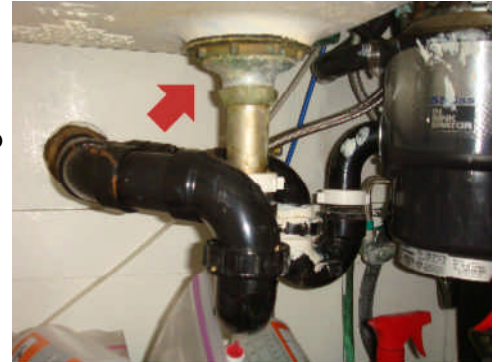
The hot and cold water supply pipes are reversed below the sink.

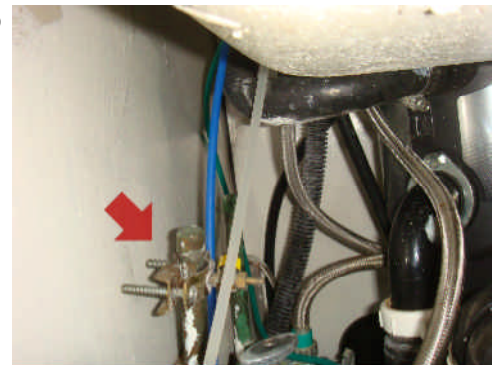
A 1/4" needle valve tap has been installed into the water supply pipe nipple. This is a substandard valve /installation.

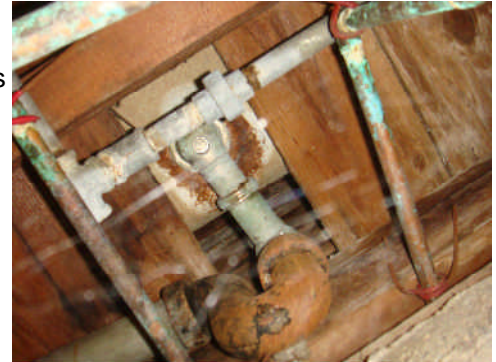
The bottom of the tub is rusting, and the trap is rusted. No leaks evident.

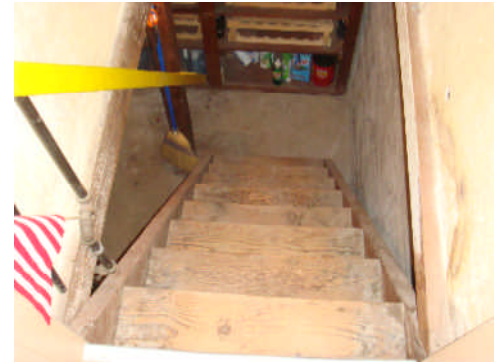
**1524
STAIRWELL(S)** [SC] The basement steps/stairwell is steep. I recommend installing a handrail at the right side for safety.
