# *Pre-purchase Home Inspection Report*

Sample of a 83 year old 1,000 square foot house

California Real Estate Inspection Association Master Inspector

***Steve Garcia Inspections***

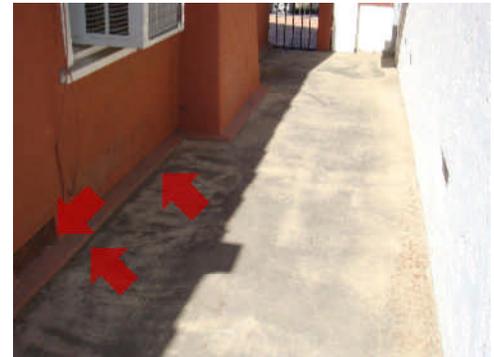
[CR] The grade at the rear adjacent to the garage left side door is improper and a low point.

[CR] The grade /hardscape at the left side of the house is above the house foundation mud sill improperly. A concrete curb has been added due this condition. The bottom of the foundation vent is 6" above the wall frame / mud sill. The curb does not correct the improper drainage condition.

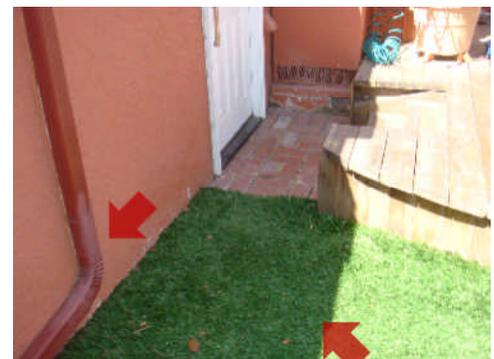
[CR] The improperly sloped grading noted above will cause water to puddle next to the building and garage.

The picture shows the grade slope to the garage, and the roof downspout does not terminate to the alley as it should.

[FE] The site should be evaluated during or after a heavy rain, for grade corrections, drainage installation and downspout termination.

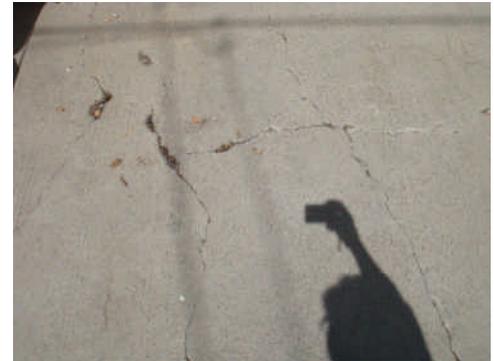
[CR] The concrete driveway is broken with cracks are up to 1/2".

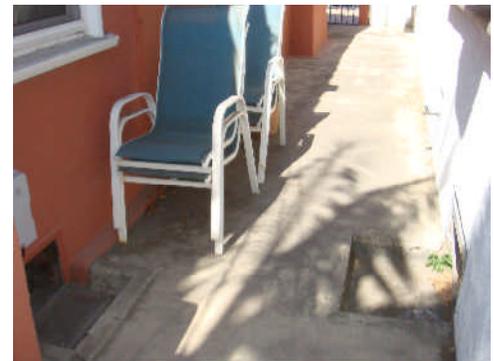
[CR] Signs of puddling water is evident at the left walkway.

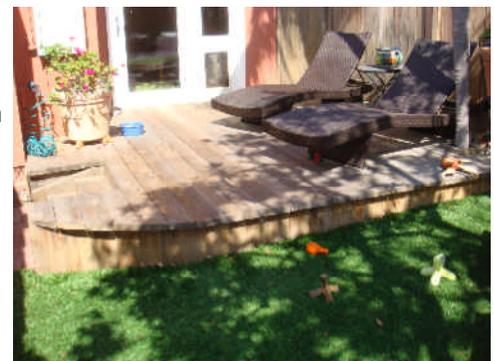
[FE] Lag screws into the house wall frame rim joist are visible in the crawl space.

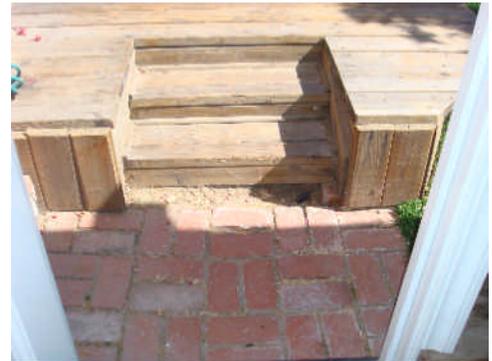
[SC] The deck wood steps rise is improper and uneven. The steps exceeds the 3/8" allowed variance. This condition is a trip hazard.

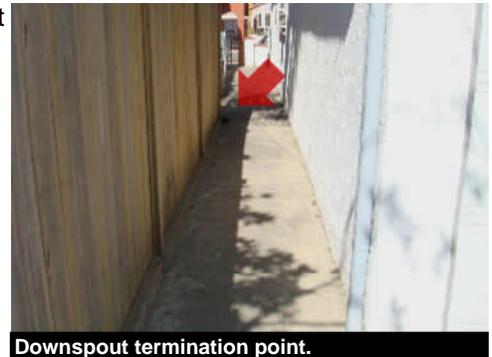
[CR] The house roof drain downspout terminates at the left fence corner. The sidewalk where the downspout terminates does not appear to slope towards the alley as it should. This is an improper downspout termination point due to the improper slope of the sidewalk.

Downspout termination point.

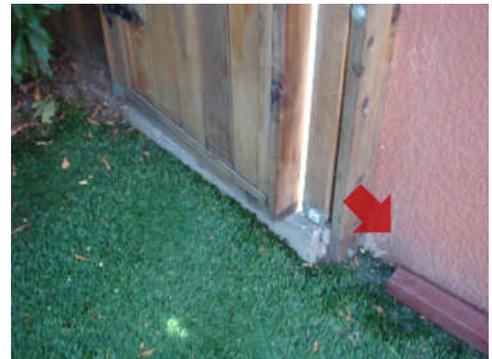
[CR] The garage downspout terminates at a concrete curb and fence post. The grade slopes back towards the house. This is an improper termination of the downspout.

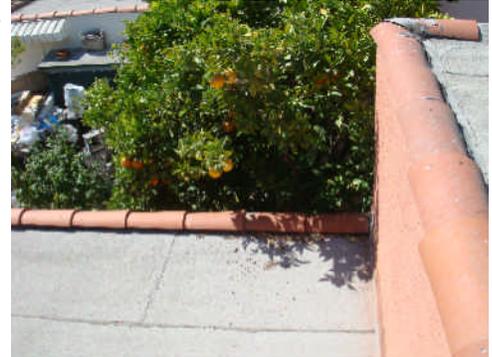
[CR] The tree at the right side of the garage is touching or over-hanging the roof. I recommend the tree be trimmed to prevent debris from falling onto the roof.

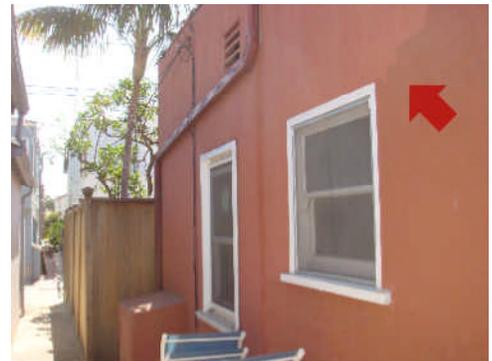
[FE] The stucco at the rear left appears to have two paint colors, and the downspout appears to have been recently relocated. I recommend the home owner be consulted as to the paint colors.

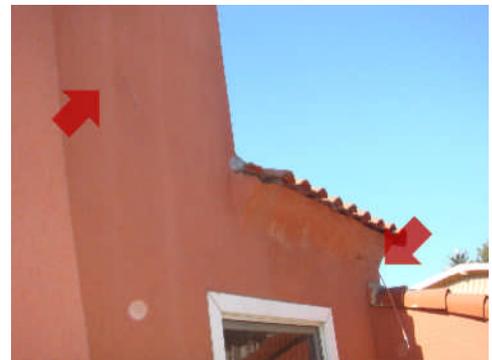
[CR] Wires are sticking out of the stucco wall at the left side, and water stains are evident below the roof. The roof should have a drip edge flashing or the roofing material should have extend past the stucco. The interior wall is moisture damaged at this area.

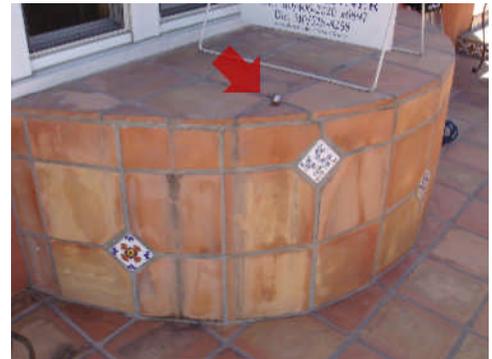
**322 COMMENTS** The suspected pot shelf at the front of the house has a tile top. The tile grout should be sealed with a grout sealer.

The shelf framing /structure is not visible. The grout sealer may prevent moisture from entering the material below.

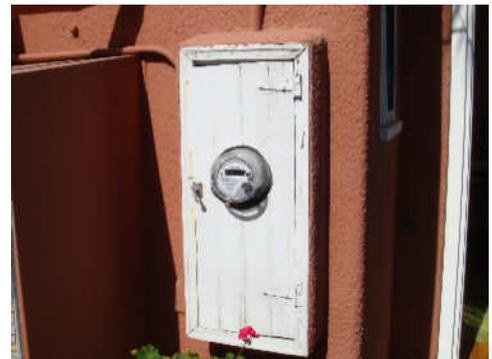
[CR] The rear garage door exterior trim is worn, weathered and the paint is chipping off.

[CR] The kitchen door stucco molding is moisture damaged.

[CR] The exterior cabinet doors and stucco trim for the electric panel and gas meter are moisture damaged, with broken hinge at the gas meter.

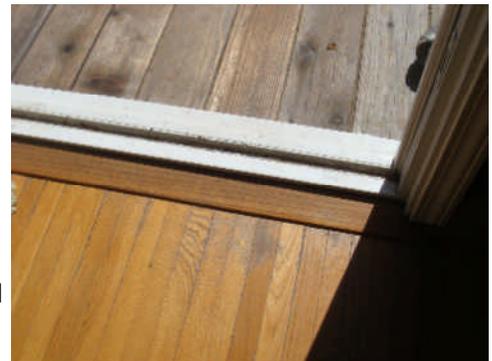
[CR] The kitchen exterior door is damaged with excessive deterioration.

[FE] The bedroom door is functional, with exception. The bottom weather strip has slight damage, and a doggie door has been installed into the side light.

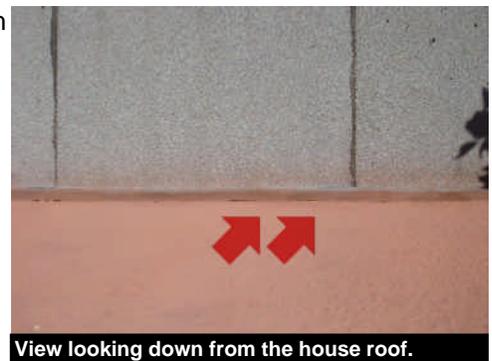
[CR] The mastic is starting to peel off. The mastic will need to be maintained.

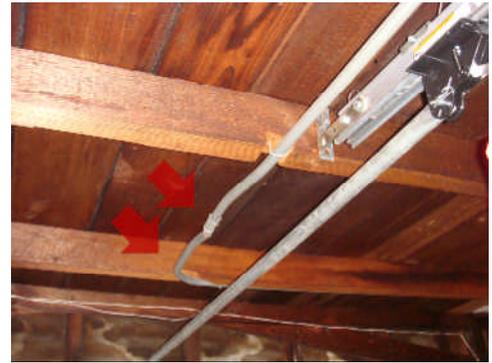
[CR] Two of the roof rafters have been notched improperly up to 3/4". The door opener track and the separated electrical conduit are hung from one of the notched rafters!

[CR] Areas of the framing has insect damage and moisture damage to the rear door jambs.

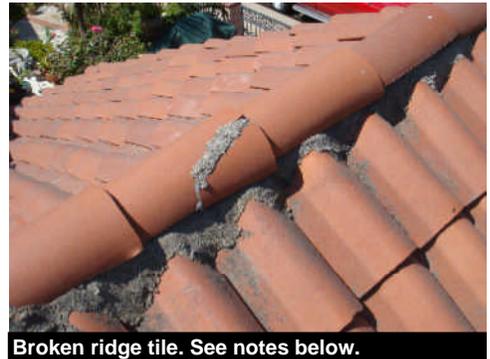
Broken ridge tile. See notes below.

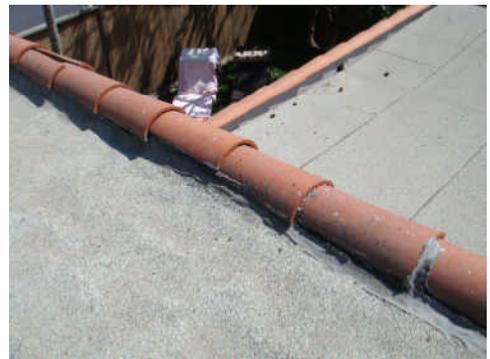
[CR] The parapet walls tile caps are broken and missing.

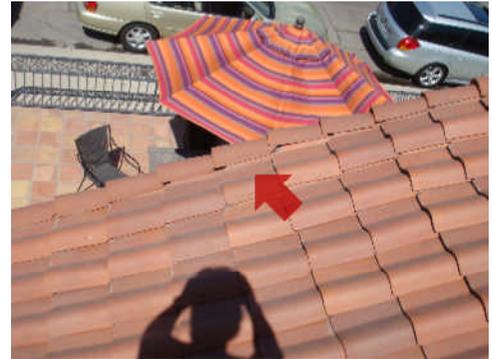
[CR] One ridge tile is broken, and the right side rake tile installation is uneven and irregular.

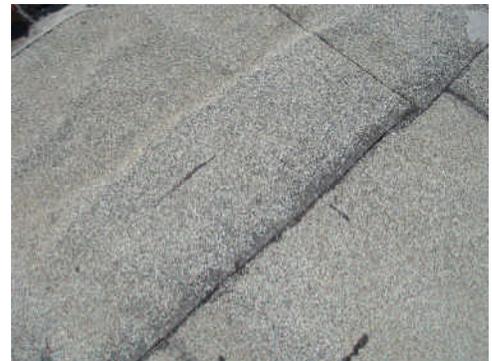
[FE] The roofing material is blistered and the mineral surface is weathered and worn off at areas.

This roofing material is at or nearing its life expediency.

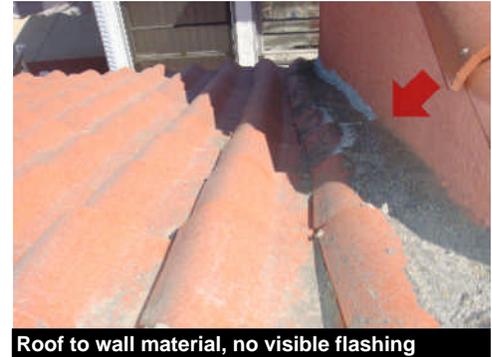
[CR] The tile roof to the wall intersection has cracked mortar and mastic sealant.

Roof to wall material, no visible flashing

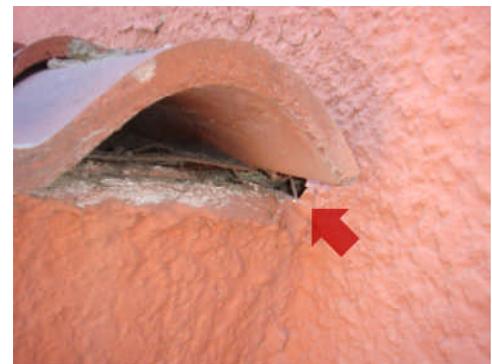
[CR] There is no kick-out flashing at the tile termination and stucco wall. Void /gap evident at the right side.

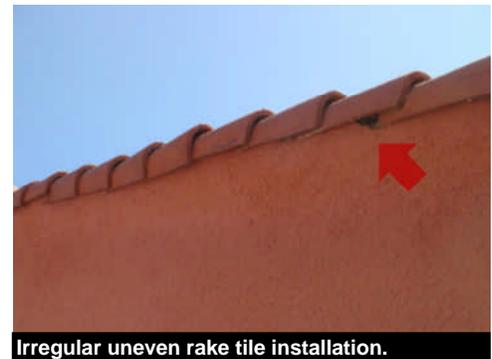
[CR] The rake tiles and down-sloped edge of the roof does not have flashing or underlayment over the edge /stucco wall.

Irregular uneven rake tile installation.

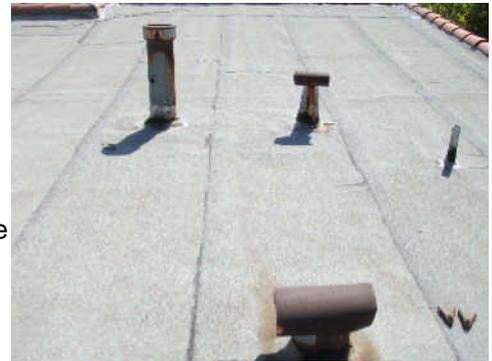
[FE] The older wall furnace vent flue and cap is rusted.

[FE] The two wagon caps are rusted. One wagon cap function is unknown, and may have been for a water heater in the kitchen.

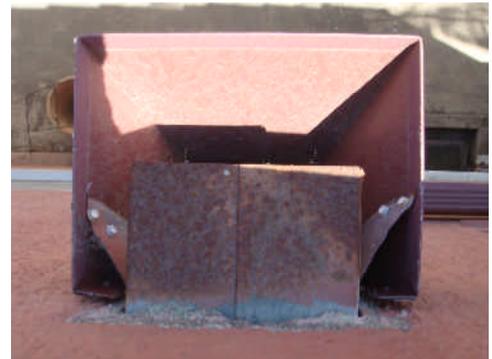
The house roof drain is rusted. Paint the metal with a oil based rust inhibitor.

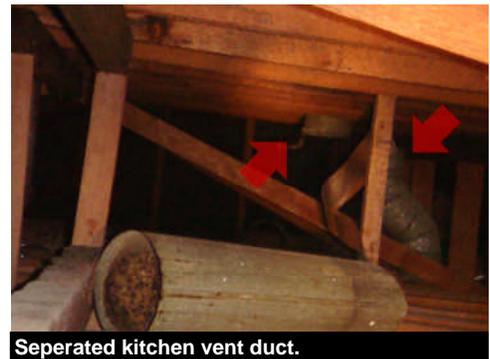
**602 COMMENTS** [SC] The kitchen vent duct is separated. This condition is potential a fire safety hazard.

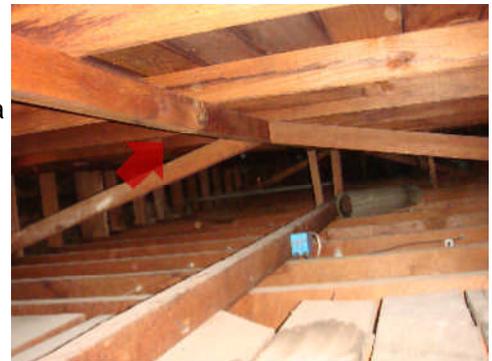
[FE] One visible purlin has a sag adjacent to a knot.

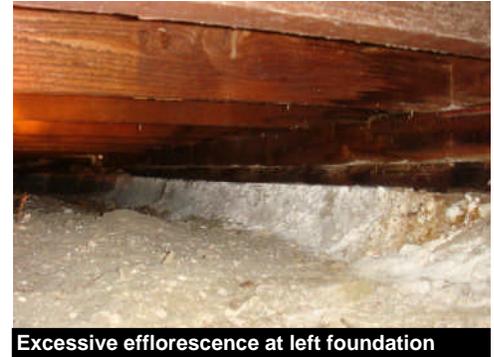
Excessive efflorescence at left foundation

[CR] There is a condition known as efflorescence on portions of the foundation walls. This is a salt deposit left when moisture in the foundation evaporates. It indicates that the foundation is experiencing wet and dry cycles. I recommend the exterior grading and drainage be improved to divert moisture away from the foundation.

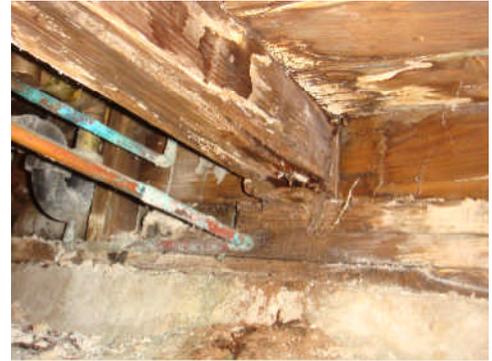
[CR] Moisture damage is evident below the bathroom at several locations.

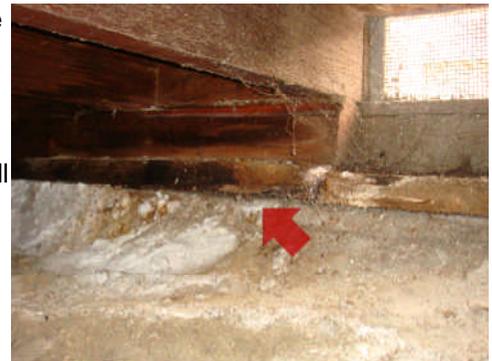
**809 MUDSILLS** [CR] The visible mud sill at the left side on the foundation appears to be lifting on the inside / opposite side of the rim joist bearing point.

[FE] The mud sill appears to have moisture damage at areas, and lacking section of the sill at the left side.

[RU] The mud sill is not bolted down to the foundation. I recommend blocking, metal fasteners and hold downs /bolts.

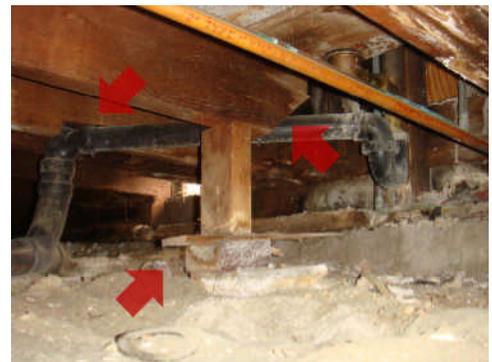
[CR] The floor joists under the bathtub has been notched and cutoff /supported improperly.

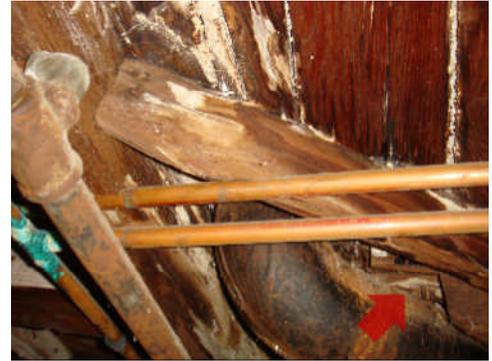
**813 SUBFLOOR** [CR] Moisture stains, damage and notched framing is evident below the toilet.

The tile flooring around the toilet is uneven from movement.

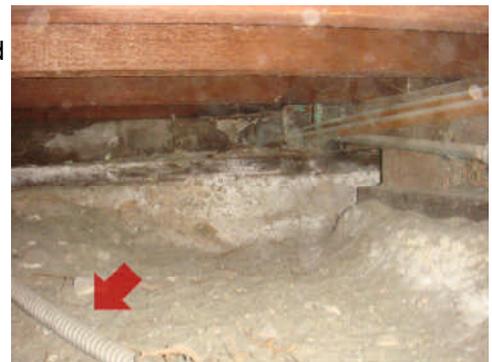
**815 COMMENTS** View of electrical metal flex conduit on the soil improperly, and foundation /crawl space limited access adjacent to the water heater.

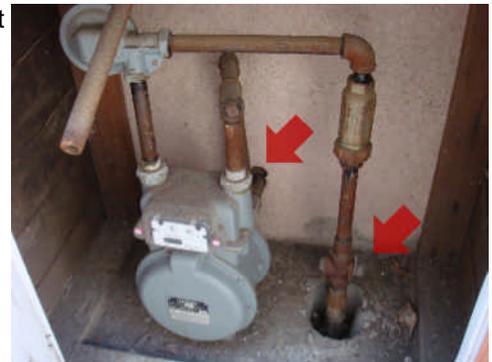
The picture shows the cut /notched framing adjacent to the toilet water closet.

Seal the stucco wall at the gas supply pipe.

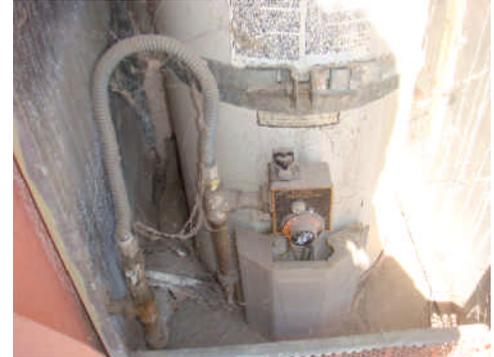
[CR] There is lint buildup that should be cleaned out for fire prevention.

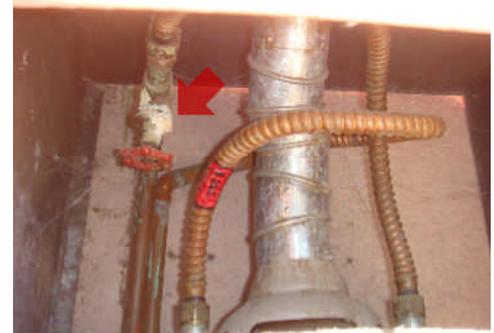
[CR] The water supply shutoff valve is corroded. I recommend replacing with a ball valve.

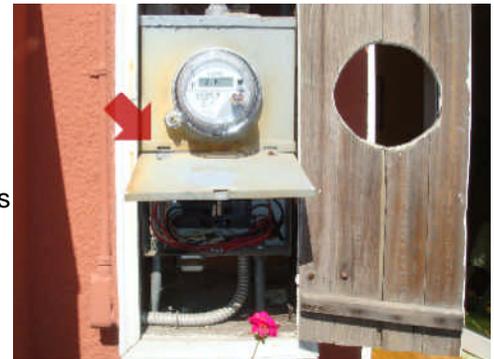
[CR] The circuit breakers should be labeled as required after the cover is installed.

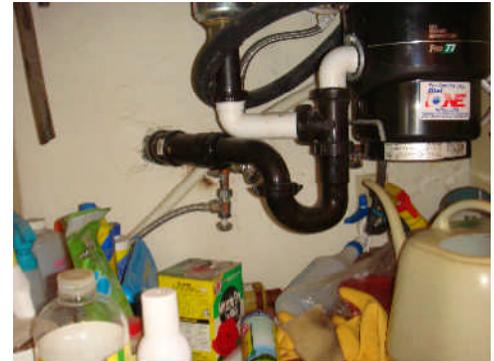
[CR] The kitchen left sink drain is slow or blocked. The drain pipes configuration is irregular.

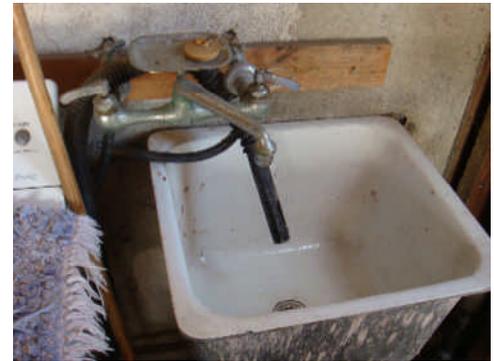
[CR] The faucet leaked at the handles when operated.

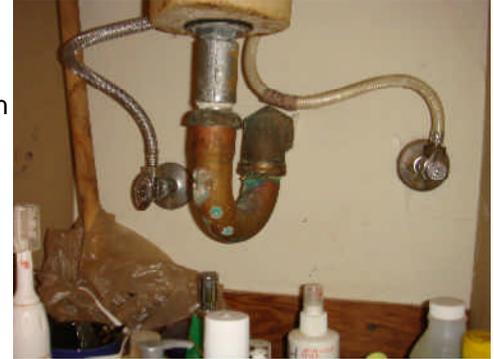
[CR] The drain pipe is corroded, and the basin is lacking a drain screen.

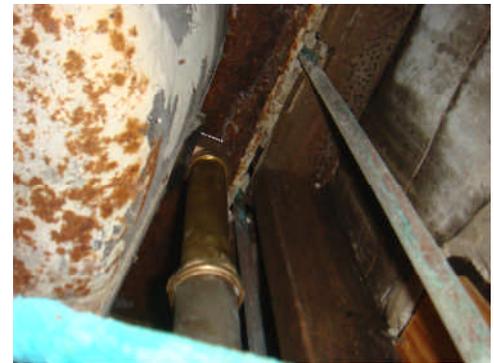
[FE] The underside of the tub is rusted.

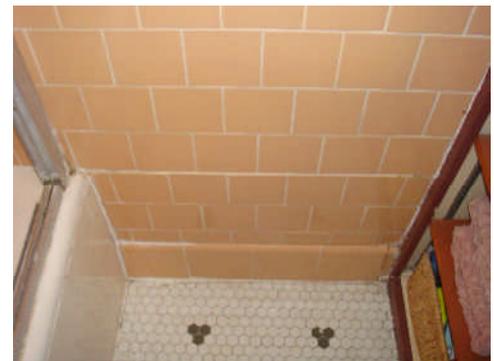
[CR] The tiled wall below the window is moisture damaged and loose.

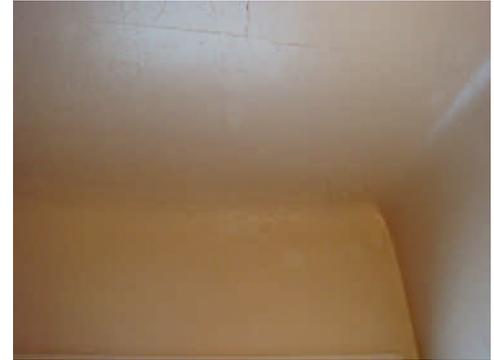
[CR] The bathroom ceiling is blistered, the paint is chipping and peeling.

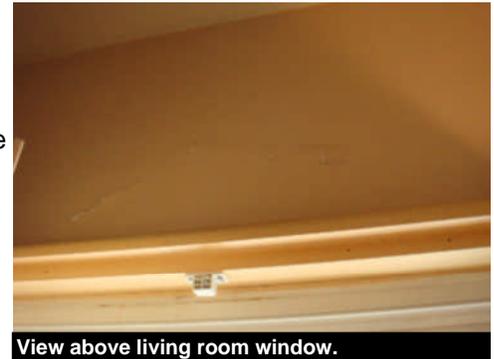
[FE] Peeling and chipping paint in the living room.

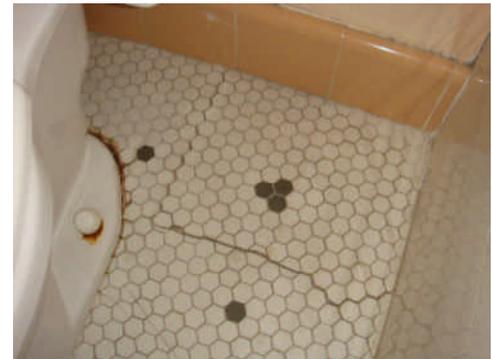
[CR] The bathroom tile flooring is cracked, lifted and damaged.
