Pre-purchase Condominium *Inspection Report*

Sample of a 18 year old 2,400 square foot Condo

Steve Garcia Inspections

FILE/DATE/TIME This is a preliminary report before the recommended specialist evaluation /reports.
 File # 180910
 Date of inspection: September 18, 2010
 Time of inspection: 1:00 PM - 7:00 PM.

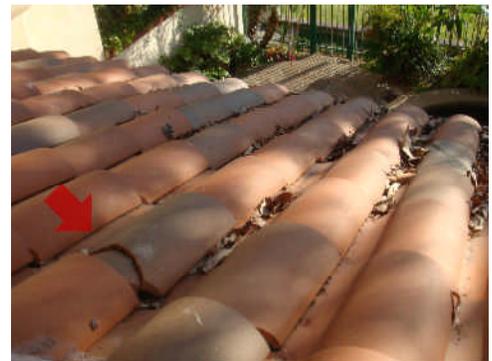
DESCRIPTION**502 ROOF
COVERING(S)**

The original clay tile roofing system was only viewed from the ground and interior windows.

[CR] Loose mortar plugs and overexposed tiles at the left side of the wall flashing intersection.

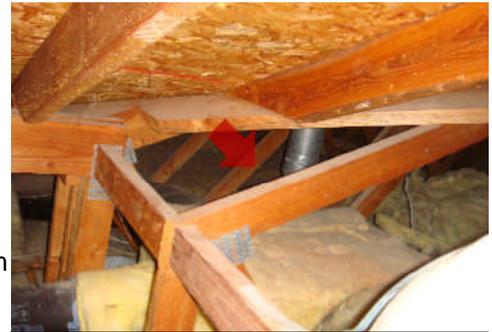
Pictures were taken from the master bedroom and bath wall into the hallway and center bedroom.

Inaccessible over the furnace. See flue.

602 COMMENTS [FE] Some rodent droppings are evident over the master bathroom.

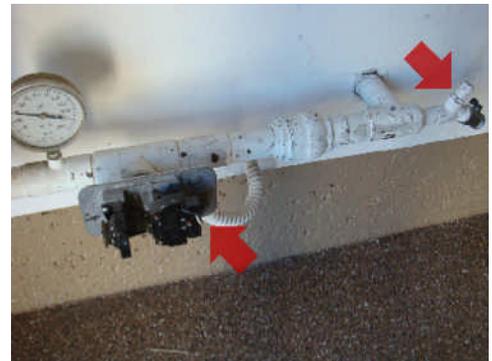
The valve at the end of the pipe is only for the sprinkler system and should not be turned.

[FE] These systems are outside the scope of the inspection and are not inspected. I recommend consulting with a specialist regarding the systems operation and maintenance.

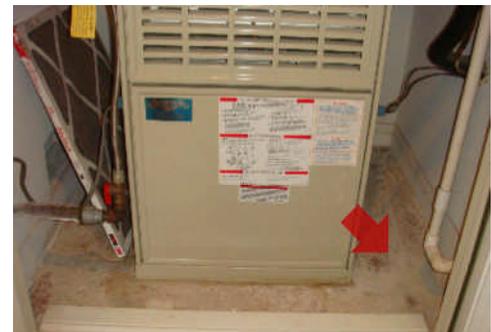
The furnace /burners functioned properly.

Furnace is on the return air plenum.

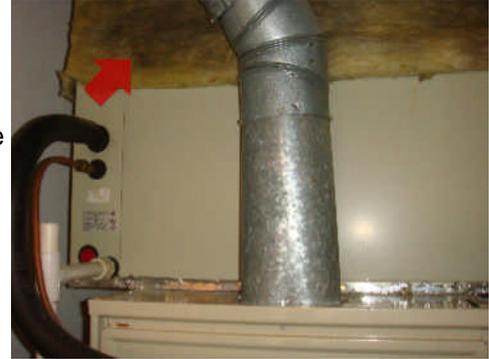
[FE] There are apparent air leaks, the fiberglass insulation on the cooling coil and supply plenum is soiled.

[FE] The air supply plenum is not visible in the attic.

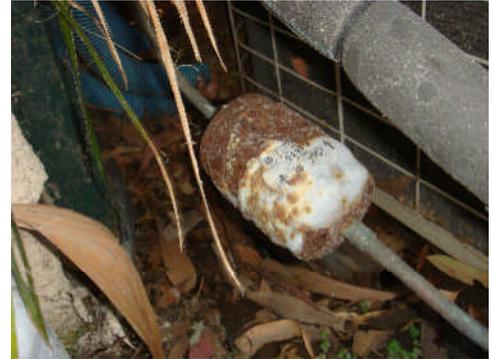
[CR] The refrigerant dryer is rusted and damaged.

The line set is only visible at the cooling coil and condenser.

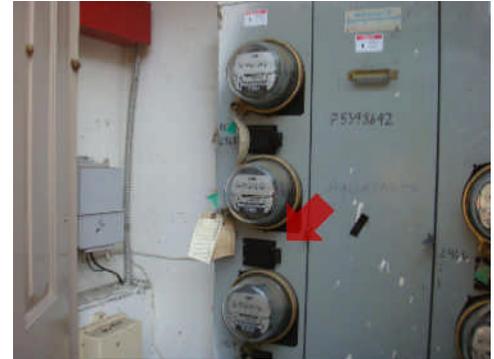
There is a common area panel in the front left exterior closet. The panel is sealed and is not inspected.

The main panel contains the unit 125 amp. main disconnect only.

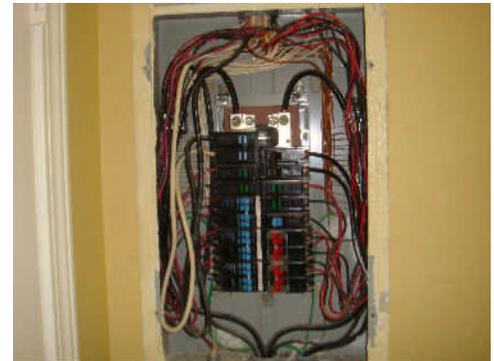
1212 LOCATION The 125 amp. sub panel is located in the laundry room.

The sub panel has 20, 110 volt circuit breakers, and 4, 220 volt circuit breakers.

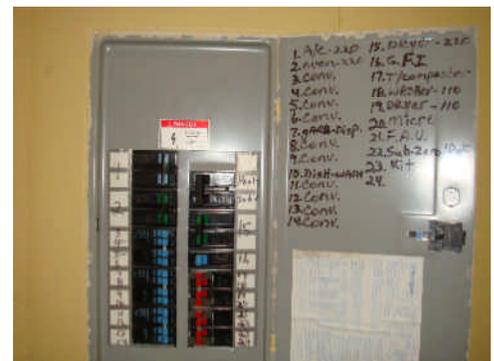
1215 SUB- PANEL

The circuit breakers in the panel are labeled. The accuracy of the labeling is not verified.

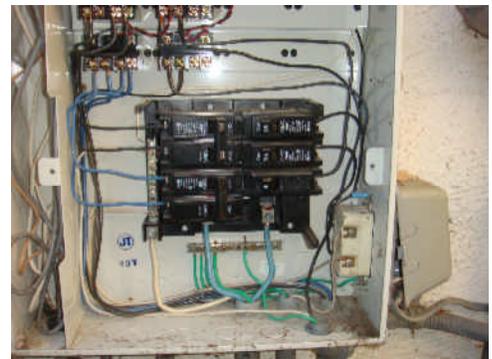
**1216
WORKMANSHIP**

The wiring within the panel appeared serviceable.

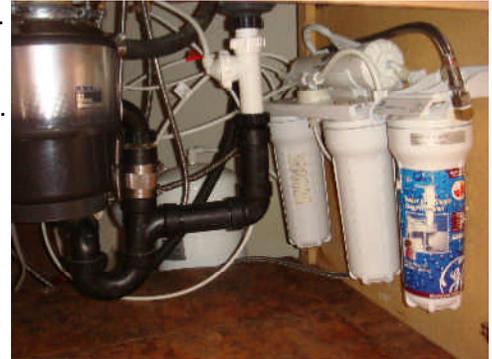
The faucet, sink and plumbing were functional.

[FE] The water filtration system is outside the scope of the inspection and was not inspected. I recommend consulting with a water conditioning specialist regarding the system operation and maintenance.

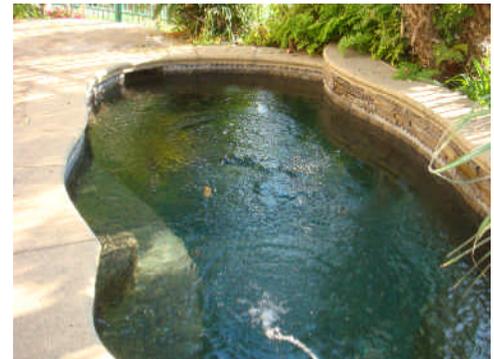
1619 VESSEL [FE] The vessel surface is not all visible.

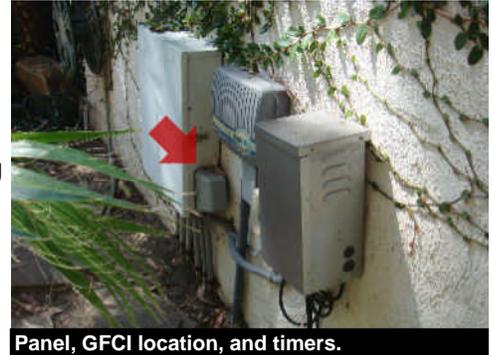
The GFCI protection device for the pool/spa luminaire [light] functioned/tripped when the test button was operated. I recommend testing the device at each use.

Panel, GFCI location, and timers.

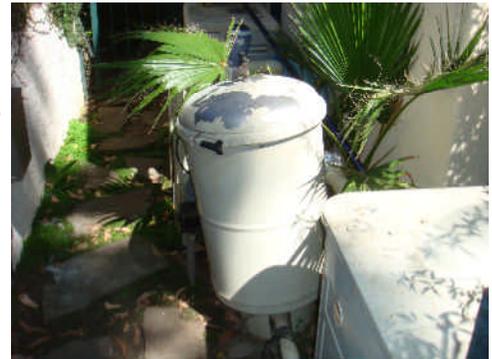
[CR] The Diatomaceous earth filter is leaning. The platform has settled.

[FE] The filter should be opened and the grids inspected.

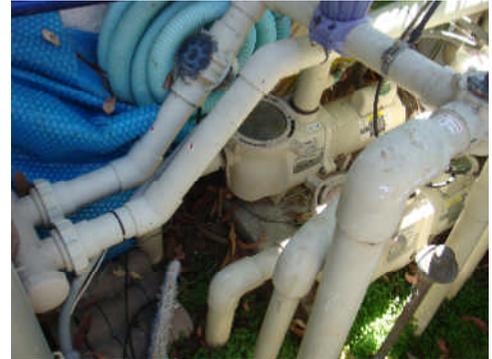
1643 VISIBLE PIPING

The plastic PVC visible piping, valves and connections appeared functional.

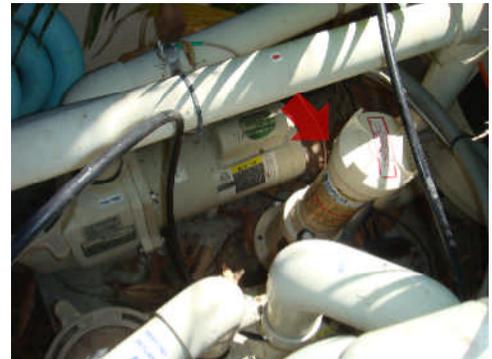
EXCLUDED BY THE STANDARDS OF PRACTICE**1652 CHLORINATOR**

These units /systems are outside the scope of the inspection and are not inspected. I recommend a full evaluation by a specialist.
