Pre-purchase Town Home Inspection Report

Exclusively for: John Smith

Long Beach, CA. 90803

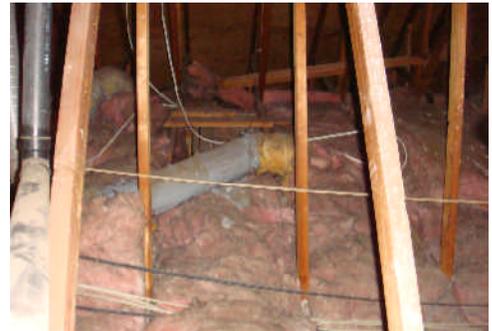
603 DESCRIPTION Truss framing system with plywood roof deck sheathing.

View into the attic.

604 ROOF FRAMING The visible areas of the roof framing appeared functional, with exceptions noted.
