# *Pre-purchase Home Inspection Report*

Exclusively for: Good Client

Sample of a 33 year old 3,400 square foot house with pool & spa

***Steve Garcia Inspections***

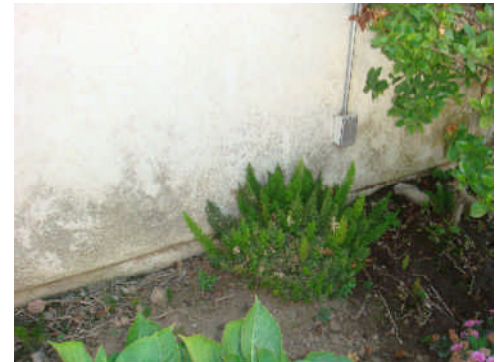
[CR] The planters around the house are lacking drains, and only one roof gutter is provided at the right side. The stucco is soiled from roof water runoff splashing planter soil on the left wall. See picture.

[FE] The site should be evaluated during or after a heavy rain, for gutter installation and downspout location /termination.

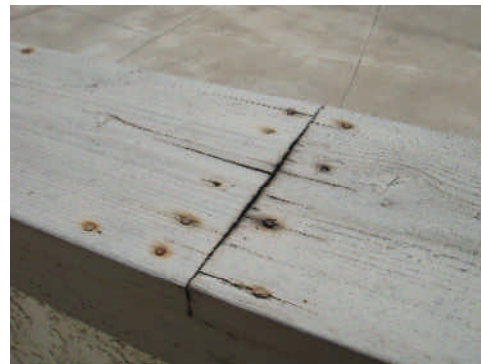
[CR] The wood wall cap is separated and deteriorating at the butt joints with rusty fasteners.

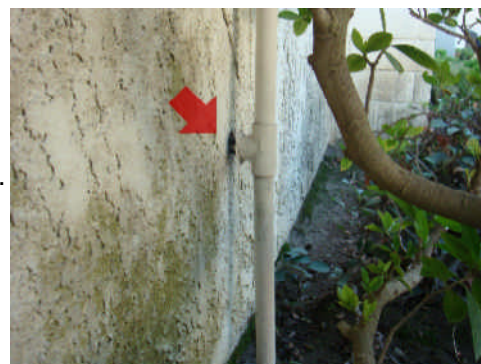
[CR] The stucco walls have been penetrated at areas with low voltage wires without sealing.

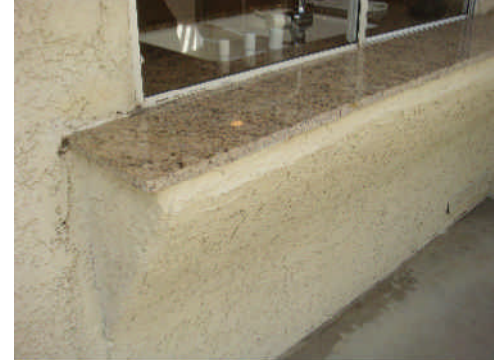
[CR] The kitchen window drain /weep holes have been blocked by an added shelf. This condition is conducive to moisture intrusion.

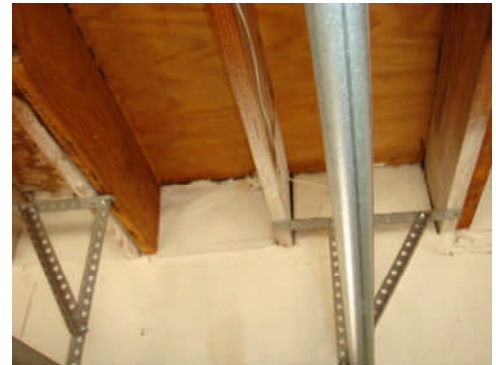
The detached garage wall tie framing members attached to the top of the walls are not designed to support stored items.

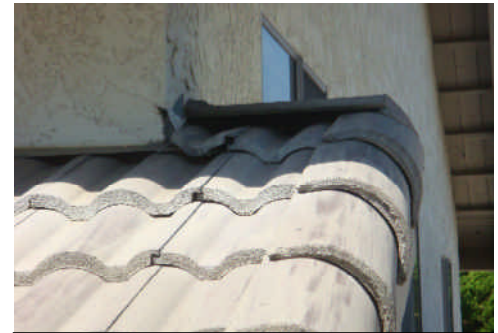
**Irregular tile installation at the rear.**

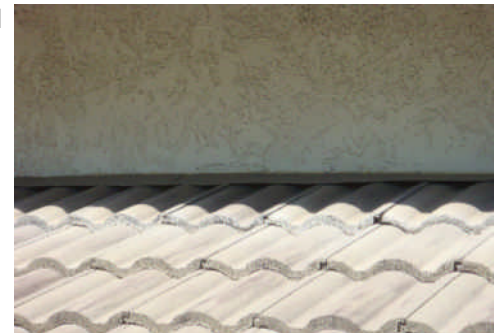
[CR] A few of the rake tiles are overexposed with the top fastener exposed at the right side.

[FE] The rake tile fasteners are rusty.

**Right side tile visible fasteners.**

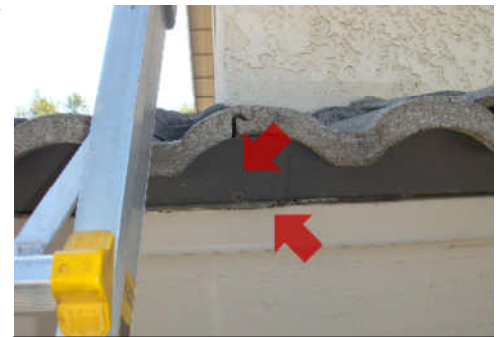
[CR] The edge of the pan flashing is crushed/bent.

[CR] The tile support is not cut open for water runoff at some of the pan /channel flashings.

Crushed pan flashing & no opening.

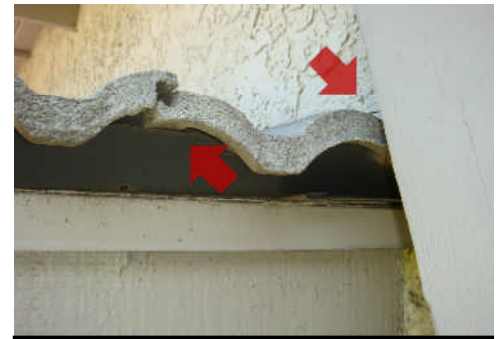
Tile & riser has an irregular fit.

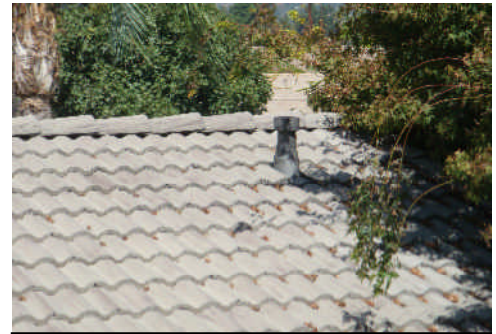
Cut the tree back from the furnace flue.

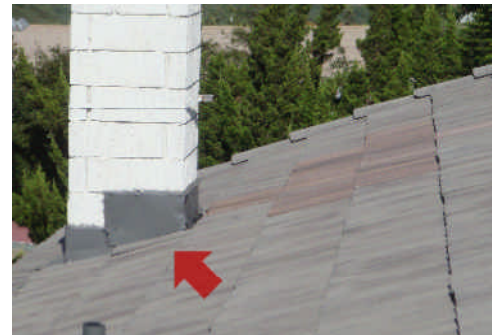
Uneven tile should be evaluated.

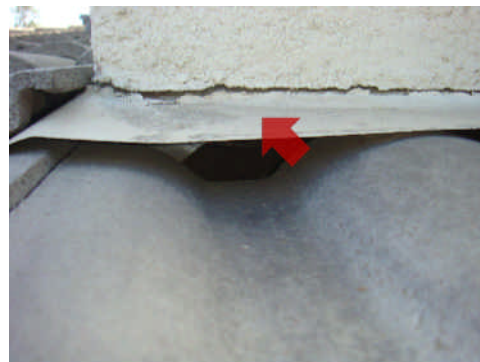
[CR] View of loose apron flashing at the rear left.

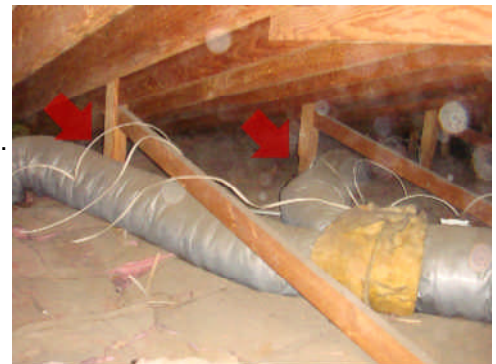
[FE] The rear attic has struts attached to every 4th rafter. This framing detail is irregular. The bearing point of the struts were not identified.

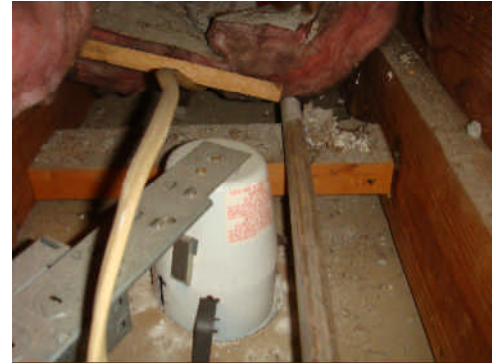
[SC] The insulation is in contact with some of the non-insulation contact (Non-IC) rated recessed light fixtures.

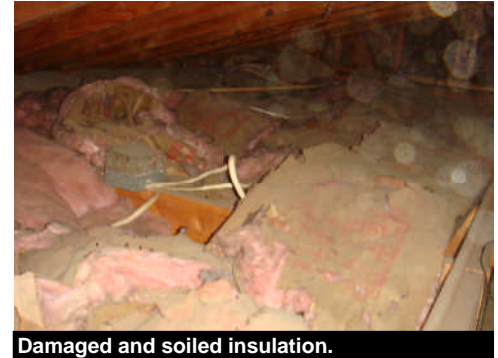
[SC] The rear attic fiberglass insulation is installed upside down, with the paper facing exposed to the attic space. The paper face should be in contact with the ceilings. This condition is considered to be a fire safety concern.

[CR] The exposed paper is deteriorated. The soiled and damaged insulation should be replaced properly.

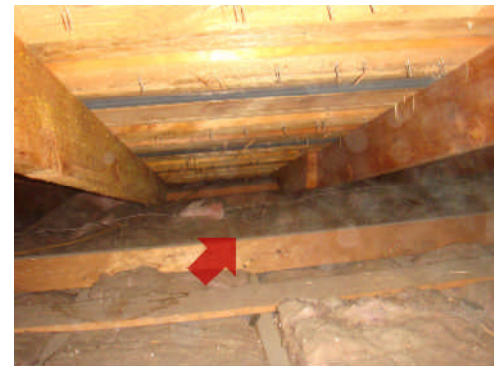
Soiled debris area adjacent to the chimney, appears to be squirrel debris.

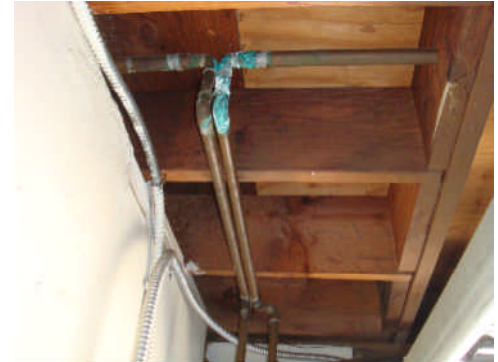
[CR] The added 3/4" copper piping in the garage is corroded and evidently has leaked.

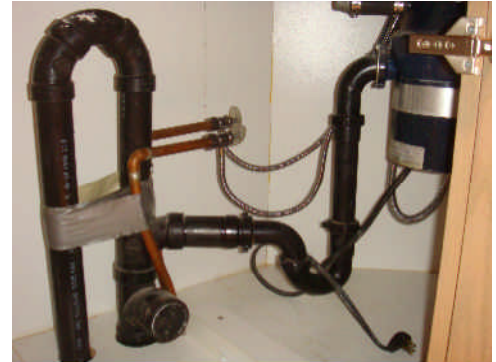
[CR] The island sink drain vent riser loop is short. The loop should be installed as high as possible below the counter top.

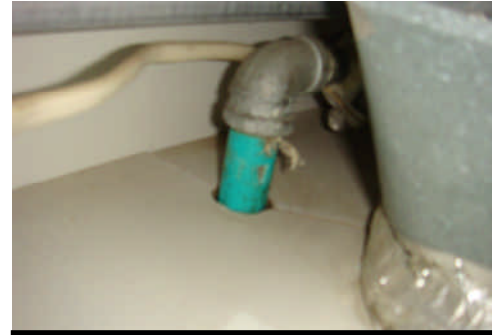
[FE] The kitchen cooktop gas supply pipe is fed below the slab. There is no exterior vent for the gas pipe sleeve. It is unknown if the pipe underground is in a sleeve.

Gas pipe below the cooktop cabinet shelf.

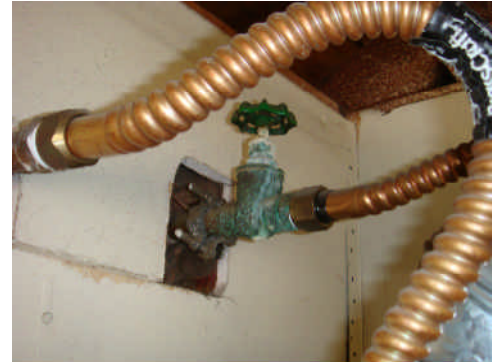
[CR] The water supply shutoff valve is corroded. I recommend replacing with a ball valve.

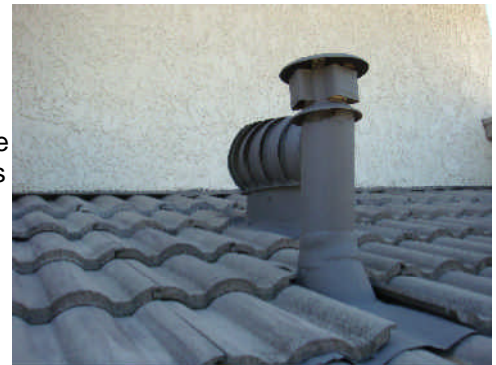
[SC] Duct tape is wrapped around the connector /vent flue pipe improperly, this condition is a potential fire hazard.

[FE] The suspected asbestos transite flue pipe is broken at the top, and the termination is less than 8' from the wall.

The connector has slight corrosion noted.

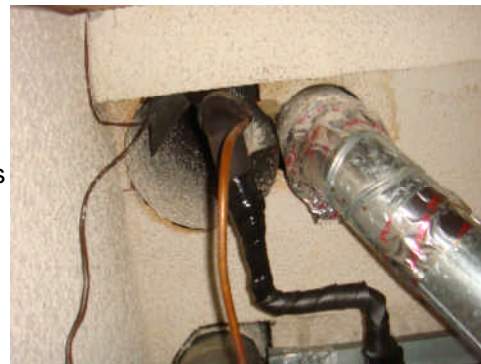
[FE] The vent connector and flue connection is tapped irregular. The vent connector and flue does not need tape, if the proper materials are used.

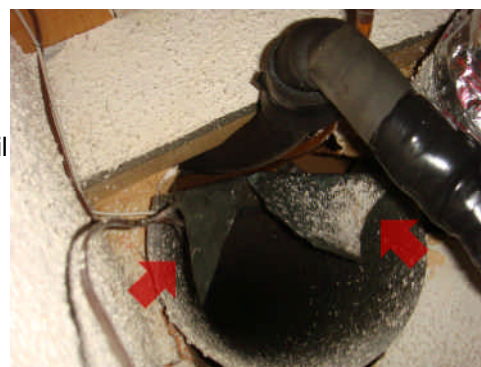
The combustion air supply for the furnace appeared adequate, with exception.

[FE] The combustion air duct has been bent improperly for the installation of the cooling coil line set.

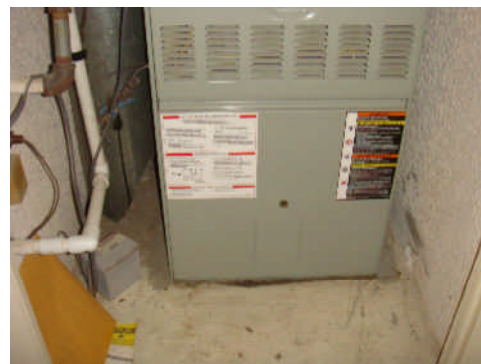
**1111 FAN(S) /  
HOUSING(S)**

The fan and cabinet are functional.

I recommend the fan cover be taped and sealed with metal tape.

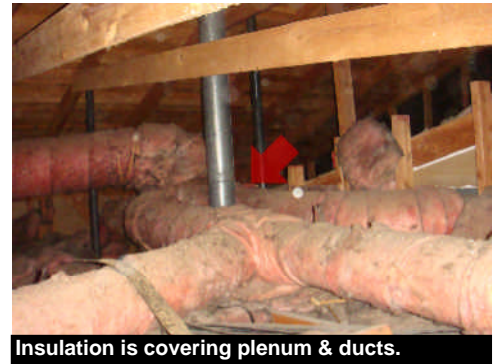
**1113 AIR  
SUPPLY  
PLENUM(S)**

The supply air plenum and duct connections appeared to be functional, insulation is blocking view in the attic.

Insulation is covering plenum & ducts.

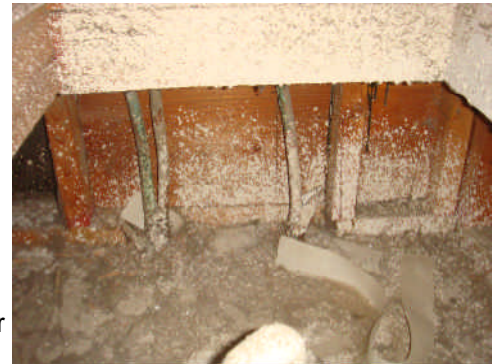
[SC] The furnace is located in a closet over the return air grill, the door to the closet is lacking a gasket to seal tight. This condition can draw products of combustion into the conditioned air.

The return air grill and plenum is dirty. I recommend cleaning this area of all dirt and/or debris.

[RU] I recommend green board or plywood be installed in the return plenum to seal the exposed wall framing and any voids /gaps.

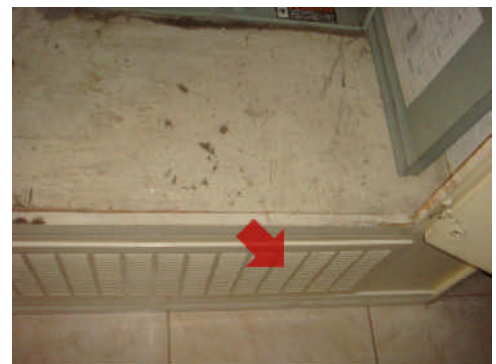
[FE] If a gas dryer is installed I recommend the furnace and dryer be operated and the air flow between the dryer and furnace return be evaluated with a smoke stick.

Air from the dryer should not be pulled in from the return air grill.

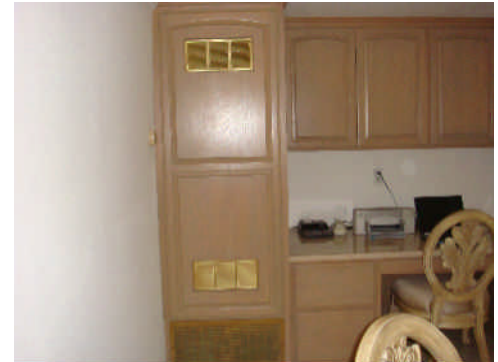
The original unit is located in the BK area closet.

[CR] The closet wall board has been damaged for the installation of the thermostat.

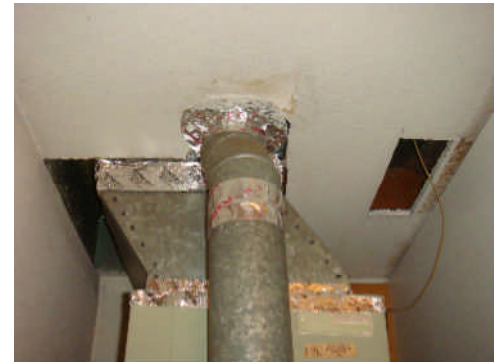
Due to age of the unit and conditions noted below the furnace appears to be at the end of or beyond its useful service life. I recommend a full evaluation, corrections and/or replacement by a licensed heating contractor specialist.

[SC] This furnace should not be operated in its condition.

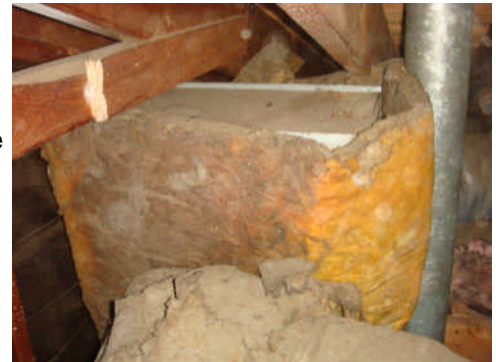
[CR] There are air leaks evident, the fiberglass insulation is soiled, loose and missing at the top.

[FE] The supply air plenum is smaller than the cooling coil.

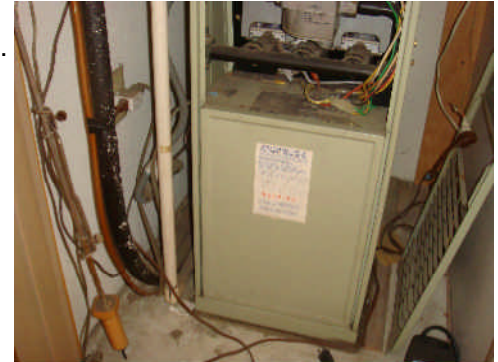
The gas shutoff valve and flexible gas connector appeared functional, with exception.

[RU] The furnace gas flex connector is not hard piped through the furnace housing.

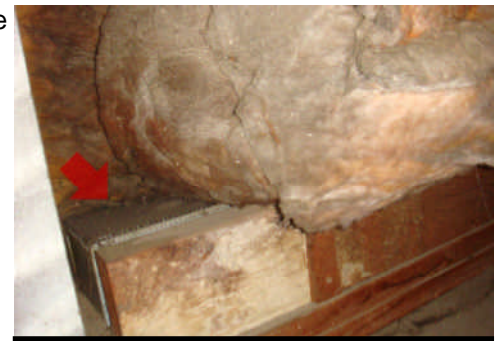
This furnace installation and conditions require corrections /replacement.

Original combustion air opening blocked.

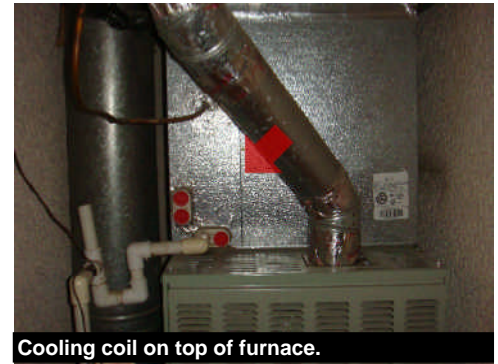
Cooling coil on top of furnace.

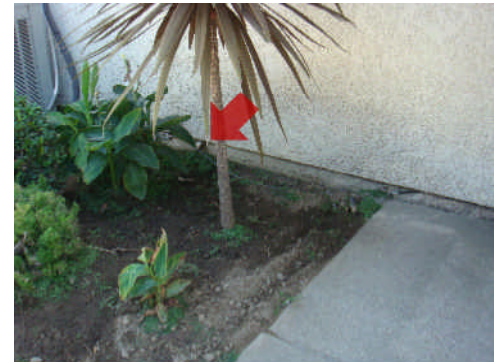
The visible areas of the condensate drain line appeared functional.

I recommend the termination point be extended away from the house foundation.

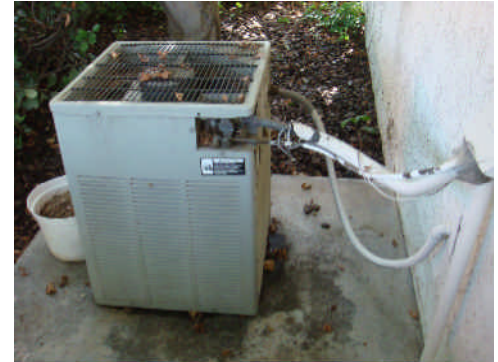
The condensing unit is functional, with exception.

[CR] I recommend the unit be cleaned by a heating contractor specialist, due to the excessive debris inside the casing.

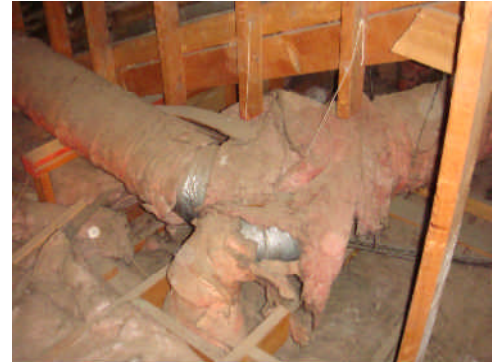
[CR] The main original air supply duct connector has improper support. Wide straps should be installed to provide adequate support.

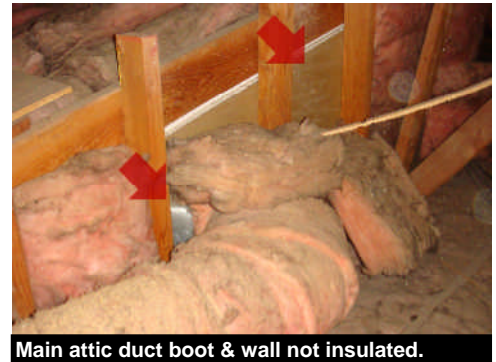
Main attic duct boot & wall not insulated.

[CR] Insulate all duct boots and connectors.

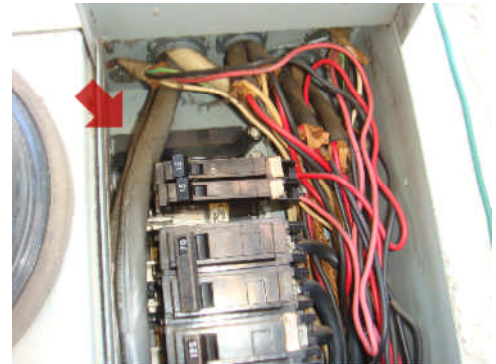
**[SC]** Double lugging /taps are evident at two of the circuit breakers.

**[CR]** Conductors /feeders are placing pressure on the breakers.

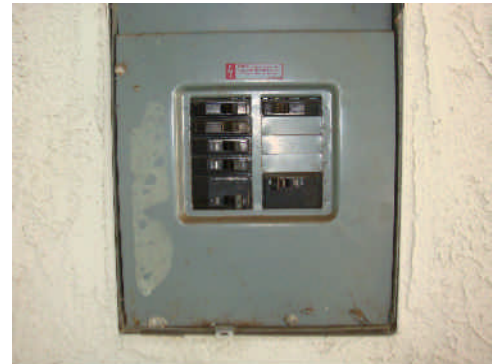
**[FE]** 120/240 volt, rated at 50 to 70 Amperes. This is only an assumption of the panel disconnect amperage. The main panel and garage circuit breakers are not all labeled as required.

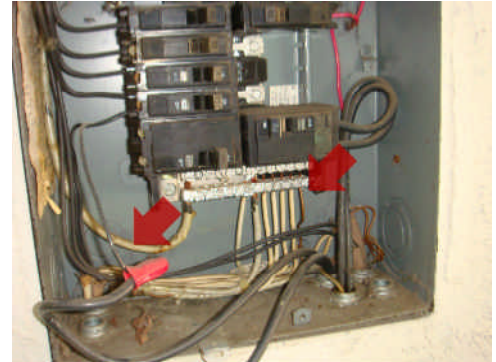
[CR] The circuit breakers are not labeled. The circuit breakers should be accurately labeled to allow individual circuits to be shut off for maintenance or emergency needs.

[SC] There is irregular /improper and abandoned wiring.

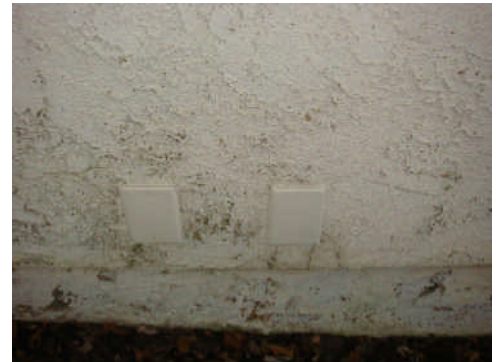
[FE] The cover plates below the panel are sealed /painted, and were not opened. The covers should be opened and evaluated.

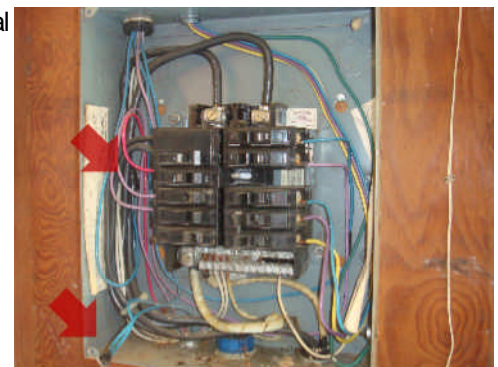
[SC] The panel is lacking a grounding terminal bar, and the ground wiring is connected to the box improperly.

[SC] The pool pumps appear to be operating from 220 volt circuit breakers or multi branch circuit breakers that are missing their handle ties? These ties are required to trip both legs of the circuit in a fault condition.

[FE] There is abandoned wiring in the box. The garage 4 plex receptacle above has two dead outlets.

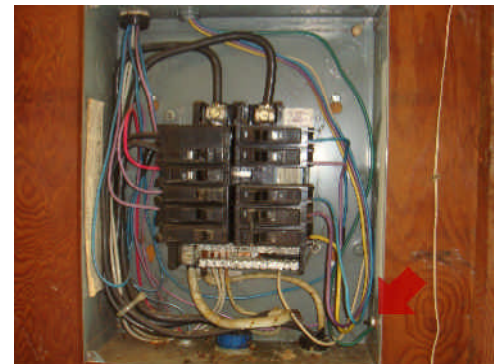
[CR] The pool pumps may be only wired to one 220 volt circuit improperly.

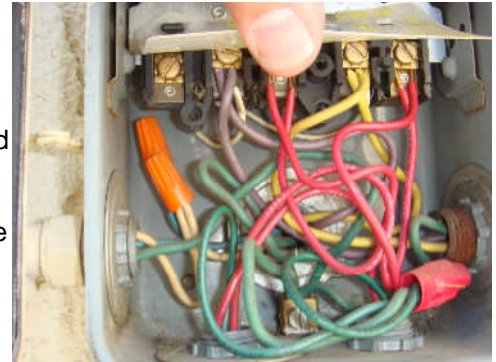
[SC] The excessive and improper wiring in the pool time clock should be evaluated and corrected.

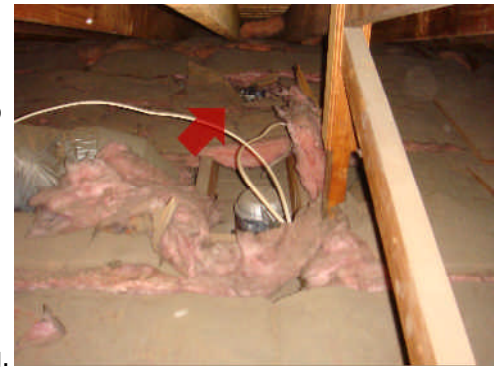
[SC] It is unknown if the all of the ceiling recessed light fixtures are "IC-rated for insulation contact. I recommend the light fixture trims and bulbs be removed to expose the manufactures label to determine the rating.

[RU] Some of the ceiling recessed light fixtures are not IC rated for insulation contact. These fixtures are not energy efficient.

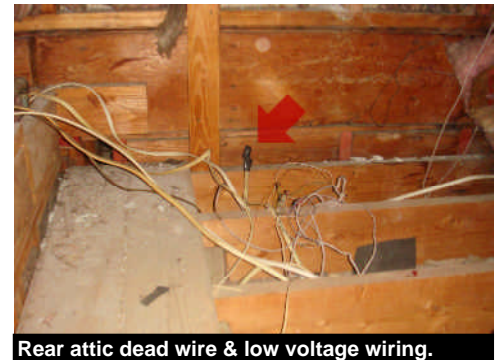
Rear attic dead wire & low voltage wiring.

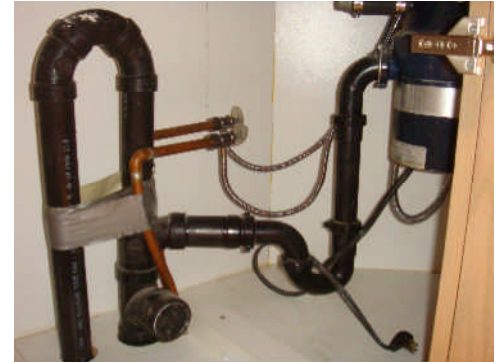
[CR] The island sink drain vent riser loop is short. The loop should be installed as high as possible below the counter top.

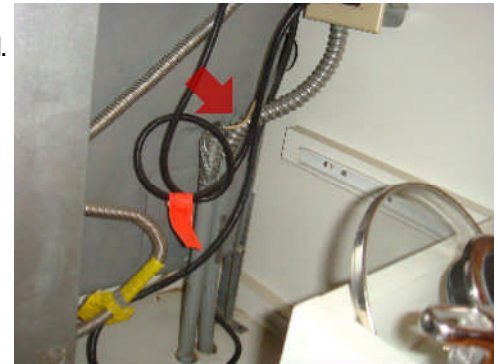
[CR] The counter GFCI receptacle adjacent to the main sink is the power supply to the island. This installation is irregular.

[CR] Only one receptacle is provided at the island, and the location is irregular.

[FE] There is an abandoned wire below the cooktop. The function of the wire is unknown.

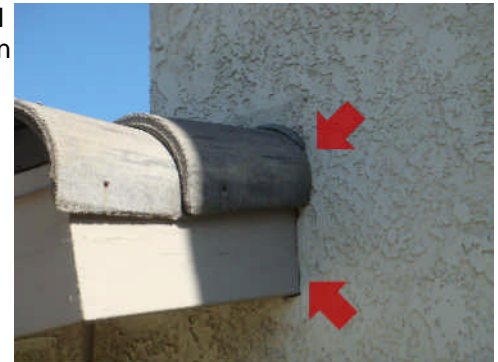
[FE] I recommend the tile roof /flashing to wall intersection be evaluated for moisture intrusion adjacent to the family room ceiling.

[CR] Wind could have driven unwanted rain water into the wall at the roof and fascia void / gap.

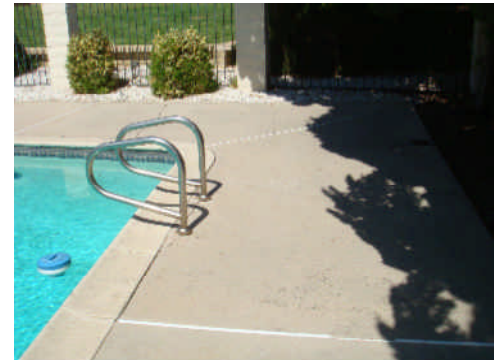
**1608 DECKING** [SC] The pool decking has settled /lifted and cracked. This condition is conducive to moisture intrusion into concealed spaces and/or a trip hazard.

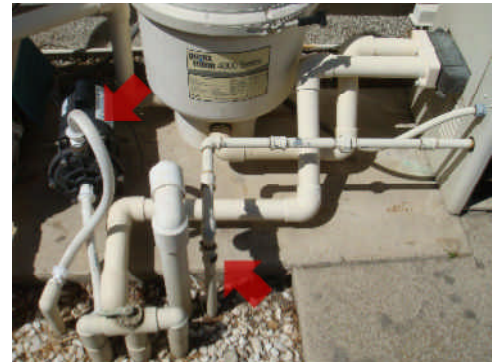
[CR] Leak evident at the pump and pipe connection.

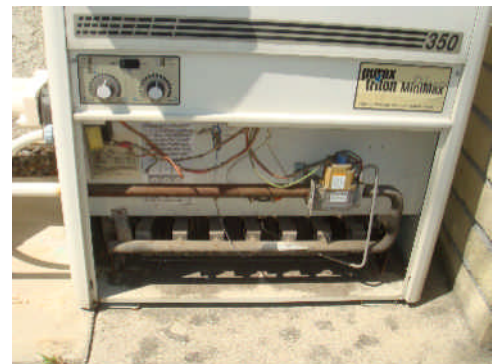
The 10 year old heater functioned, with exception.

[SC] The gas supply valve may leak.

The heater should be kept clean.

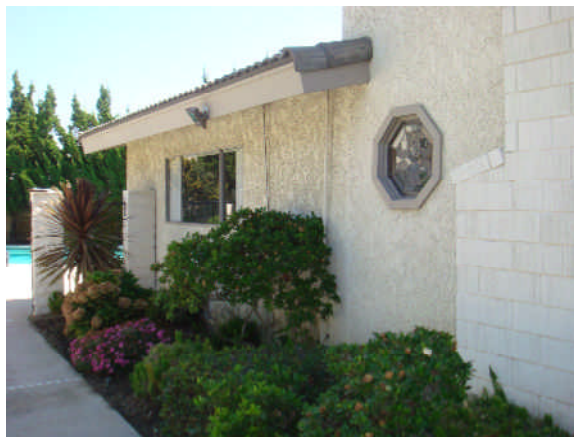
This picture shows the location to the roof and fascia location to the family room.
