Pre-purchase Home Inspection Report

Sample of a 78 year old 2,000 square foot house

Steve Garcia Inspections

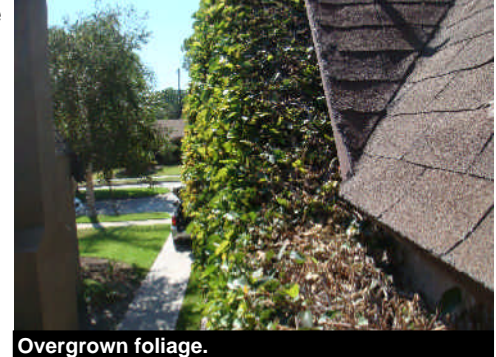
[CR] The foliage at the right side of the house is overgrown and appears to be bowing out, and is only secured by 1/8" rope and hook screws fastened into the roof edge trim boards.

I recommend an arborist evaluate the foliage and prescribe the fastening and maintenance of the bushes.

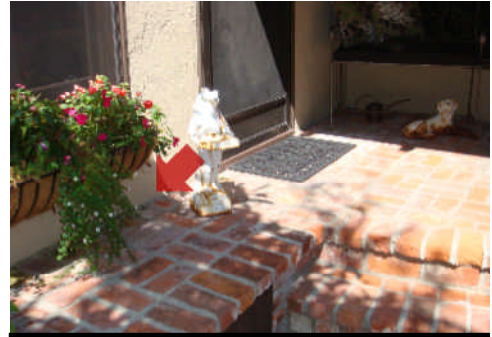
321 FLASHINGS [FE] There is no metal flashing installed behind the siding and on top of the front entry brick bench and pond.

Surface appears level with interior floor.

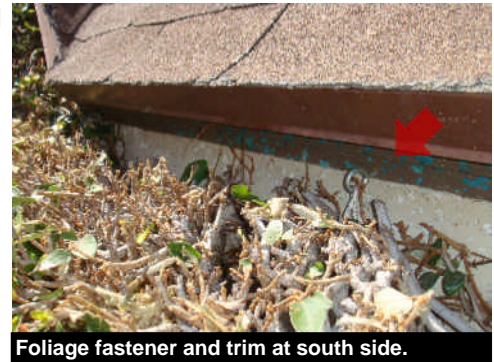
Foliage fastener and trim at south side.

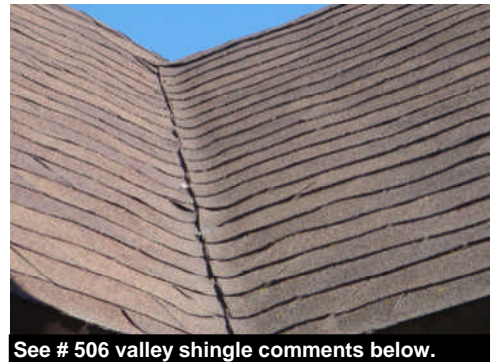
See # 506 valley shingle comments below.

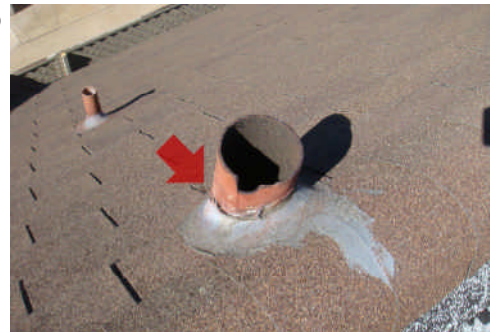
Seal chipped iron vent pipe.

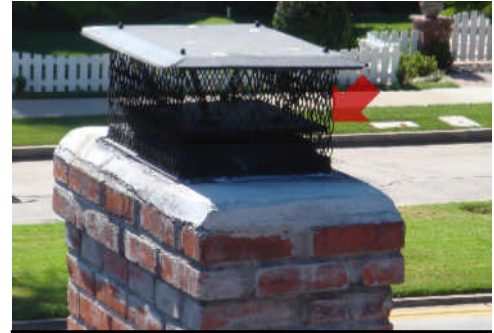
The damper operation should be evaluated.

713 COMMENTS [FE] I recommend an inspection by a qualified fireplace specialist. My inspection of the chimney flue is limited to the readily visible portion from the firebox only. The inner reaches of a flue are inaccessible. A qualified fireplace specialist will remove the flue cap and use a specialized video camera as needed to evaluate the flue.

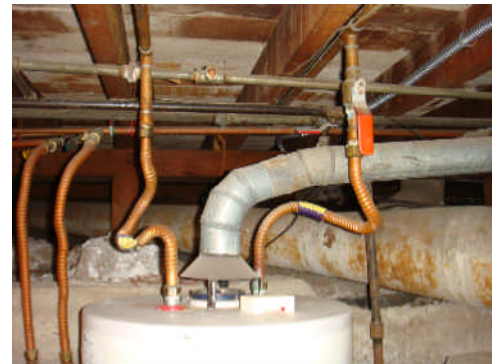
[RU] The shutoff valve and water supply connectors appeared functional. Valves are not operated.

I recommend insulating the exposed water piping and connectors to minimize heat loss.

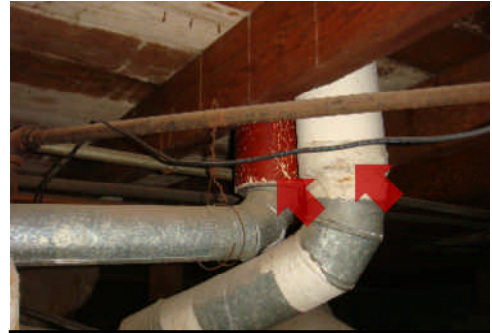
The water heater may not vent properly due to the single wall suspected undersized connector and the cementitious flue.

Water heater & abandoned furnace vent flue

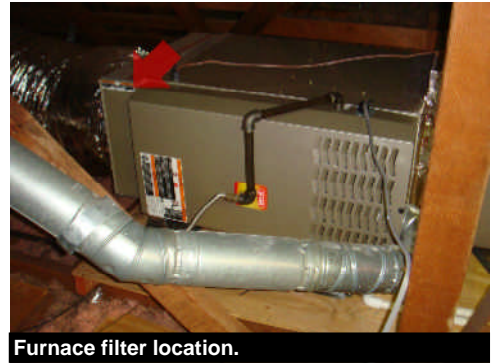
Disposable filters at the hall ceiling and side of the furnace.

Furnace filter location.

Replace the filters with pleated type every 6 mounts.

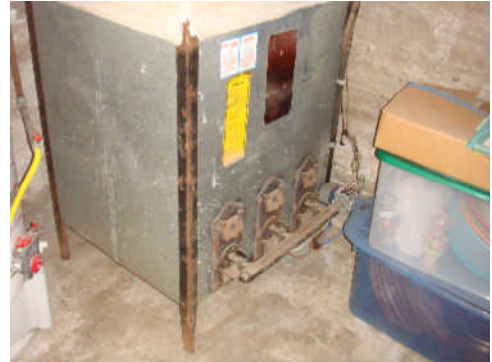
The original gravity furnace in the basement is abandoned, the gas supply is capped off.

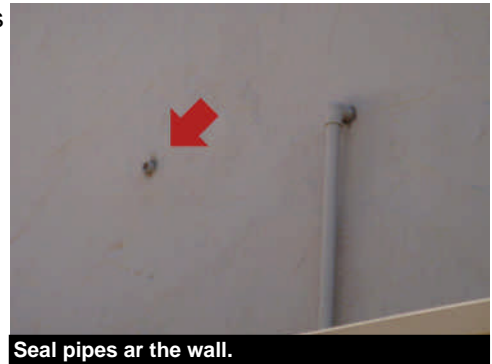
[CR] The secondary drain pipe does not extend out properly and is lacking an elbow pointing down.

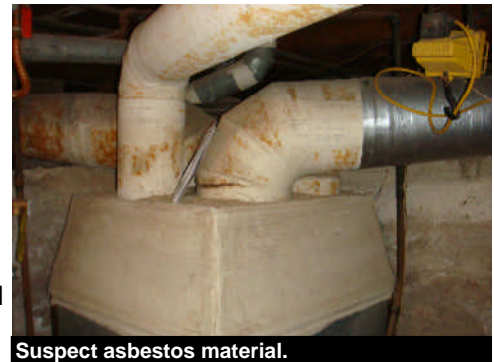
[FE] The wrap around the ducts and plenum appears to be asbestos material.

The original interior wall registers are in place. I recommend sealing off to prevent any air from entering the building from the abandoned system.

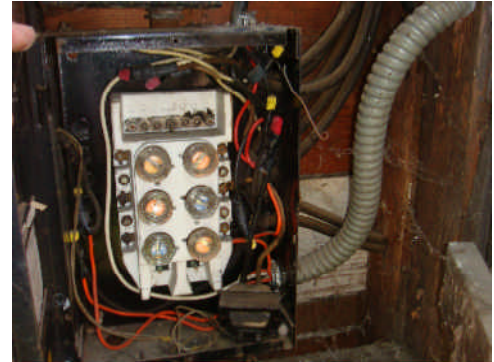
[FE] The original panel cloth insulated wiring in the original fuse box are through the metal box. When updating the main service panel the fuse box could be used as a junction box without the fuses and with bushings for wiring protection.

I recommend building permits be obtained for the updated electrical panels.

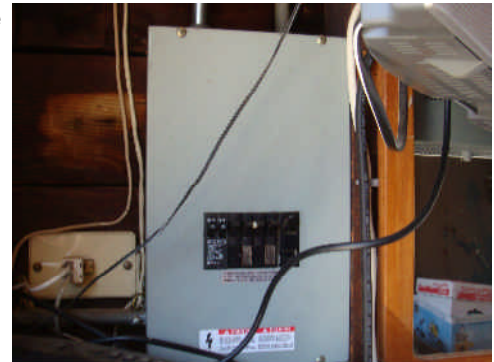
1215 SUB-PANEL(S) [CR] The circuit breakers are not labeled. The circuit breakers should be accurately labeled to allow individual circuits to be shut off for maintenance or emergency needs.

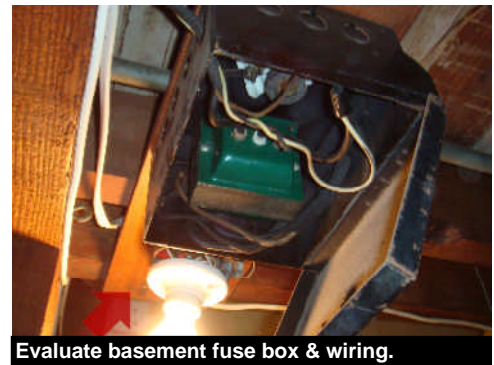
[SC] The basement light fixture bulb is hanging from it's wires.

[FE] The home owner stated the front exterior light fixture and photo cells are not operational and abandoned.

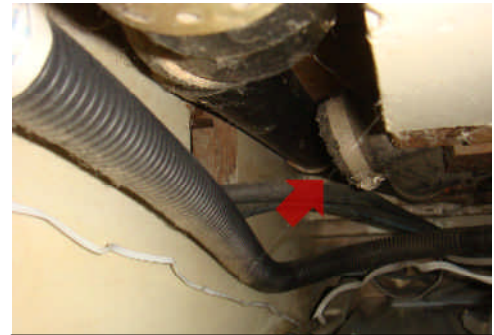
**1315 WET
BAR(S)/
PLUMBING** The wet bar drain pipe is capped off adjacent to the laundry drain pipe.

Capped wet bar drain pipe.

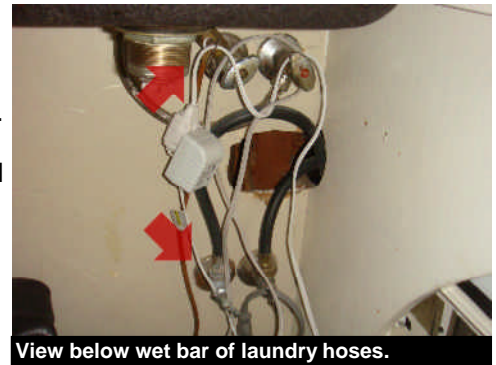
The hot and cold water supply pipes are reversed below the sink.

Copper tubing connected to cold valve is feeding filter in the craw space.

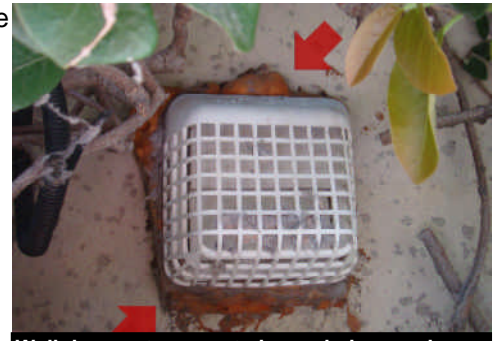
[CR] The dryer vent hood at the exterior wall should be cleaned and the screen removed.

Wall does not appear to be sealed properly

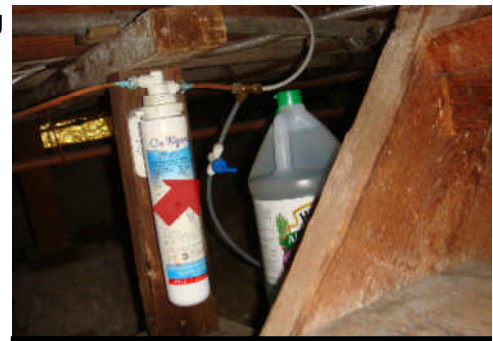
The blue valve is shutoff and the plastic tubing is abandoned in the crawl space.

Filter in crawl space.

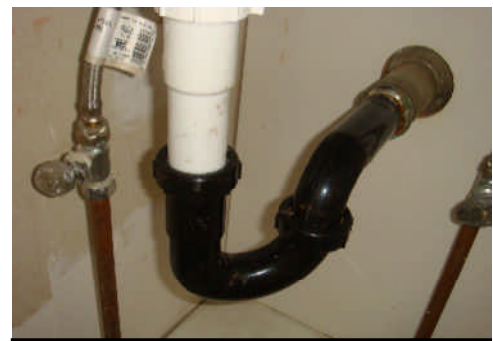
View below the 3/4 bath basin.
