# *Pre-purchase Home Inspection Report*

Sample of a 83 year old 1,000 square foot house

California Real Estate Inspection Association Master Inspector

***Steve Garcia Inspections***

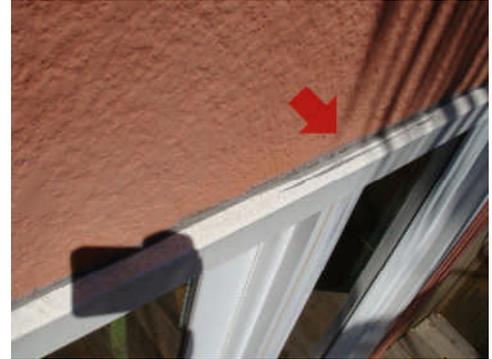
**321 FLASHINGS** [FE] There is no metal flashing installed behind the siding and on top of the door and window trims.

The caulking and paint at the heads of the trims should be maintained.

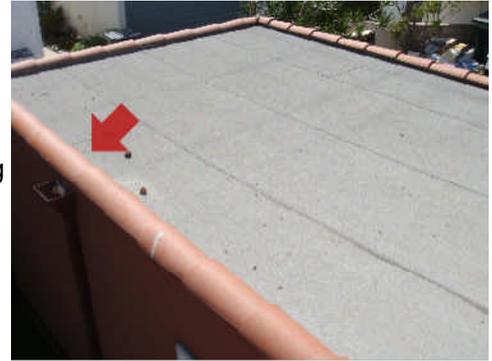
**Description:** The low sloped roofing material has been updated with a suspected single-ply torch applied modified bitumen.

The roof is functional. The roof only has one drain, and the tree drops debris that could plug the drain. Keep the tree cut back.

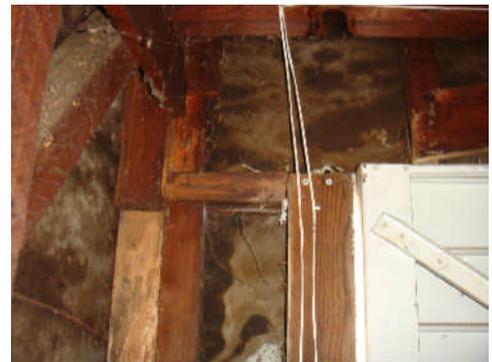
[FE] I recommend the rear door framing be evaluated and updated for seismic movement.

[FE] The exposed /visible wall sill plate has been bolted.

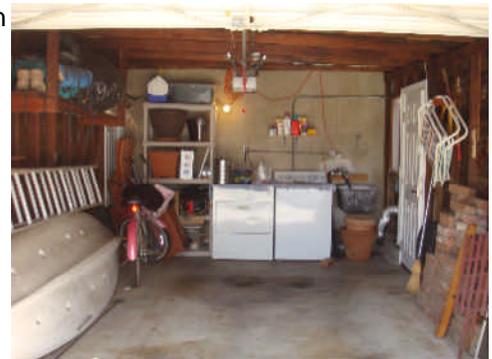
[FE] The suspected added laundry machines have reduced the garage parking space to 15' from the door to the machines.

[SC] A vehicle impact barrier post is not provided in front of the gas dryer.

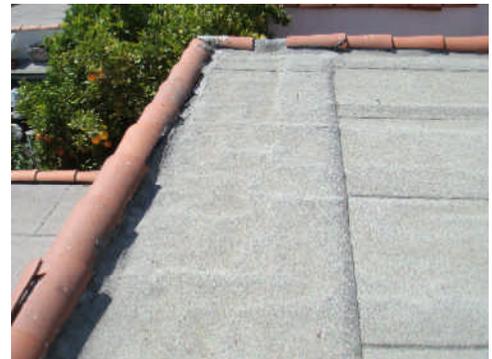
[CR] The roofing material is separating from the parapet walls below the tile caps.

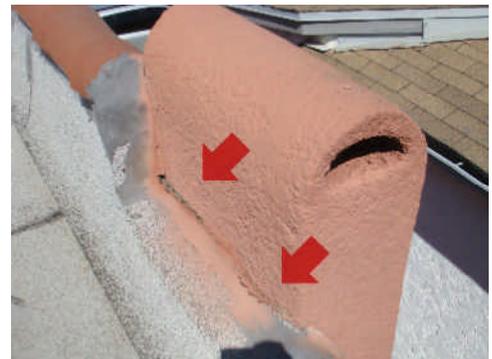
**516 COMMENTS** [CR] The roofing material and mastic /tar is separated from the left short cosmetic chimney.

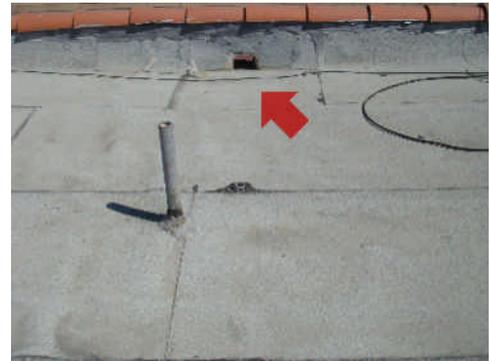
**527 COMMENTS** There is only one 4" roof drain at the left side. The roof drain area should be kept free of debris and wires.

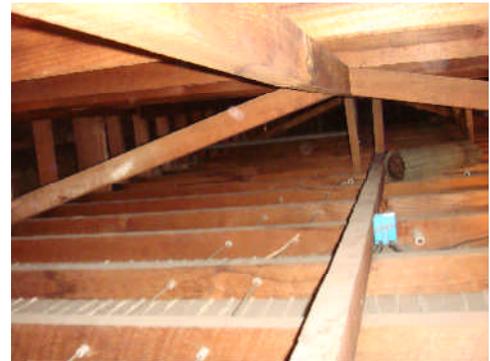
**602 COMMENTS** [SC] The kitchen vent duct is separated. This condition is potential a fire safety hazard.

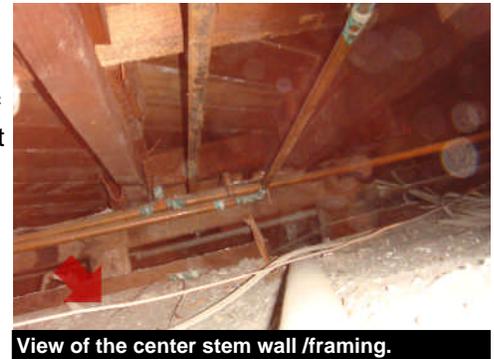
[FE] The concrete foundation has evidence of cracking possibly due to settlement/movement and/or seismic activity.

[CR] There is a condition known as efflorescence on portions of the foundation walls. This is a salt deposit left when moisture in the foundation evaporates. It indicates that the foundation is experiencing wet and dry cycles. I recommend the exterior grading and drainage be improved to divert moisture away from the foundation.

View of the center stem wall /framing.

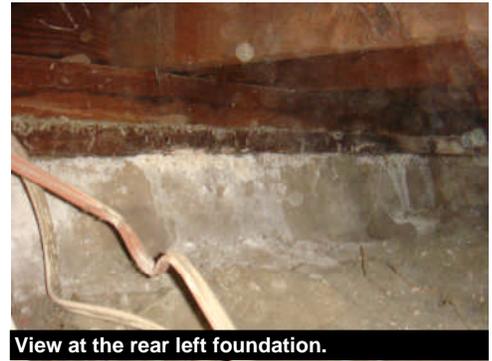
**815 COMMENTS** View of electrical metal flex conduit on the soil improperly, and foundation /crawl space limited access adjacent to the water heater.

**814 INSPECTOR RECOMMENDS** [CR] I recommend drainage improvements at the left and rear of the house /foundation.

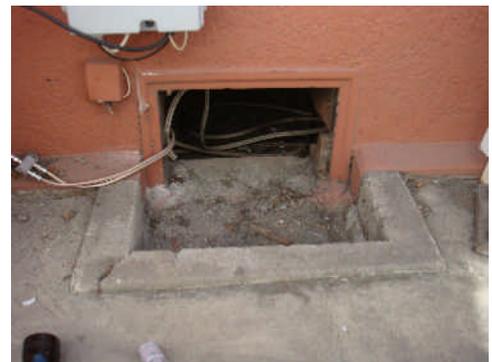
[CR] The crawl space is too low to fully enter and inspect. Only the rear left was somewhat accessible.

[FE] Only 1/4th of the crawl space could be inspected due to the low head clearance and center stem wall /framing.

[CR] Access should be made a for full inspection and maintenance needs.

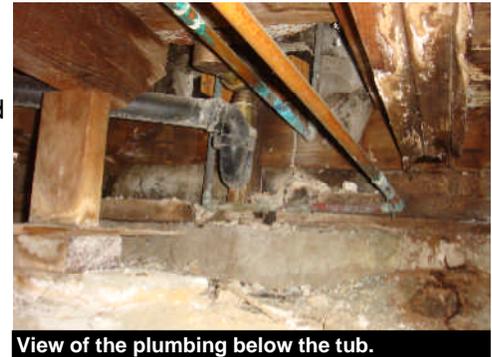
[FE] The tub spout pipe is loose in the wall.

View of the plumbing below the tub.

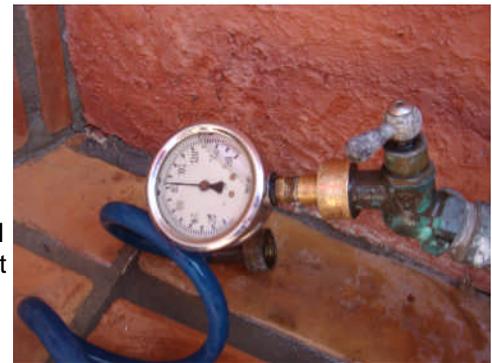
[CR] The front hose faucet /bib handle was damaged /missing.

[RU] There are no anti-siphon backflow preventers on the exterior hose faucets /bibs. I recommend installing these devices to prevent water in the hose from entering the building water supply.

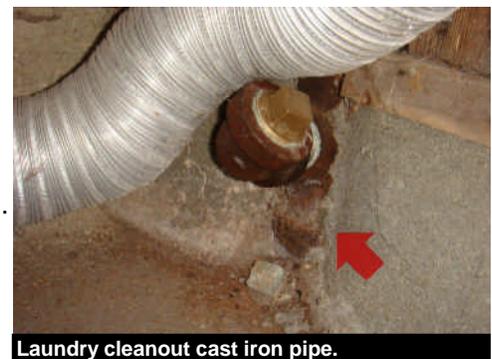
[FE] There is corrosion and rust on the cast iron drain piping, no leakage noted.

Laundry cleanout cast iron pipe.

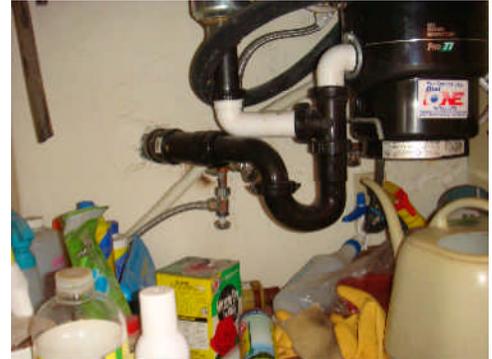
[CR] The kitchen left sink drain is slow or blocked. The drain pipes configuration is irregular.

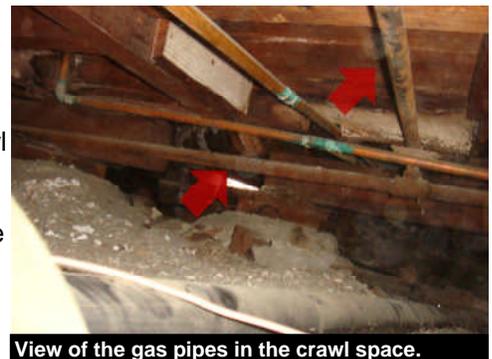
[FE] I recommend all of the rusty gas pipes be evaluated after access is made in the crawl space.

The picture shows the cut /notched framing adjacent to the toilet water closet.

View of the gas pipes in the crawl space.

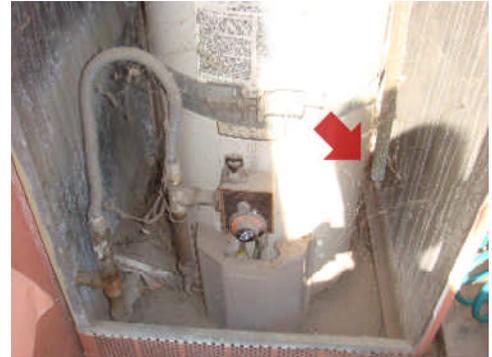
[CR] The temperature /pressure relief valve discharge line is too short. An approved discharge line should be installed extending to the exterior and terminating close to the ground facing downward.

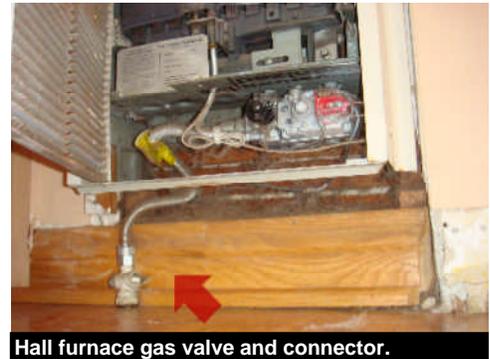
[FE] The hall furnace is an older unit. I recommend having the furnace heat exchanger evaluated by an licensed heating contractor specialist.

Hall furnace gas valve and connector.

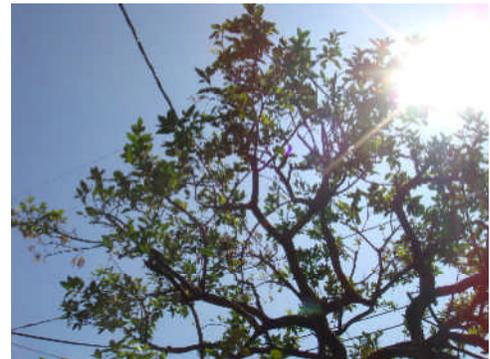
[CR] Tree branches are in contact with the overhead service entrance cables.

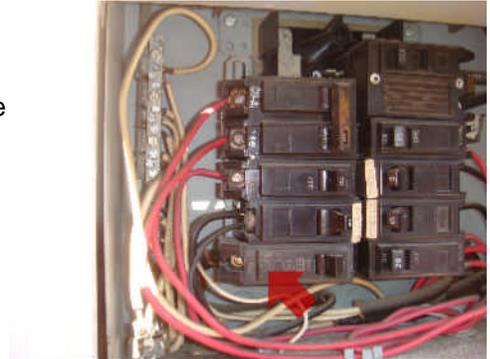
[FE] The bottom left circuit breaker may not be compatible to this panel. An original cloth insulated wire is connected to the 20 amp. breaker.

[FE] Double lugging is evident at one of the circuit breakers.

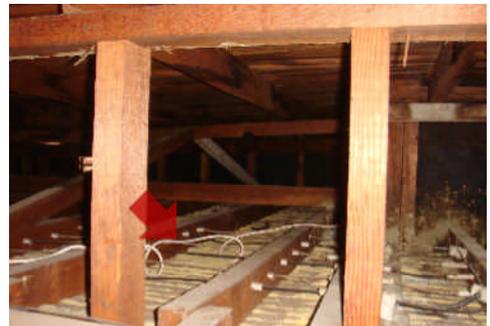
Original knob & tube & added wire in attic

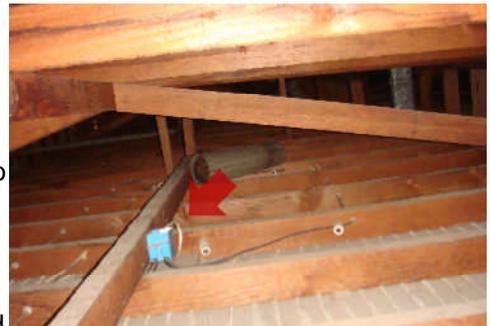
[FE] The kitchen has been remodeled with new lighting and visible wiring in the attic. The attic area over the kitchen was not accessed to inspect the wiring. There appears to be an exposed wiring splice and uncovered junction box in the attic.

Romex wire spliced into knob & tube wiring

[CR] Metal flex conduit should be secured and separated from the soil in the crawl space.

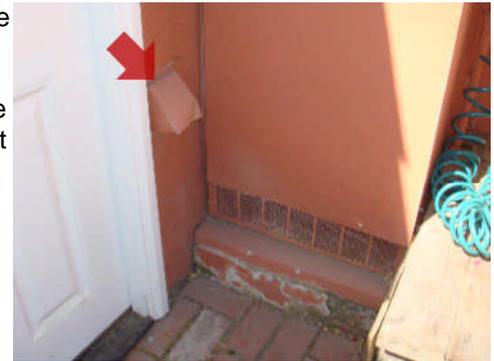
The lint is a combustible material and should not be allowed to buildup in front of the tank.

[FE] I recommend blowing the vent duct out before connecting the dryer to remove any lint that may be in the duct and hood.

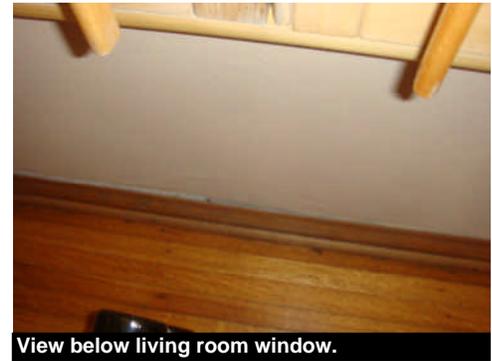
[FE] The cause of the living room wall blistering should be evaluated.

The home owner should be consulted as the cause of the hall wall damage.

View below living room window.
